# **CITY OF LOMA LINDA**

**BENCH MARKS**

# City of Loma Linda Bench Mark Map

# Bench Marks

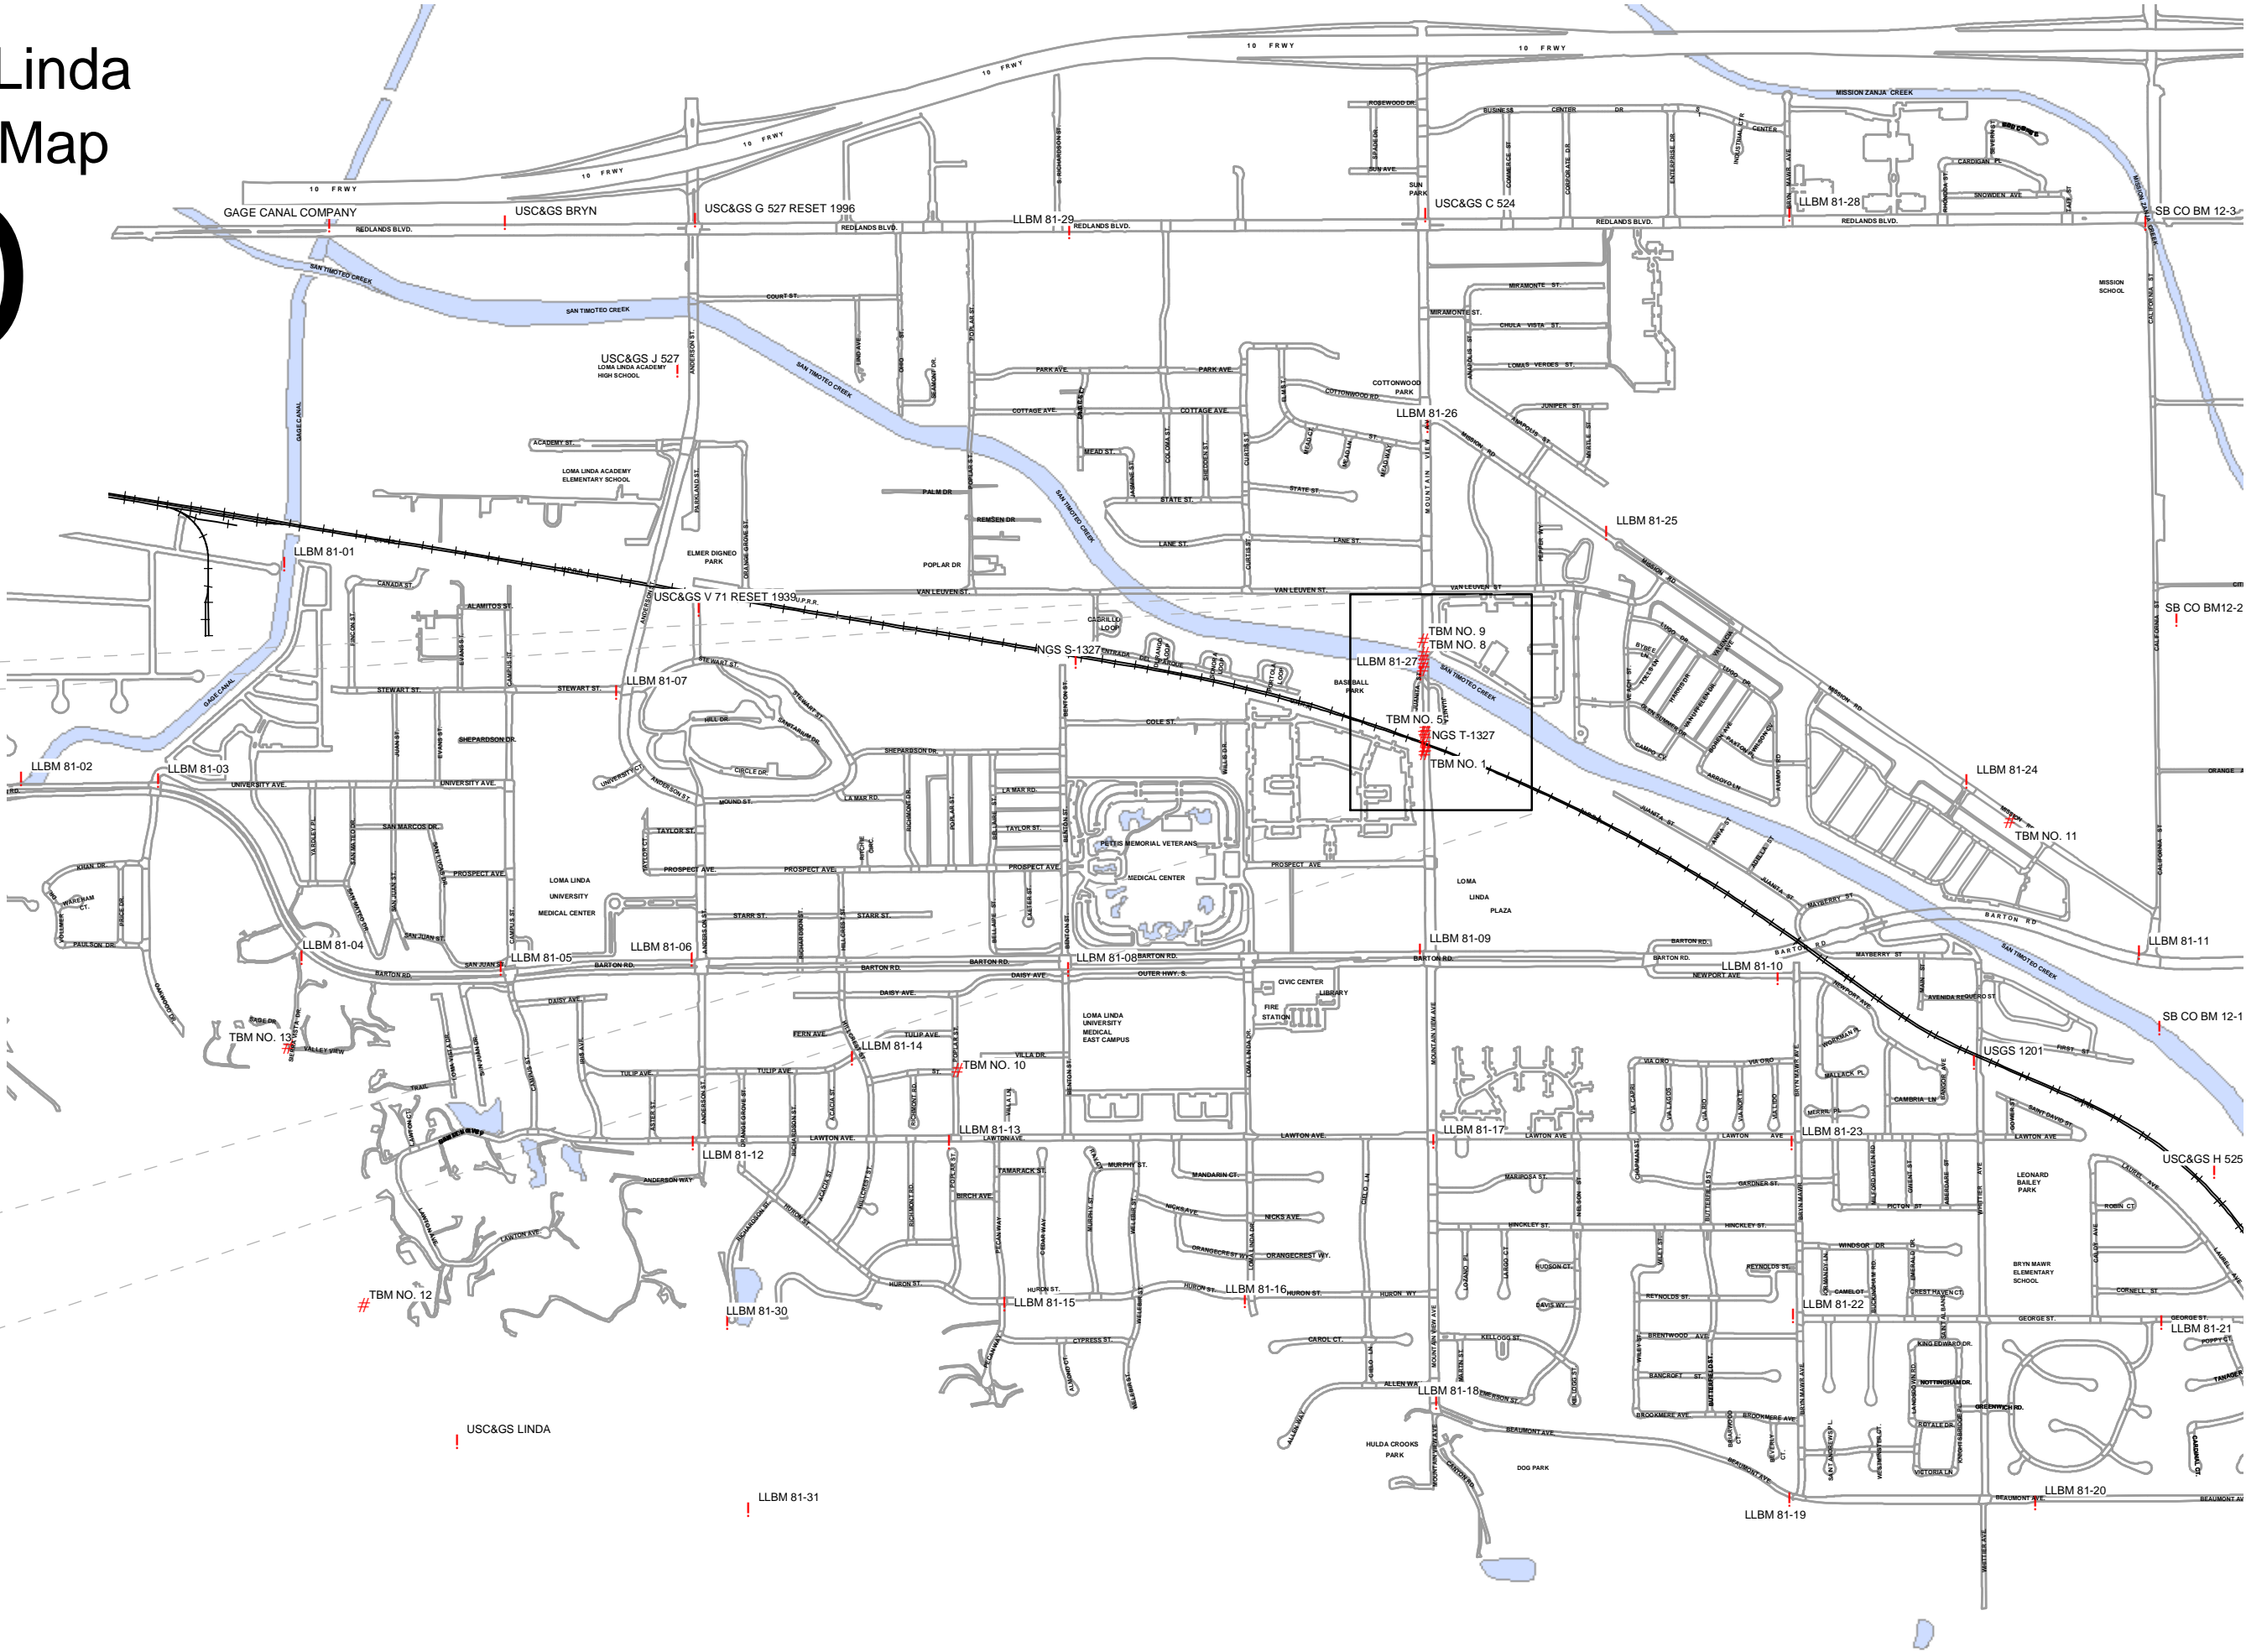
## Bench Mark Types

- # Temporary Bench Mark
- ! Bench Mark

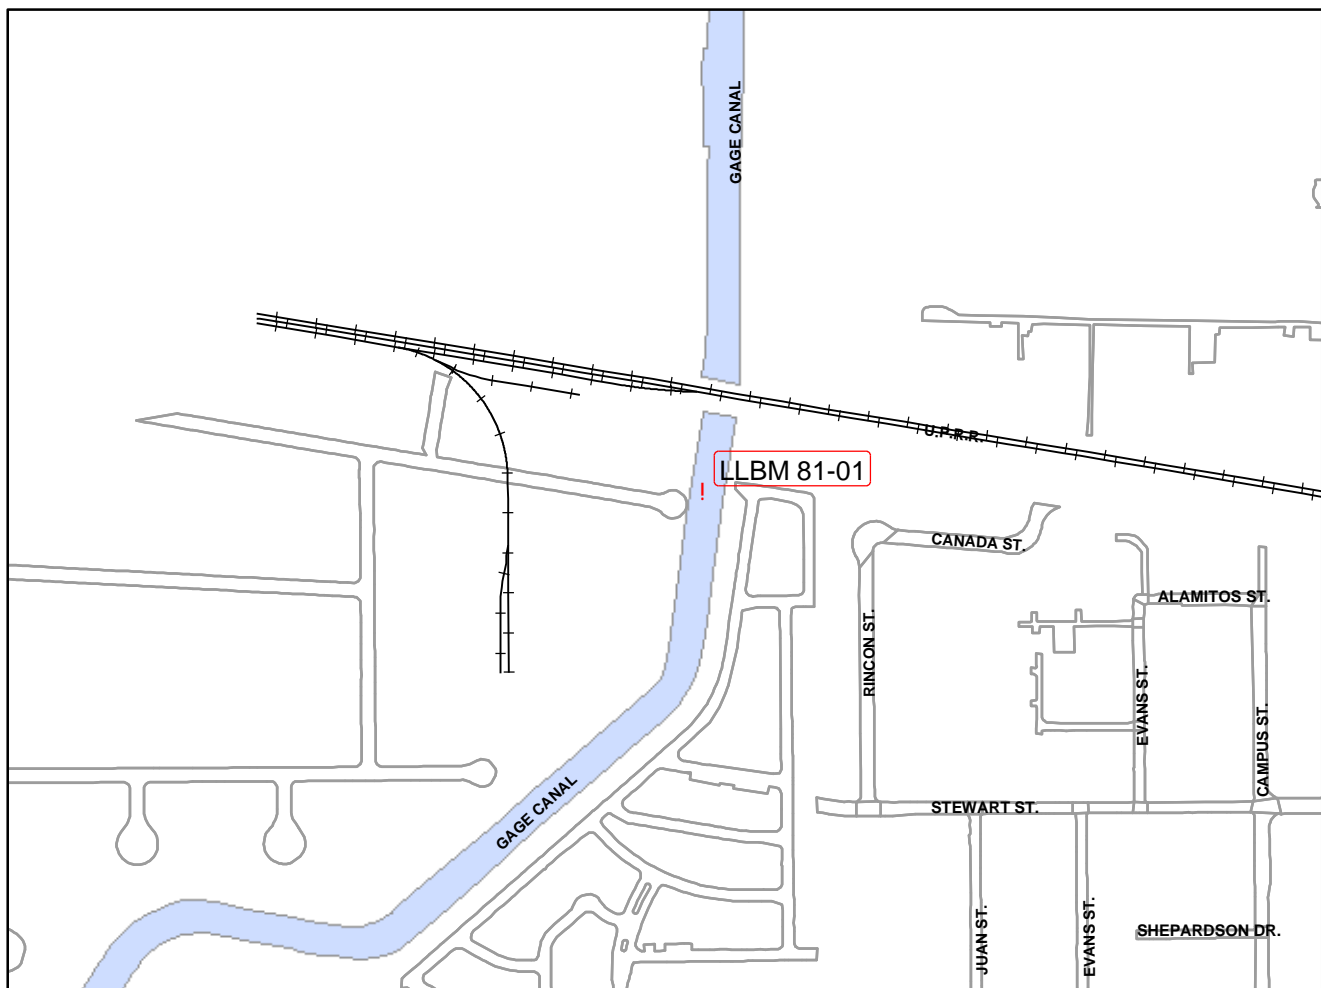
**LLBM 81-01**

BRASS CAP IN N.W. CORNER OF TOP OF CONC.  
BOX 4 FT. ABOVE GROUND OVER GAGE CANAL.  
280' SOUTH OF R.R. TRACK AND 50' NORTH AND 40'  
WEST OF CL AT DEAD END OF INDUSTRIAL ROAD

1045.844

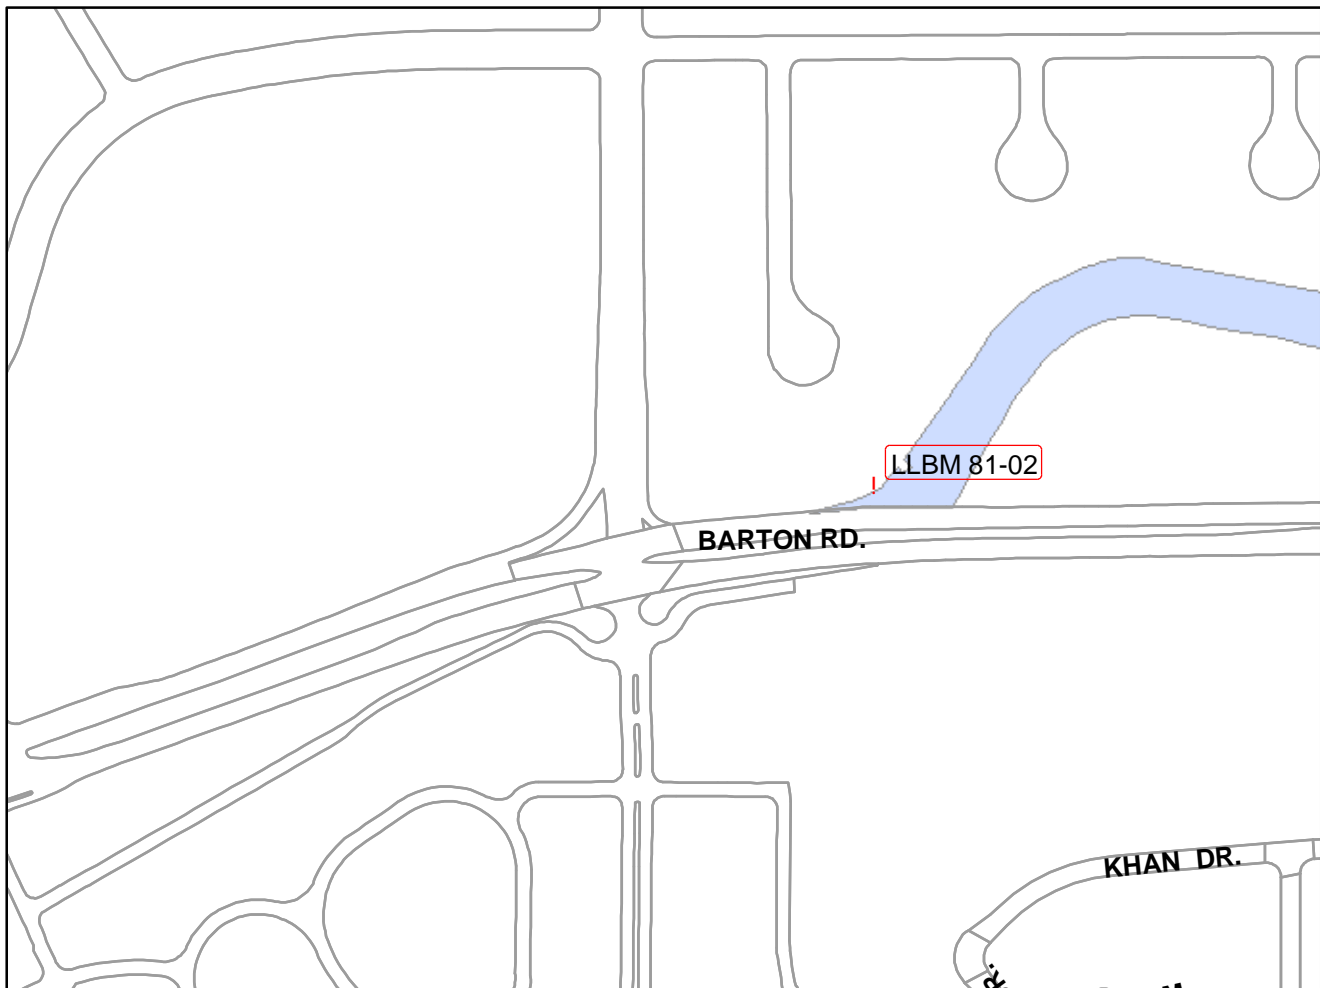
**LLBM 81-02**

BRASS CAP ON TOP OF SOUTHERLY CONC.  
HEADWALL OF OUTLET STRUCTURE FOR GAGE  
CANAL, 45' NORTH OF NORTH CURB ON BARTON  
RD., 390' + / - EAST OF INT. OF BARTON RD. AND  
WATERMAN AVE.

1040.940

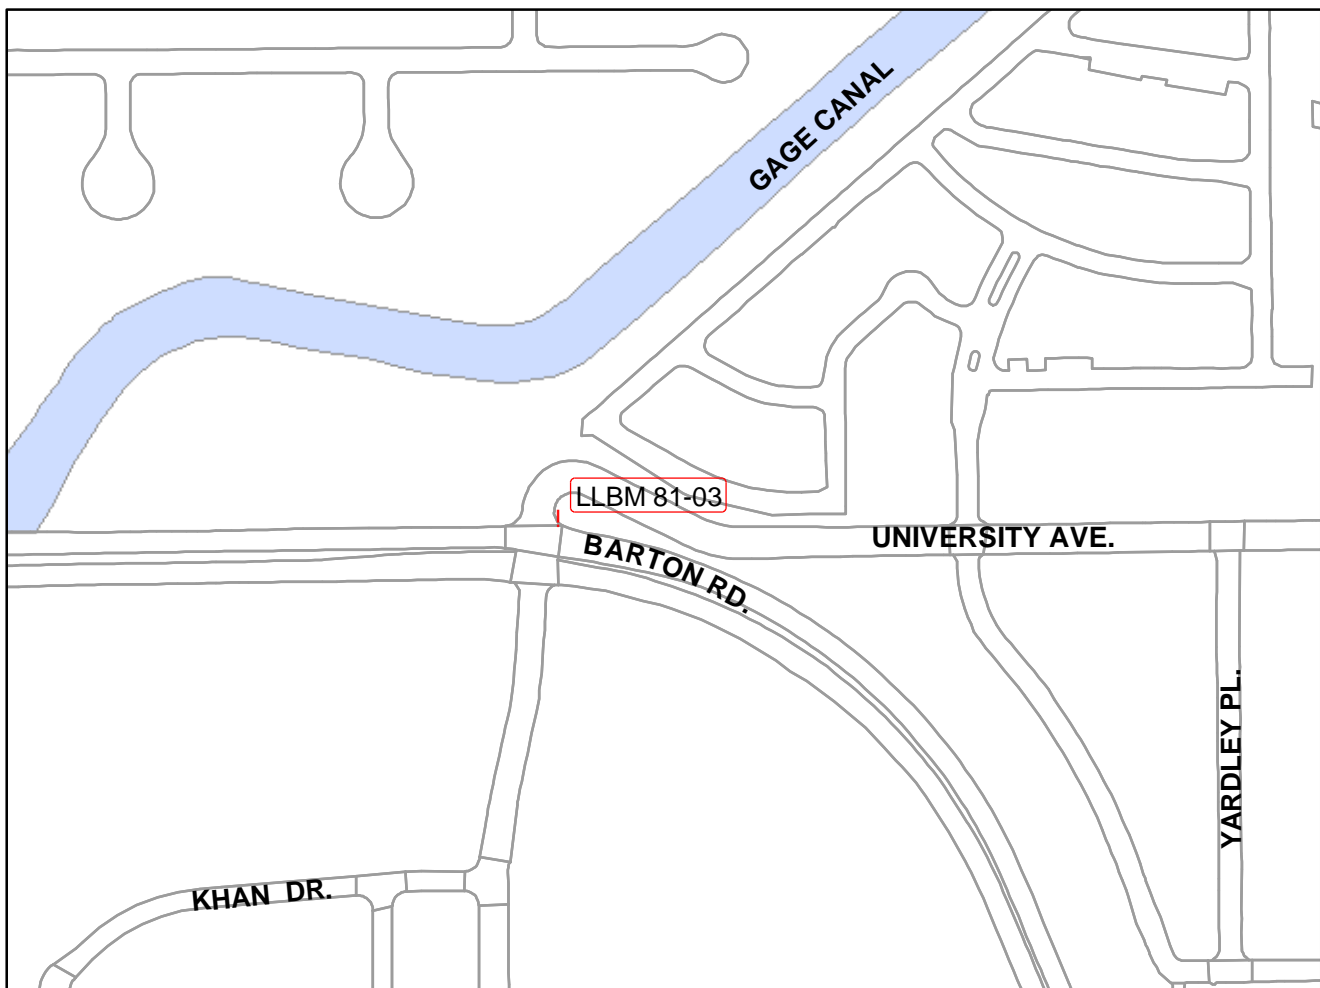
**LLBM 81-03**

BRASS CAP IN SOUTHERLY CONC. SIGNAL LIGHT  
BASE N.E. CORNER AT INT. OF BARTON RD. AND  
UNIVERSITY AVE.

1062.309

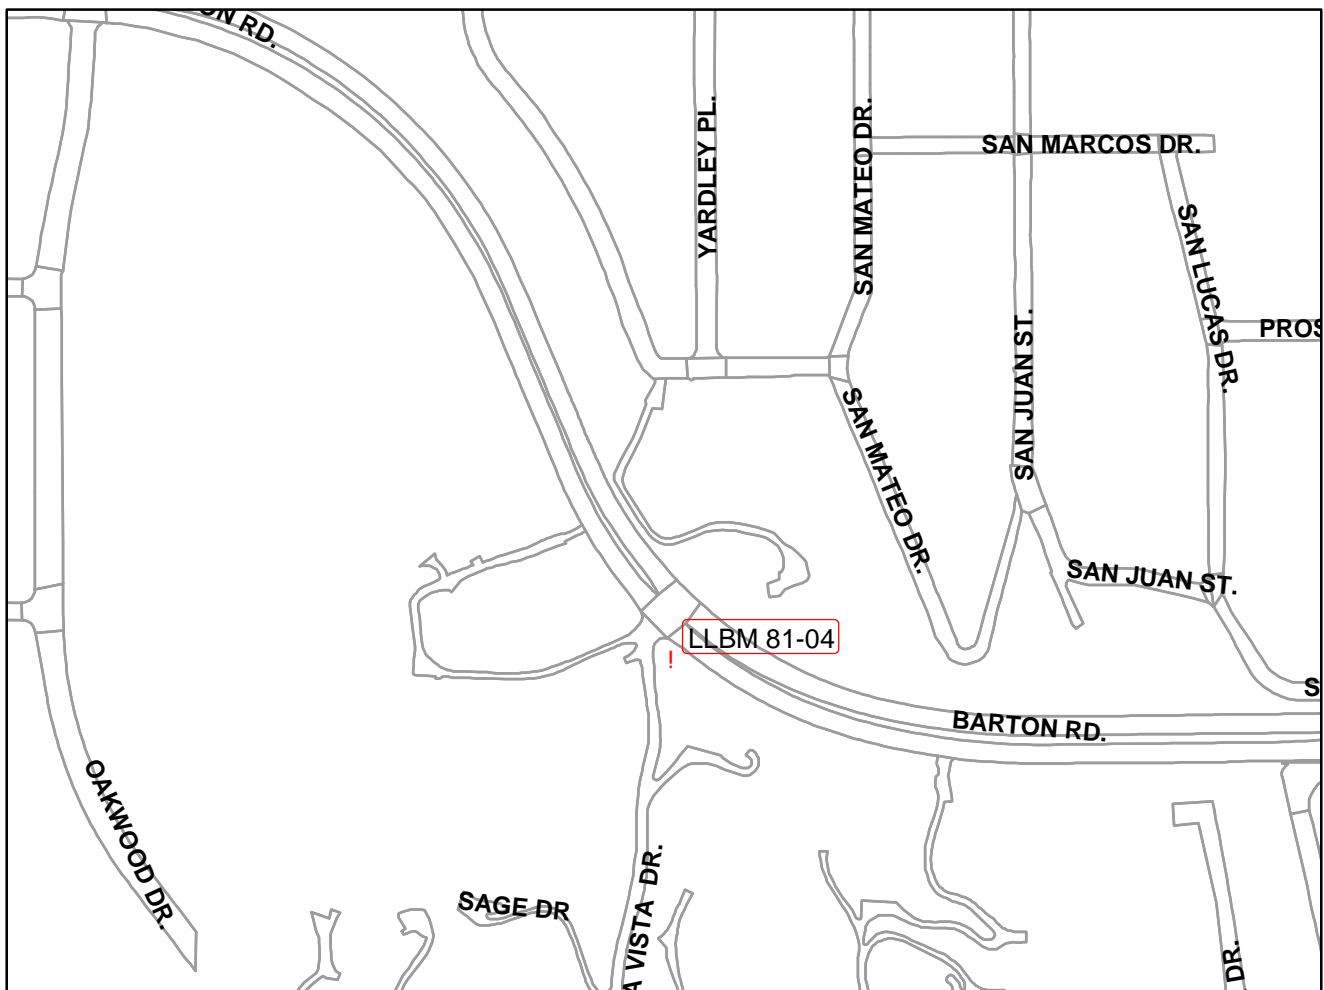
**LLBM 81-04**

BRASS CAP IN TOP OF CURB APPROX. AT M.O.C.  
OF S.E. CORNER AT INT. OF BARTON RD. AND  
SIERRA VISTA DR., 1' N.W. OF POWER POLE

1147.090

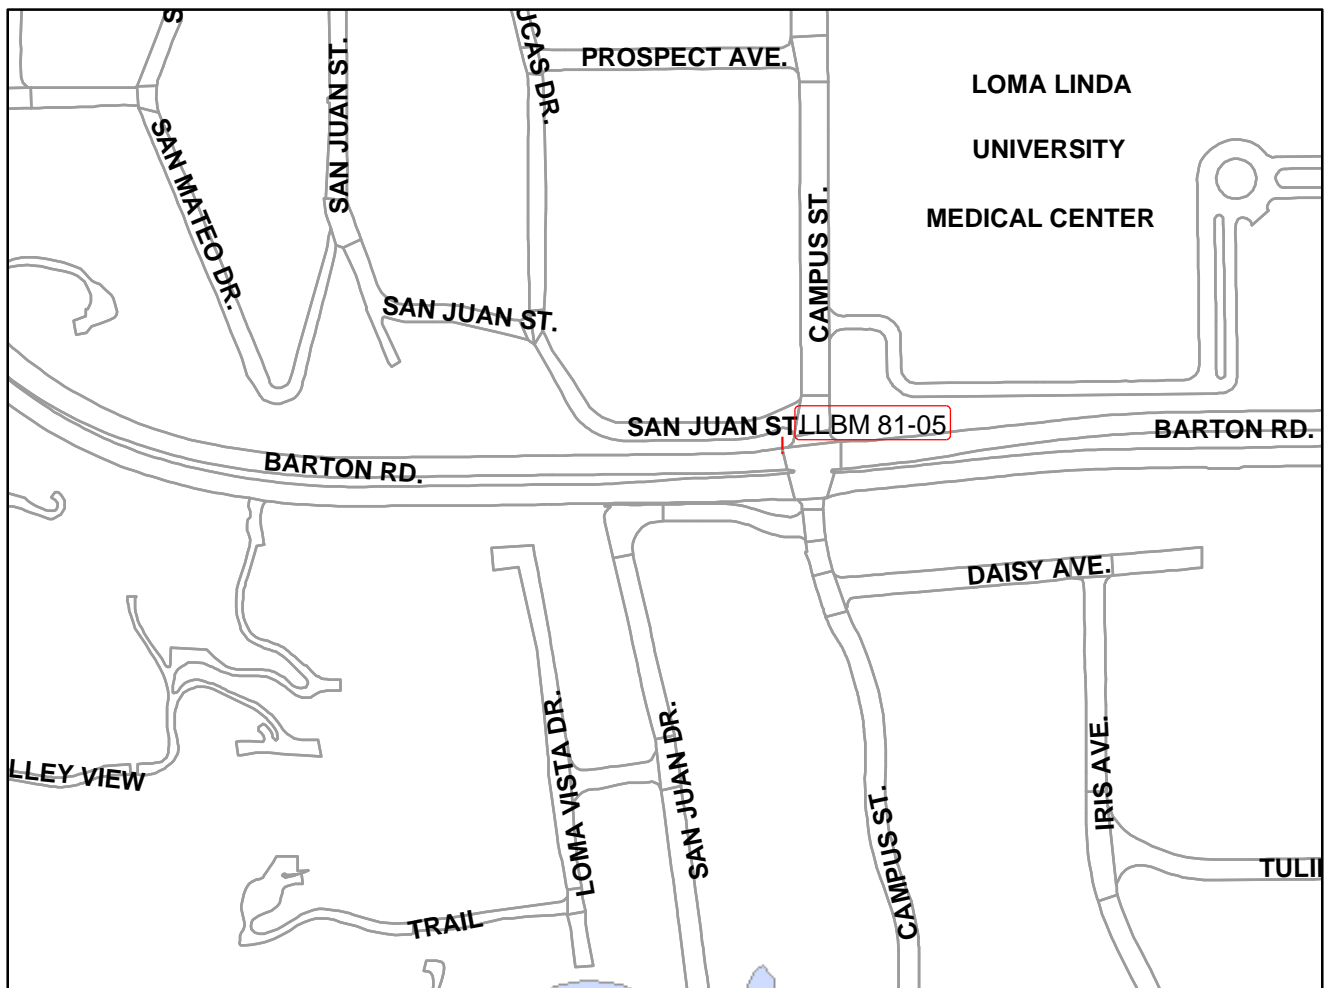
**LLBM 81-05**

BRASS CAP IN CONC. SIGNAL BASE, N.W. CORNER  
AT INT. OF BARTON RD. AND CAMPUS ST.

1152.045

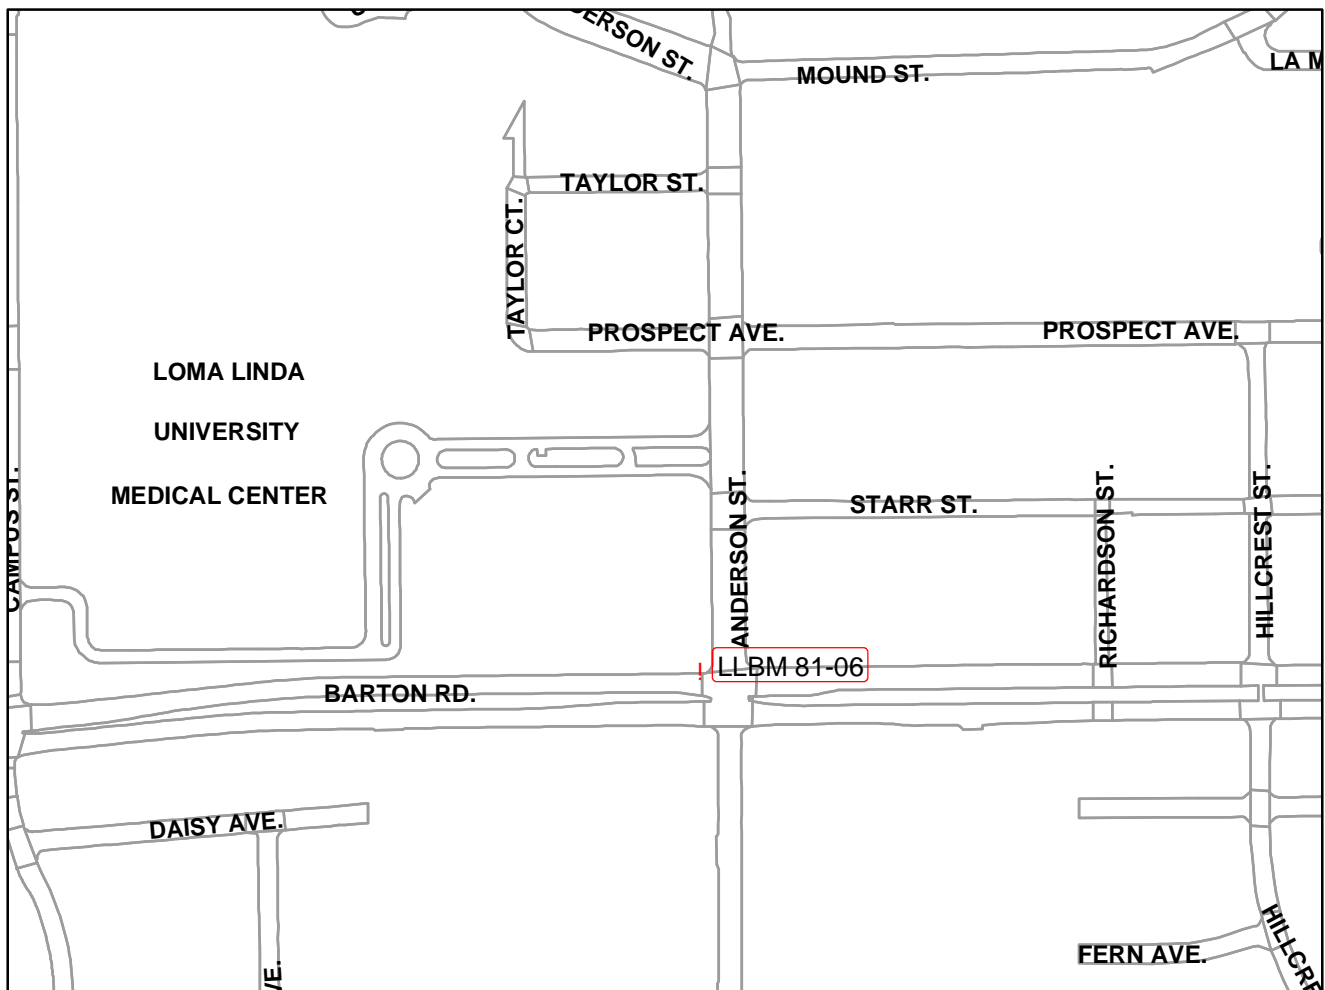
**LLBM 81-06**

BRASS CAP IN CONC. SIGNAL LIGHT BASE, N.W.  
CORNER AT INT. OF BARTON RD. AND ANDERSON  
ST.

1162.385

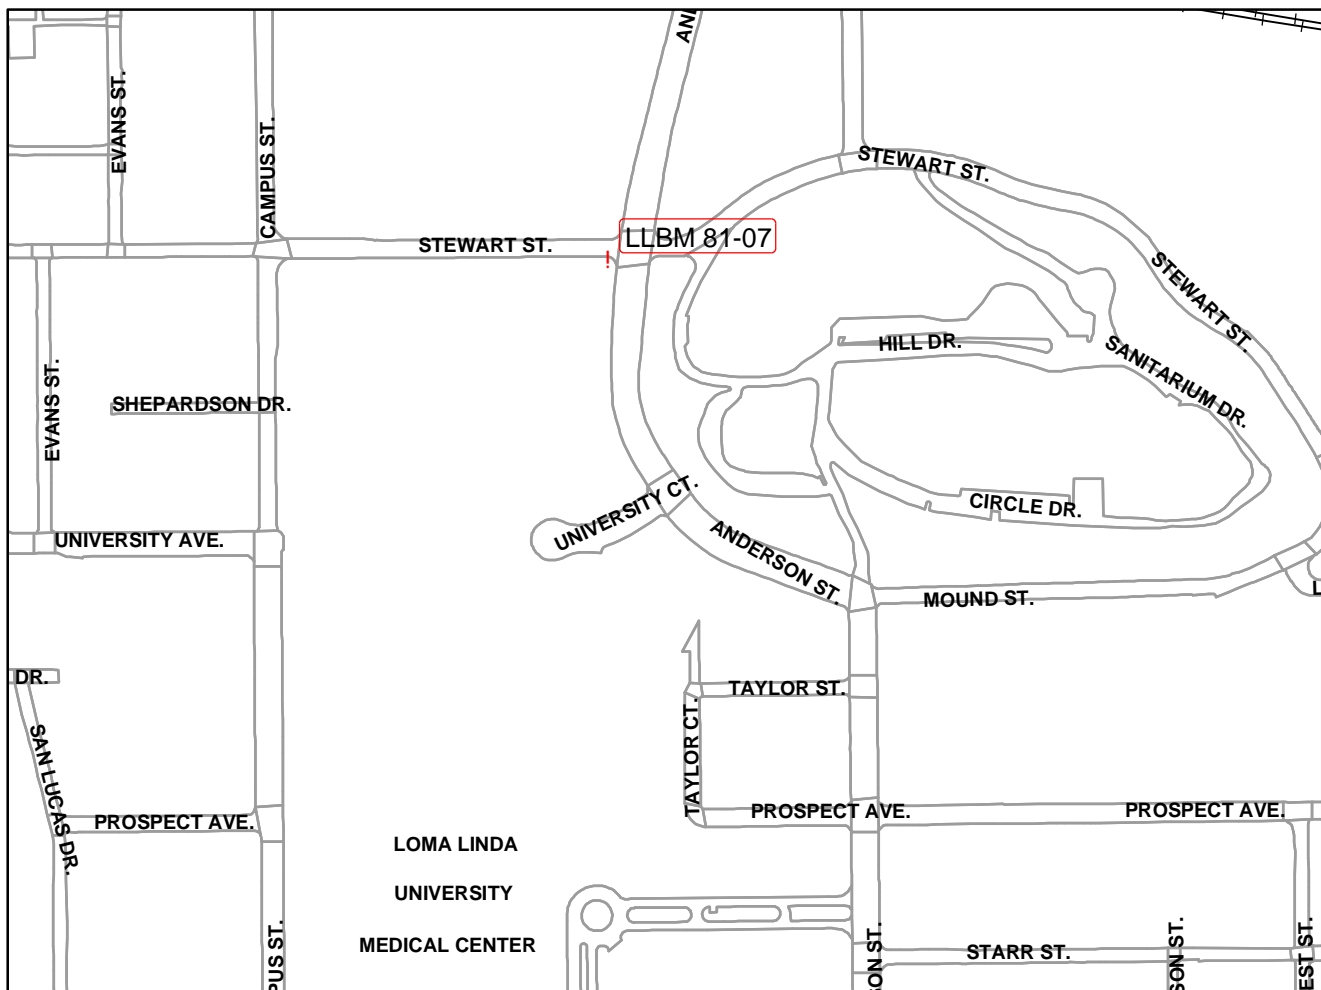
**LLBM 81-07**

BRASS CAP ON CONC. SIGNAL LIGHT BASE, S.W.  
CORNER AT INT. OF UNIVERSITY AVE AND  
ANDERSON ST.

1115.480

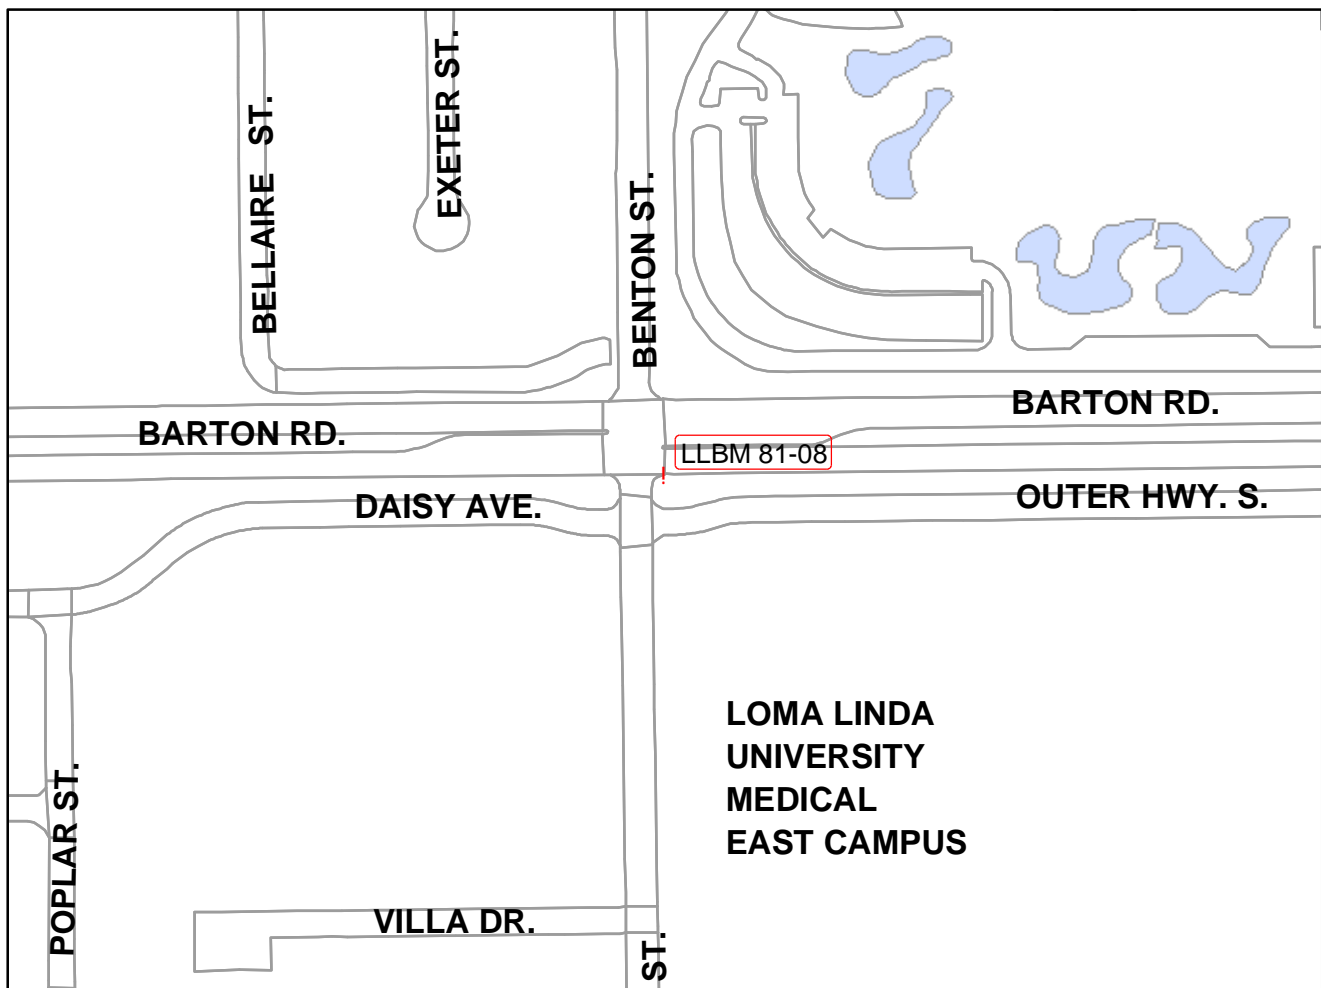
**LLBM 81-08**

BRASS CAP AT THE SOUTHEAST CORNER OF  
BARTON RD. AND BENTON ST. APPROXIMATELY 12"  
BEHIND CURB FACE.

1163.350

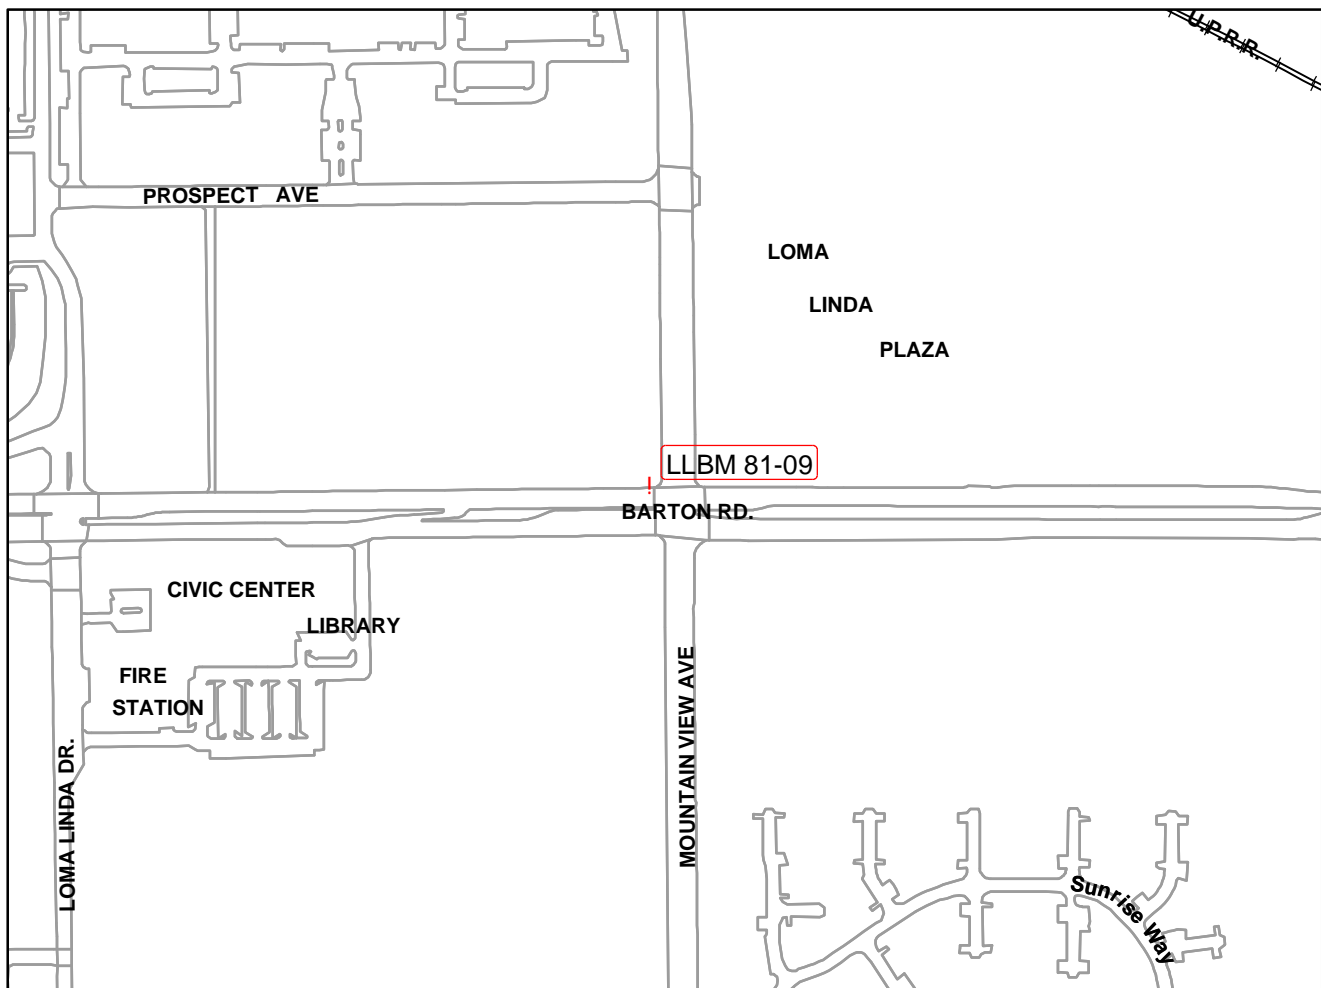
**LLBM 81-09**

BRASS CAP IN CONC. SIGNAL LIGHT BASE, N.W.  
CORNER AT INT. OF BARTON RD. AND MOUNTAIN  
VIEW AVE.

1195.247

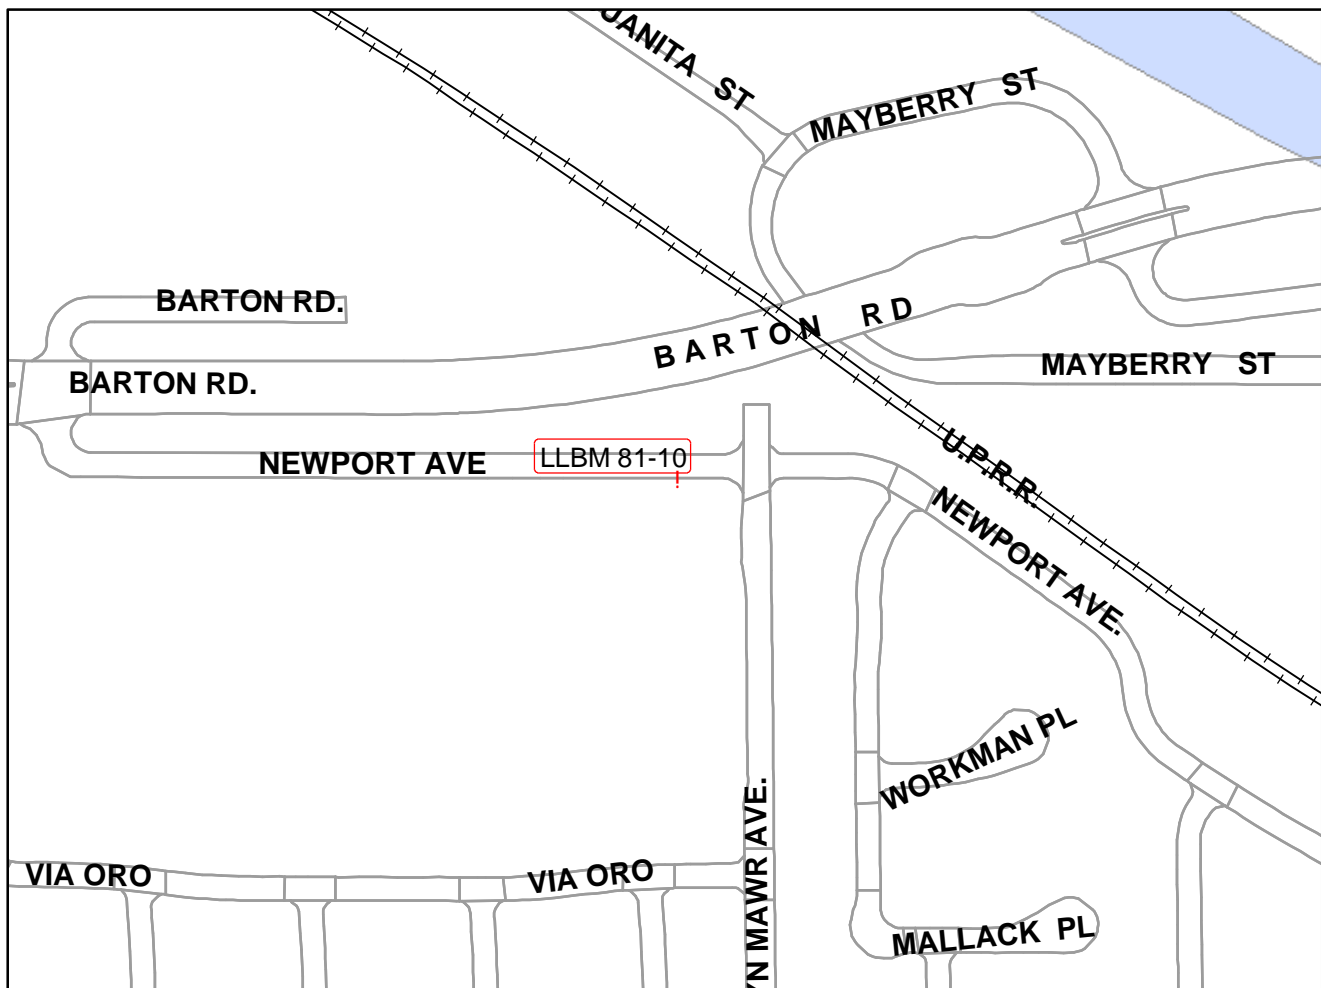
**LLBM 81-10**

BRASS CAP IN N.E. CORNER OF DROP INLET BOX 1'  
BACK OF CURB SOUTH SIDE OF BARTON  
FRONTAGE RD., 111 FT. WEST OF CL INT. BRYN  
MAWR AVE. AND BARTON FRONTAGE RD.

1182.012

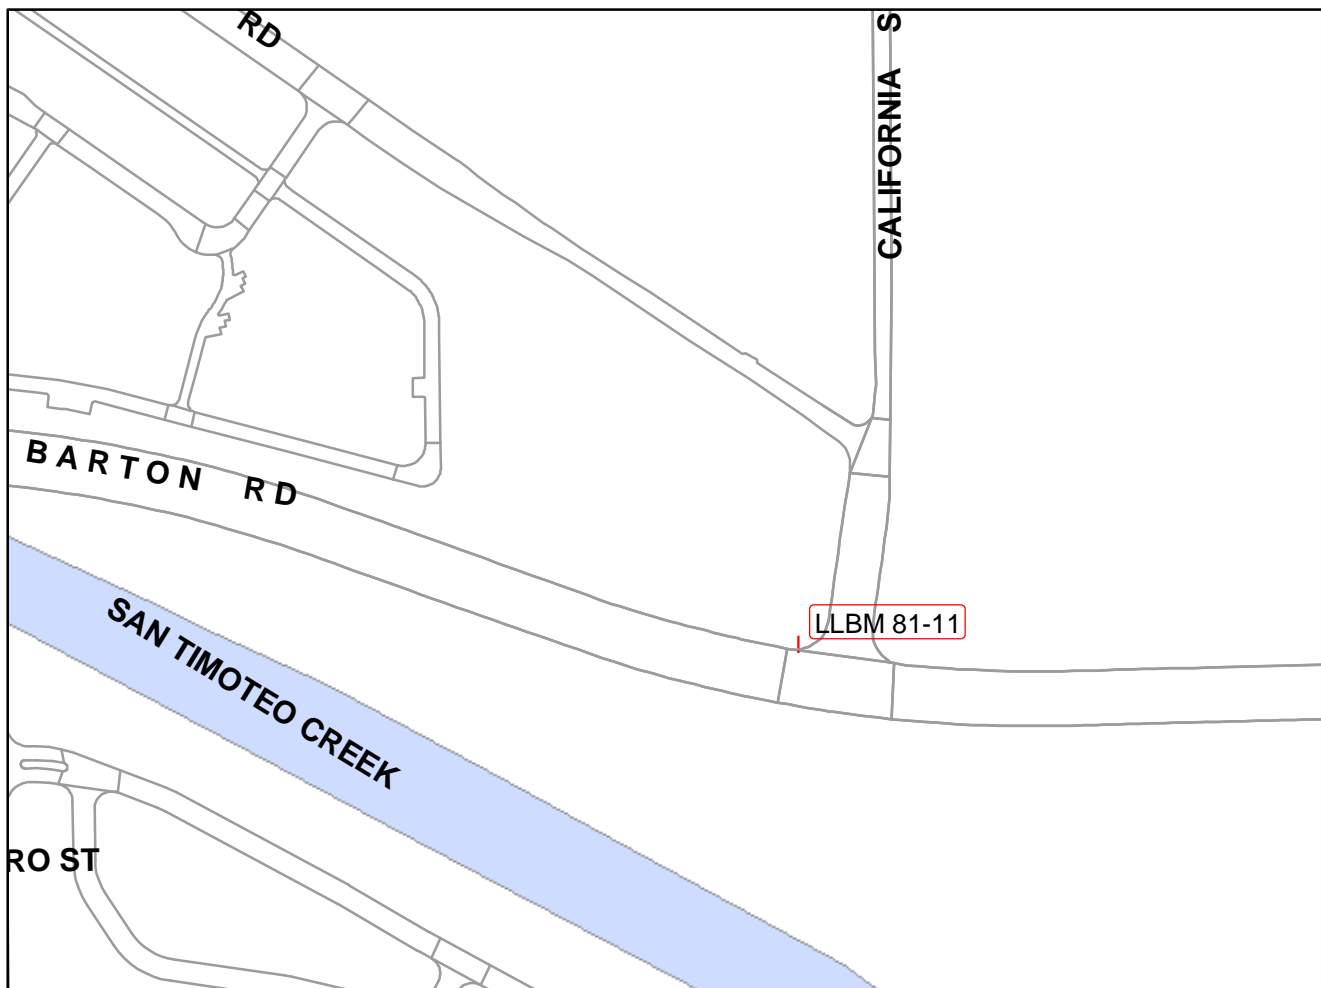
**LLBM 81-11**

BRASS CAP IN TOP OF CURB 1.5' NORTH OF  
NORTH CURB RET., 1/2' EAST OF P.P NO. 1960432 E  
AT N.W. CORNER INT. OF BARTON RD. AND  
CALIFORNIA ST.

1200.079

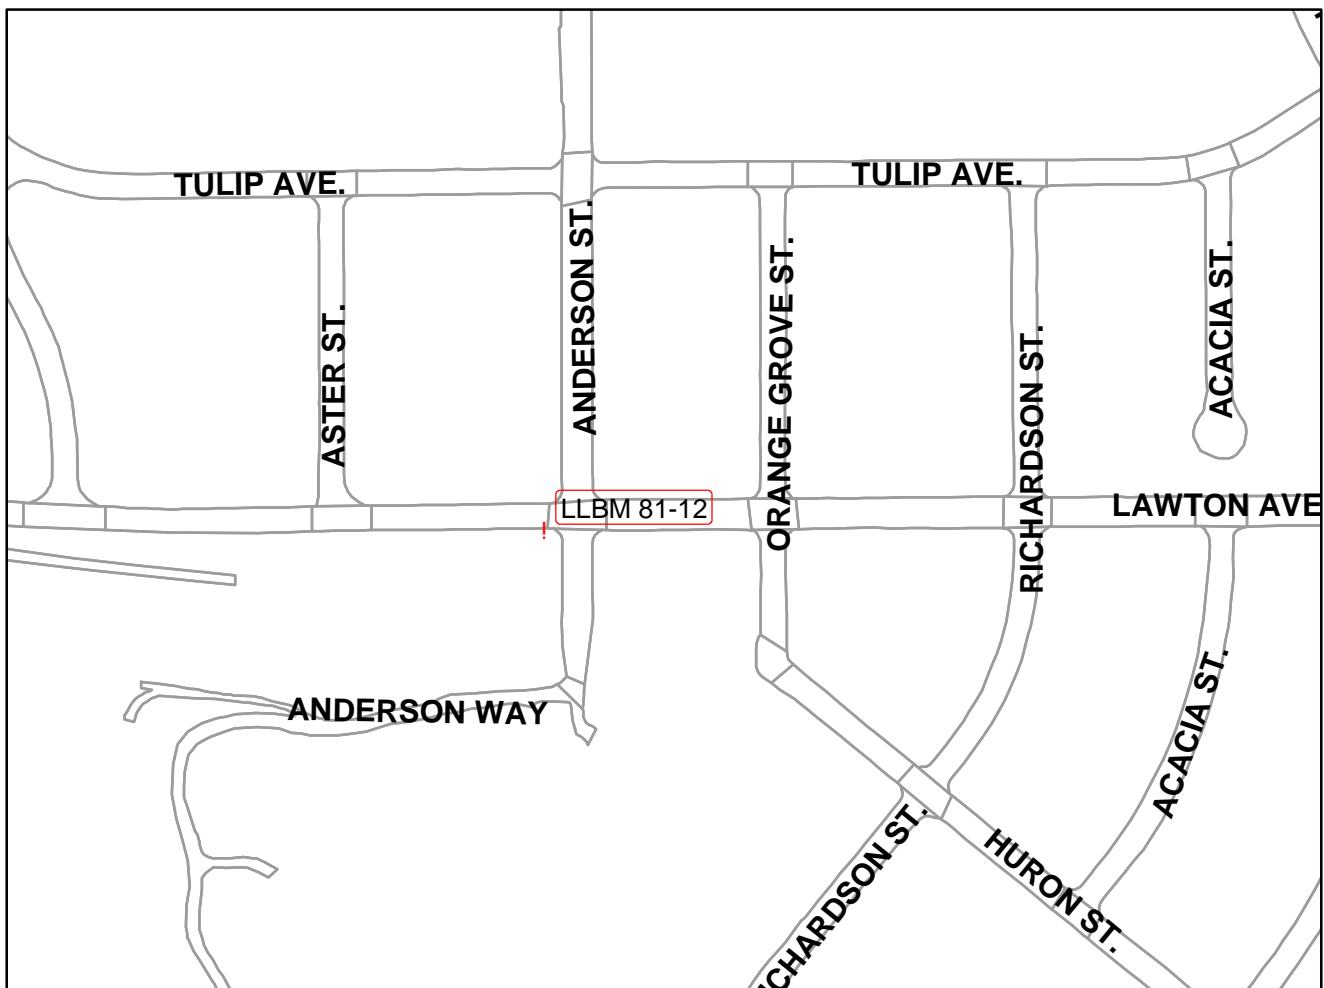
**LLBM 81-12**

BRASS CAP ON SIDEWALK 1' SOUTH OF CURB 1'  
NORTH OF STREET SIGN AT S.W. CORNER INT. OF  
ANDERSON ST. AND LAWTON AVE., 9' EAST OF  
WEST RETURN

1214.111

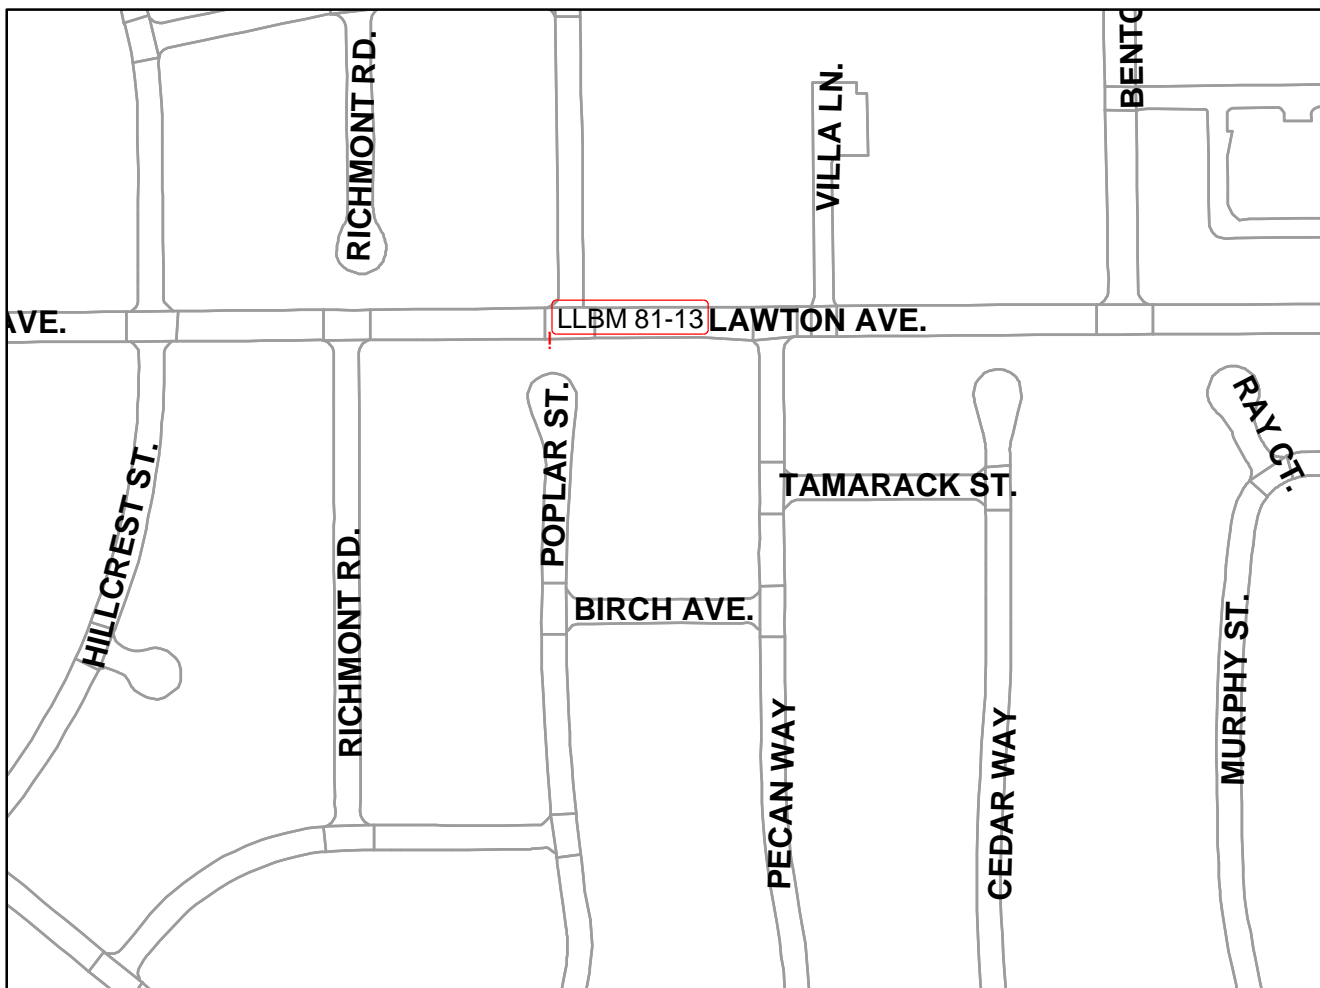
**LLBM 81-13**

BRASS CAP IN N.E. CORNER OF OARKWAY DRAIN  
SOUTH SIDE OF LAWTON AVE., 23' SOUTH AND 50'  
WEST OF CL INT. OF LAWTON AVE. AND POPLAR  
ST.

1200.714

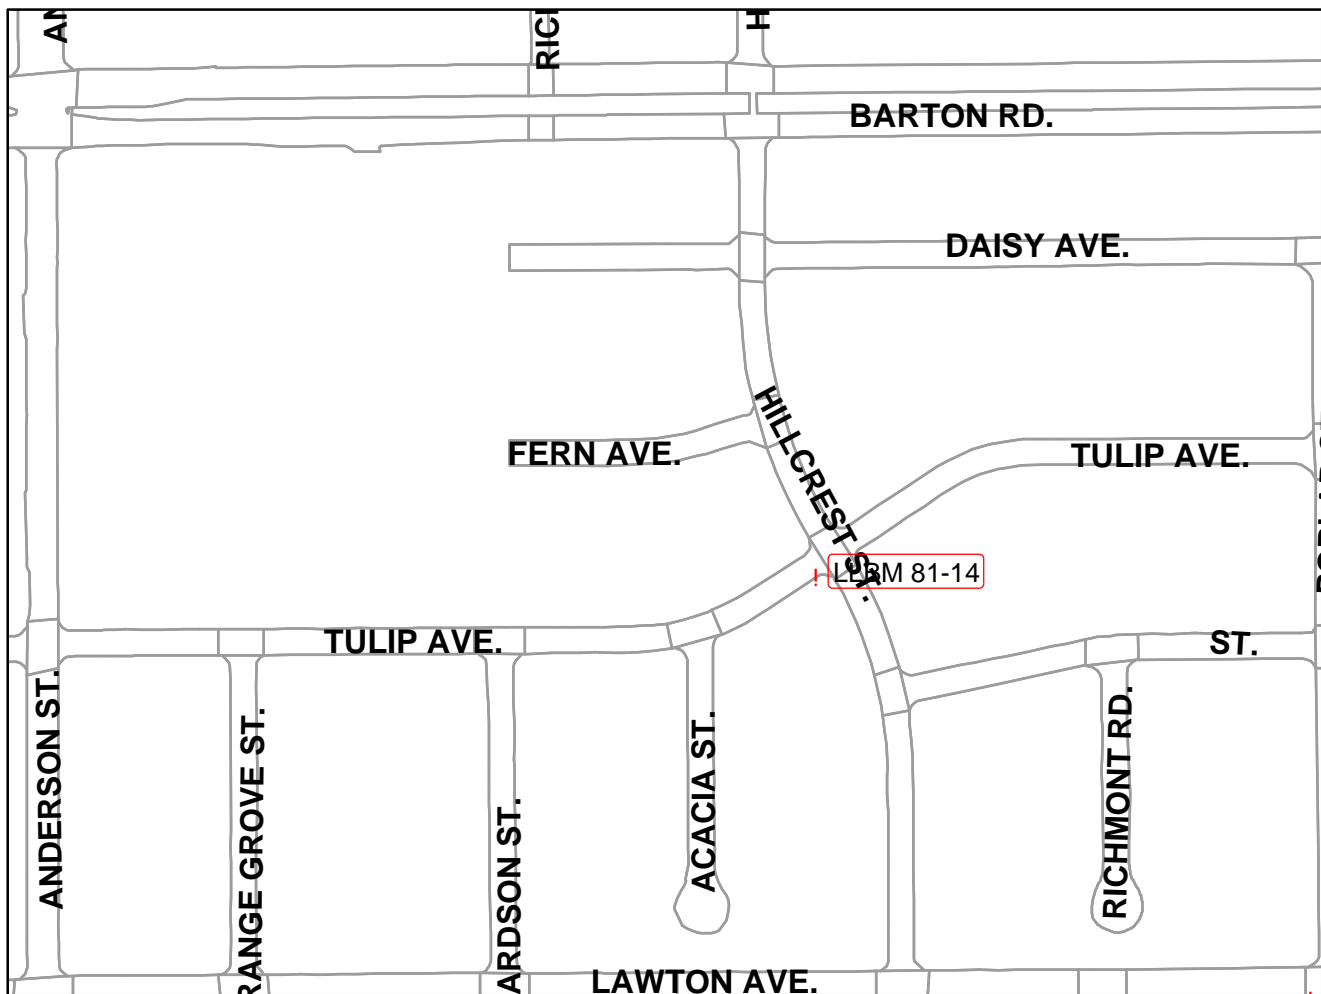
**LLBM 81-14**

BRASS CAP IN CONC. SIDEWALK 1' WEST OF CURB,  
2' N.E. OF STREET SIGN AT SOUTH END OF CURB  
RET., S.W. CORNER AT INT. OF TULIP AVE. AND  
HILLCREST ST.

1177.938
