# **CITY OF LOMA LINDA**

**BENCH MARKS**

# City of Loma Linda Bench Mark Map

# Bench Marks

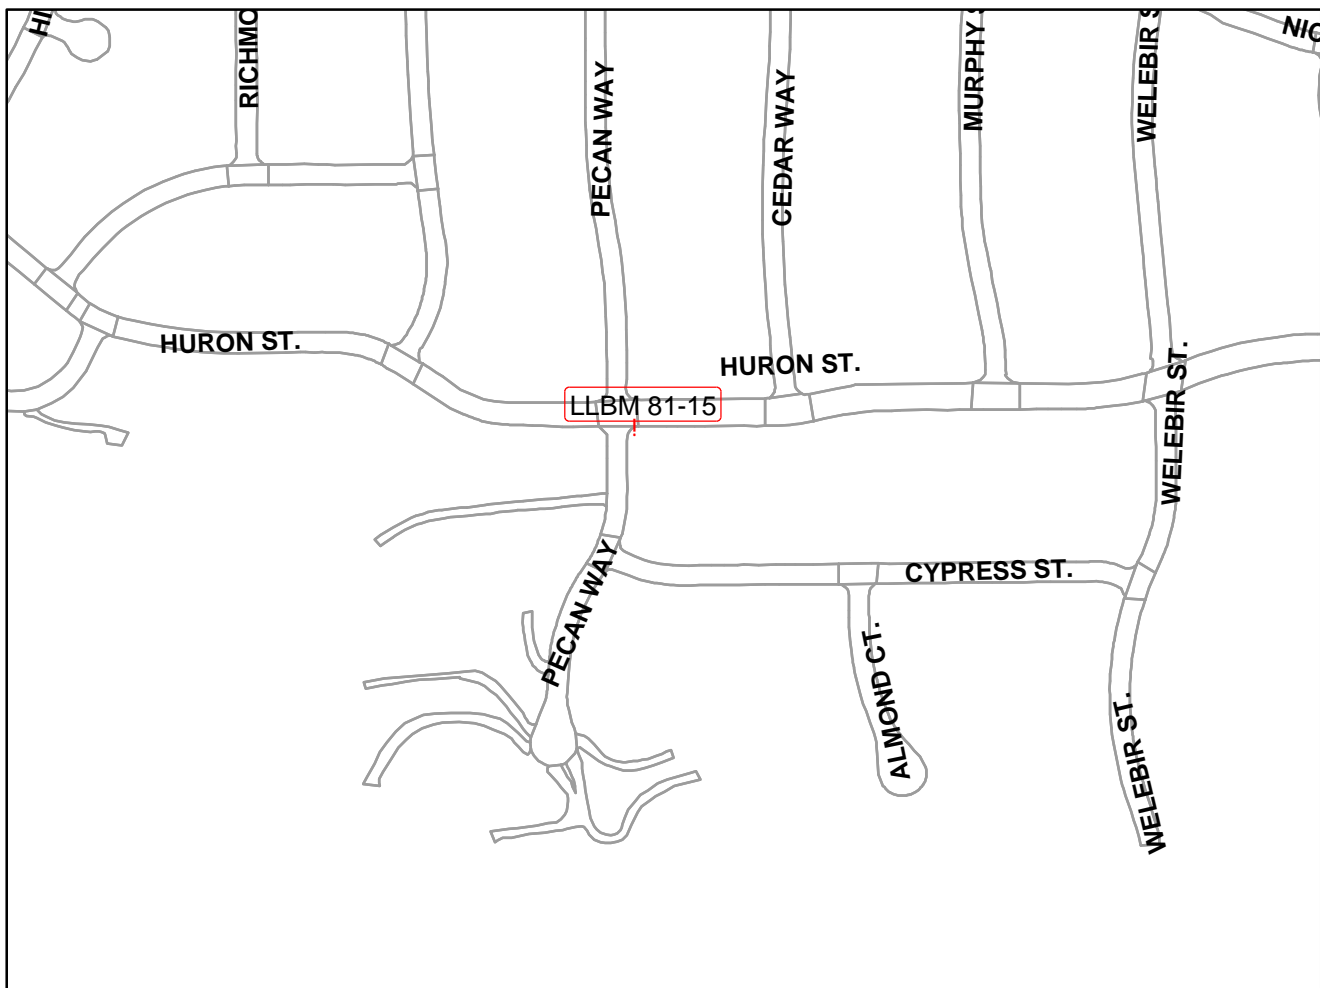
**LLBM 81-15**

BRASS CAP IN N.E. CORNER OF CONC. DROP INLET  
BOX, EAST SIDE OF PECAN WAY, 4' SOUTH OF  
CURB RET. AT S.E. CORNER OF INT. HURON ST.  
AND PECAN WAY

1267.206

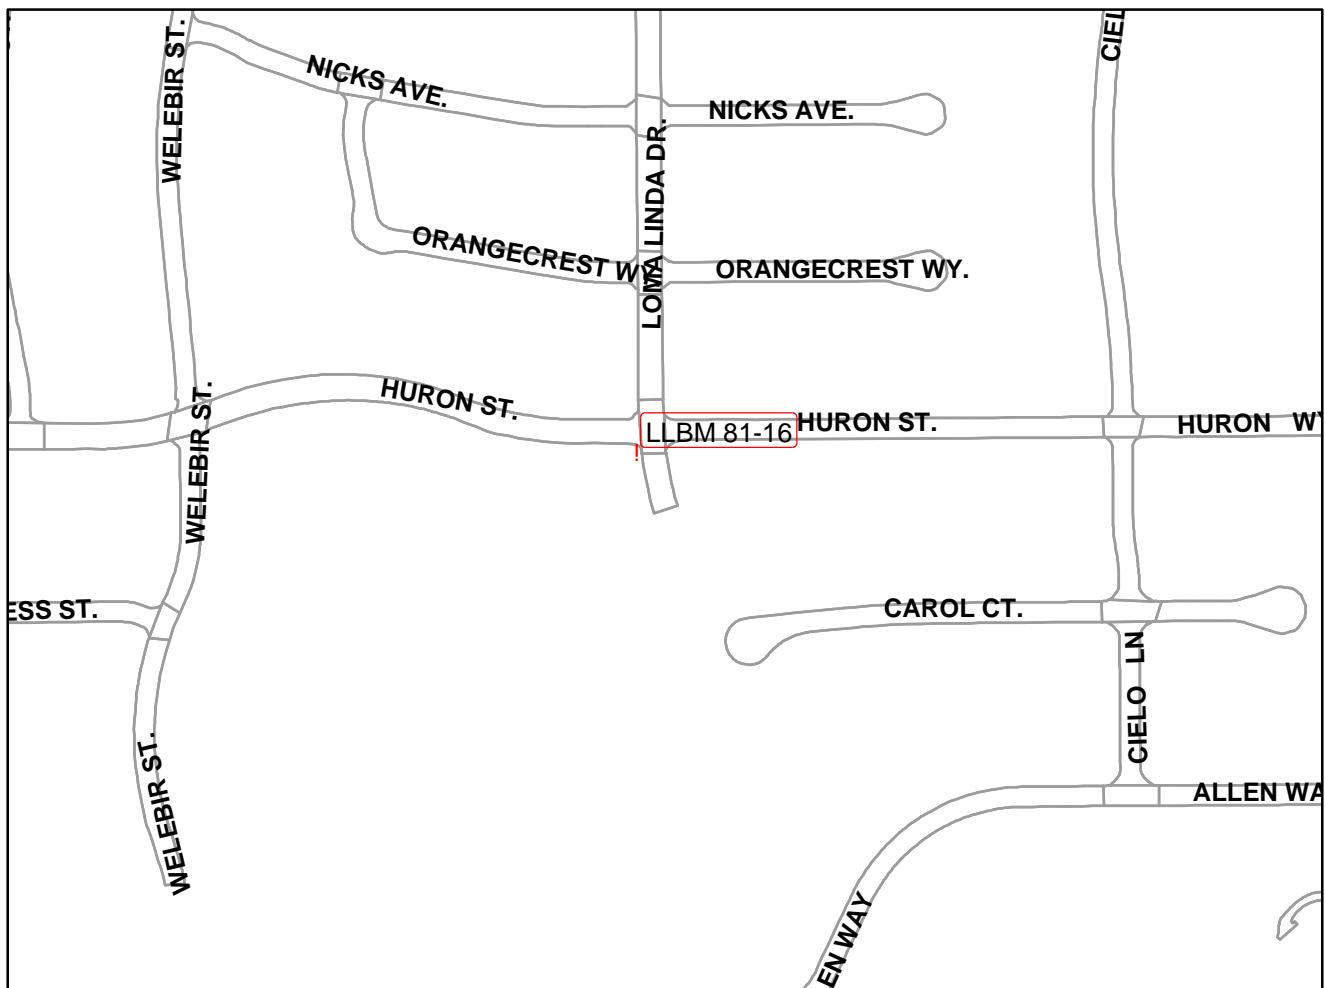
**LLBM 81-16**

BRASS CAP IN SIDE WALK 1' BACK OF CURB AT  
WEST CURB RET., S.W. CORNER OF INT. HURON  
ST. AND LOMA LINDA DR.

1255.202

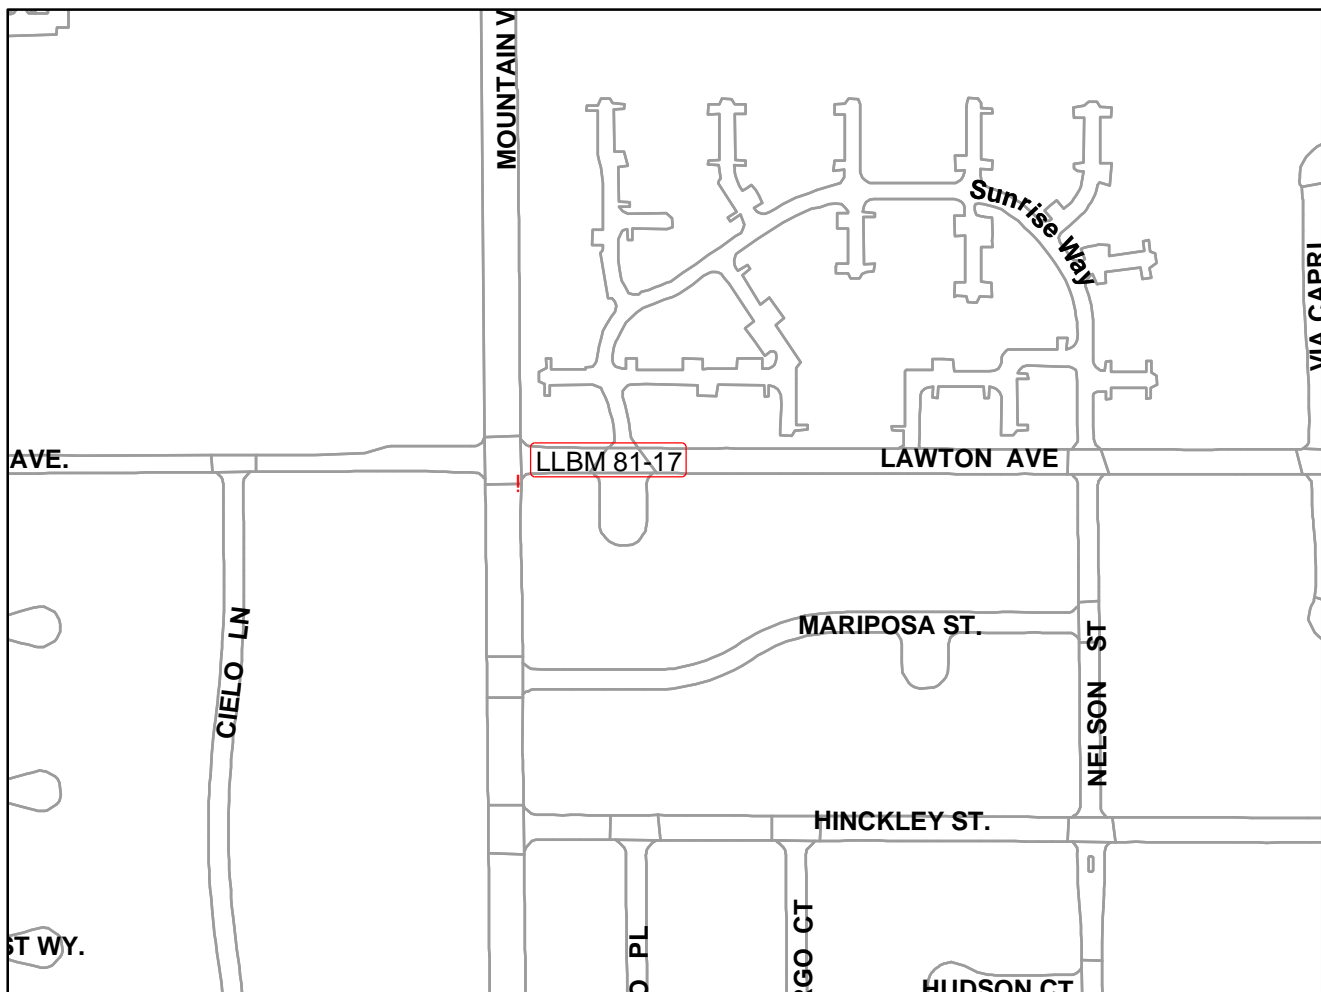
**LLBM 81-17**

BRASS CAP IN S.E. CORNER OF CONC. DROP INLET  
BOX 1' BACK OF CURB. 25' SOUTH OF SOUTH CURB  
RET. AT S.E. CORNER OF INT. OF MOUNTAIN VIEW  
AVE. AND LAWTON AVE.

1241.953

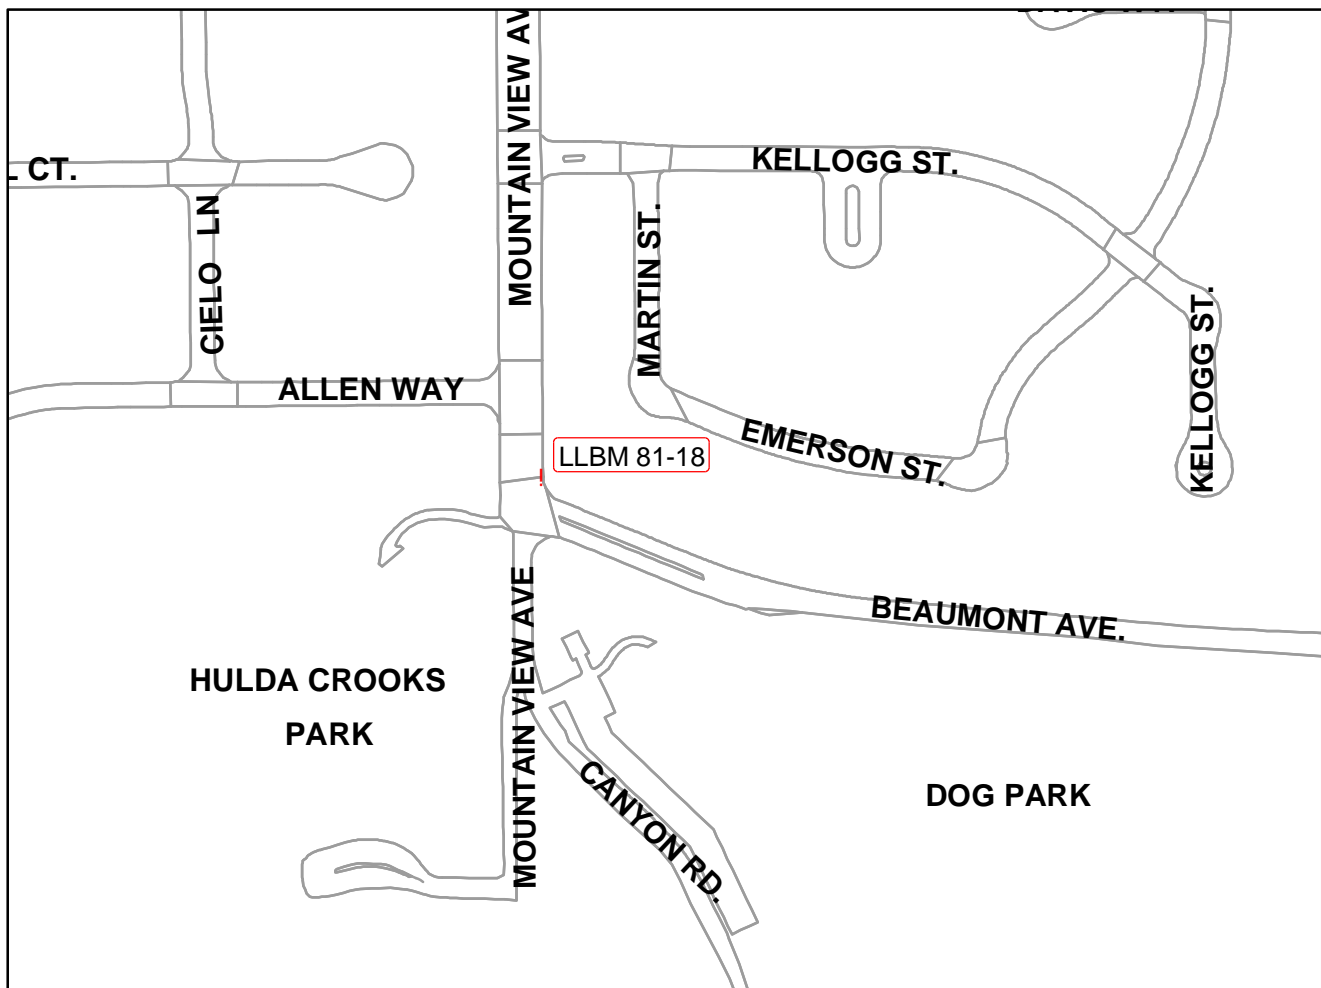
**LLBM 81-18**

BRASS CAP IN CONC. STREET LIGHT BASE 1' BACK  
OF CURB AT NORTH END OF CURB RET. AT N.E.  
CORNER INT. OF MOUNTAIN VIEW AVE. AND  
BEAUMONT AVE.

1306.316

January 18, 2006: Verified location.

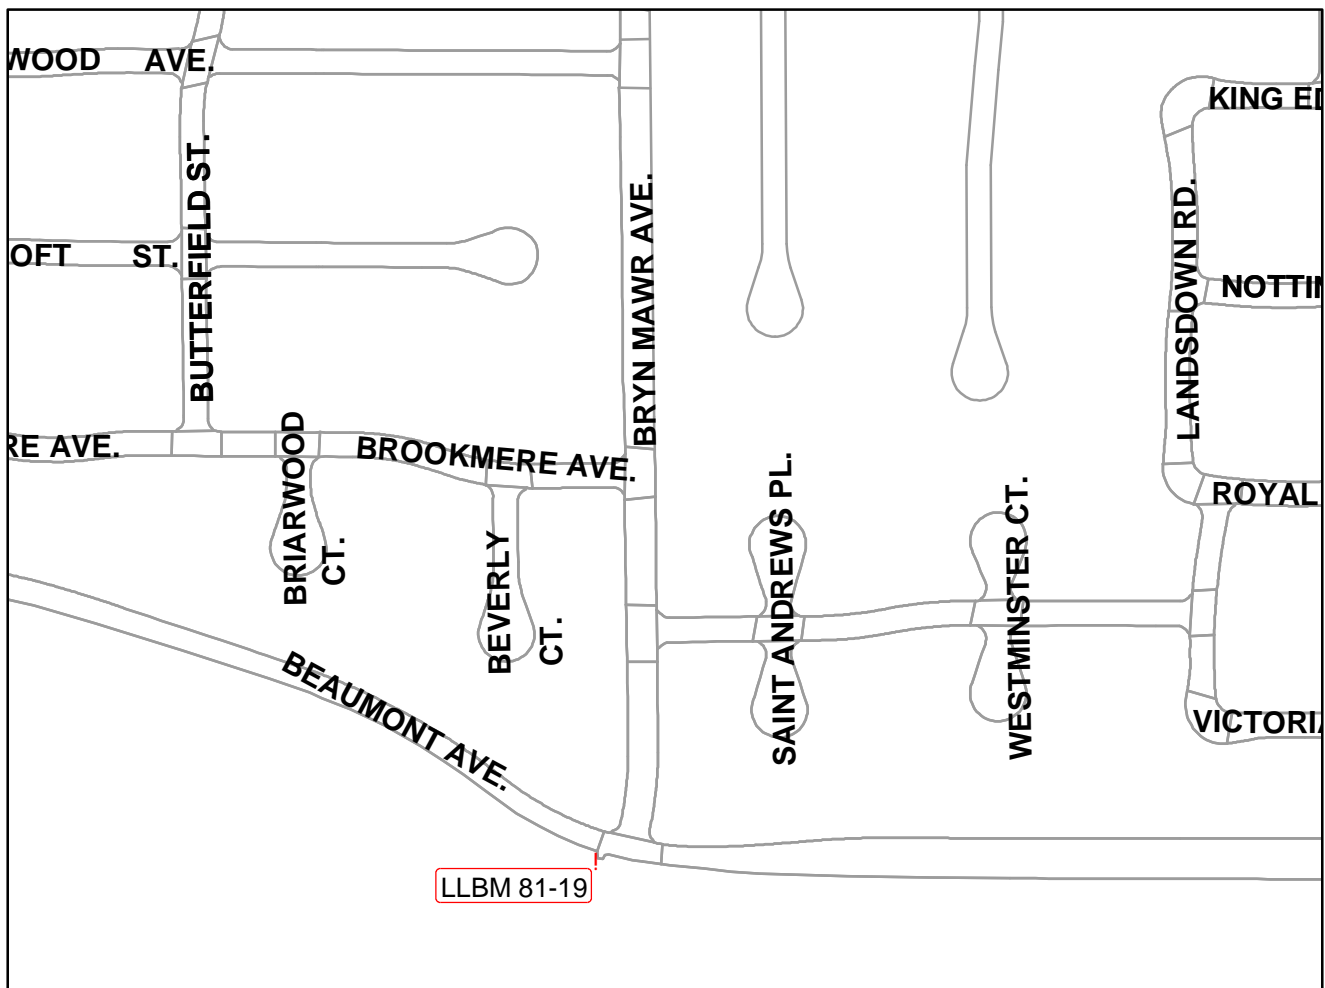
**LLBM 81-19**

BRASS CAP IN TOP OF RETAINING WALL 1/2'  
NORTH OF POWER POLE, 25' WEST AND 15' SOUTH  
OF CL INT. BRYN MAWR AVE. AND BEAUMONT AVE.

1336.592

January 18, 2006: Went to verify location,  
unable to locate.

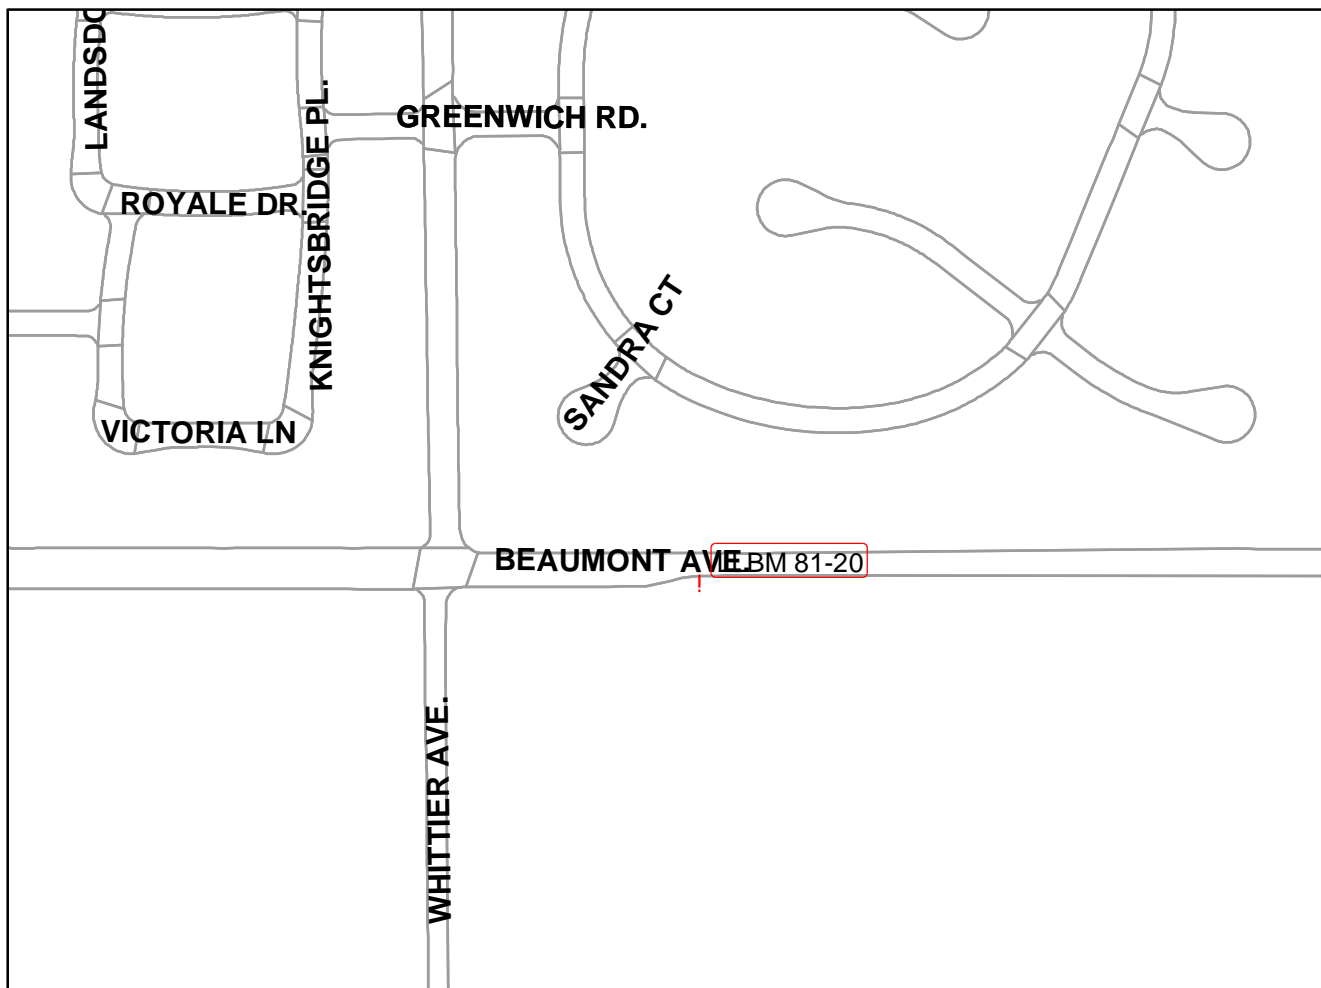
**LLBM 81-20**

BRASS CAP IN CONC. HEADWALL OF IRRIGATION  
DITCH NORTH SIDE OF BEAUMONT AVE., 400' +/-  
EAST OF INT. BEAUMONT AVE. AND WHITTIER AVE.

1332.737

January 18, 2006: Went to verify location,  
unable to locate.

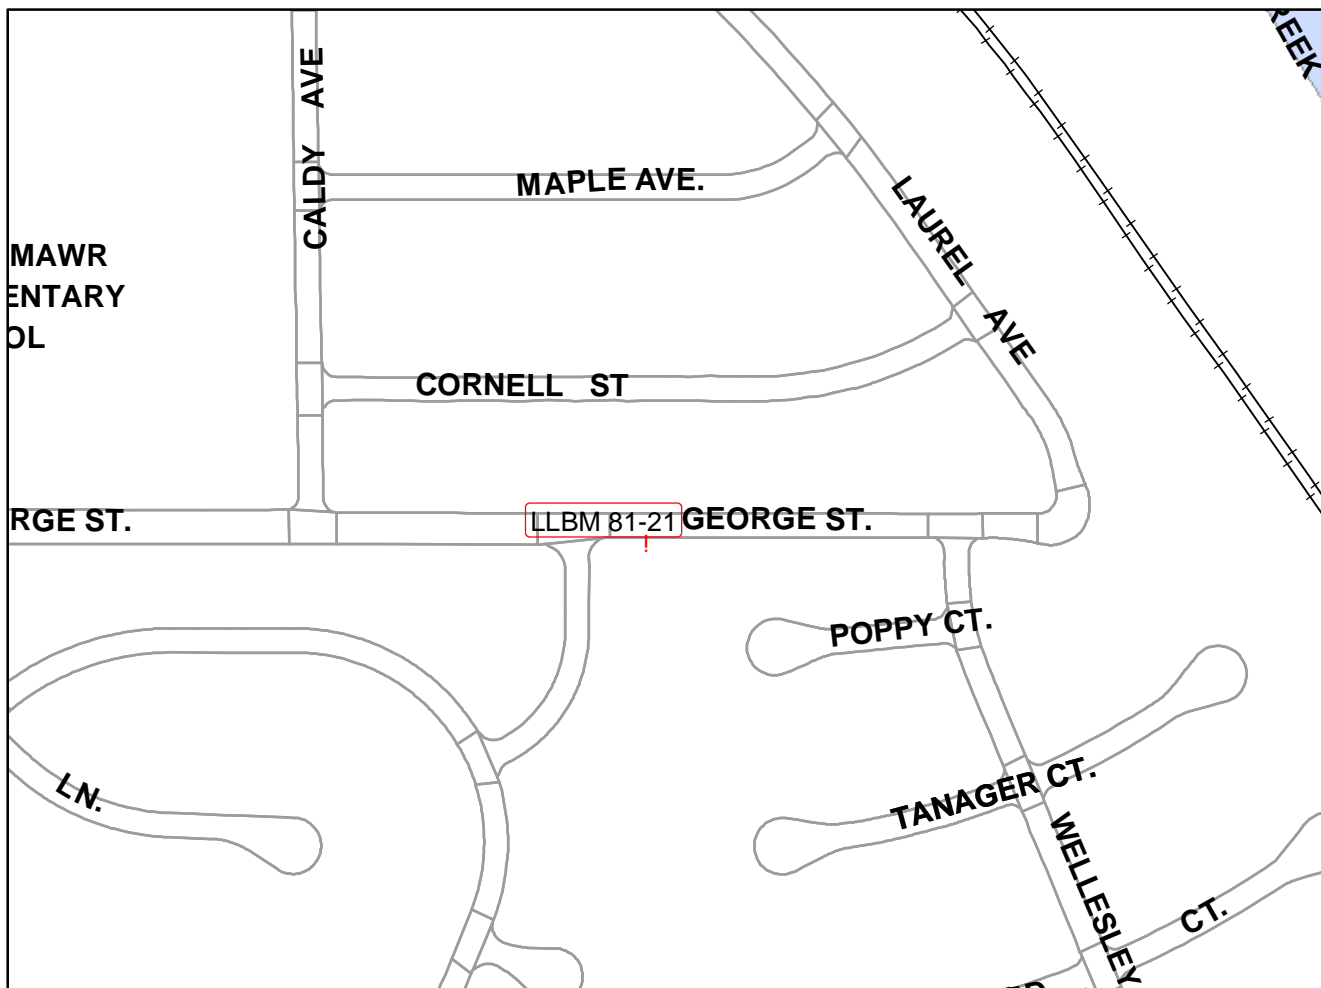
**LLBM 81-21**

BRASS CAP IN TOP OF CONC. HEADWALL FOR  
IRRIGATION DITCH, SOUTH SIDE OF SECOND ST.  
1320' +/- EAST OF WHITTIER AVE., BETWEEN 4TH  
AND 5TH POWER POLE EAST OF WHITTIER AVE.

1264.521

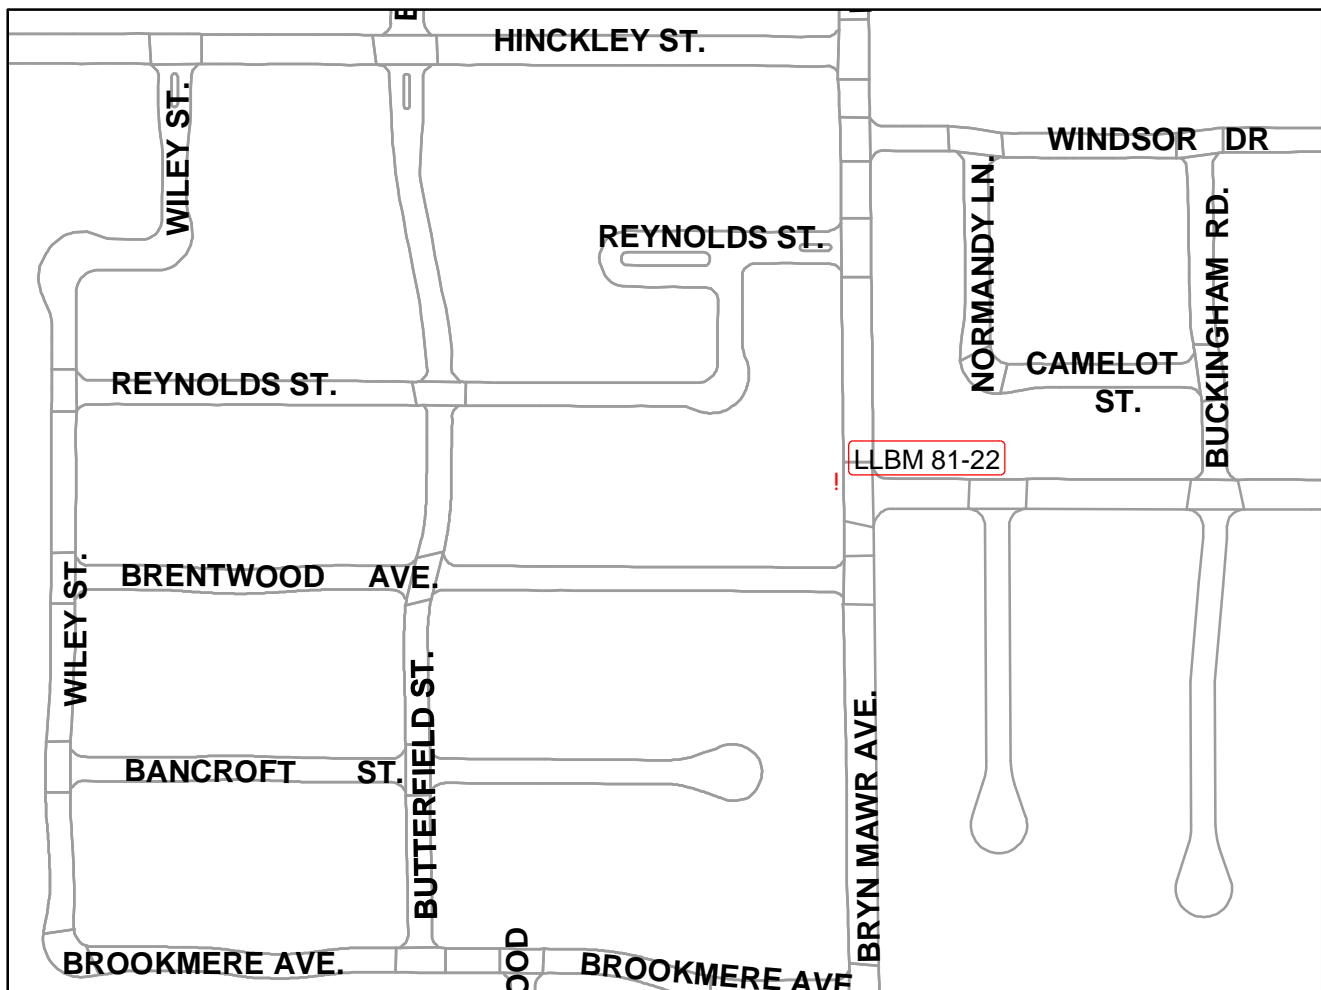
**LLBM 81-22**

BRASS CAP IN TOP OF CURB WEST SIDE OF BRYN MAWR AVE., 18' NORTH AND 22' WEST OF CL INT. OF SECOND ST. AND BRYN MAWR AVE.

1261.926

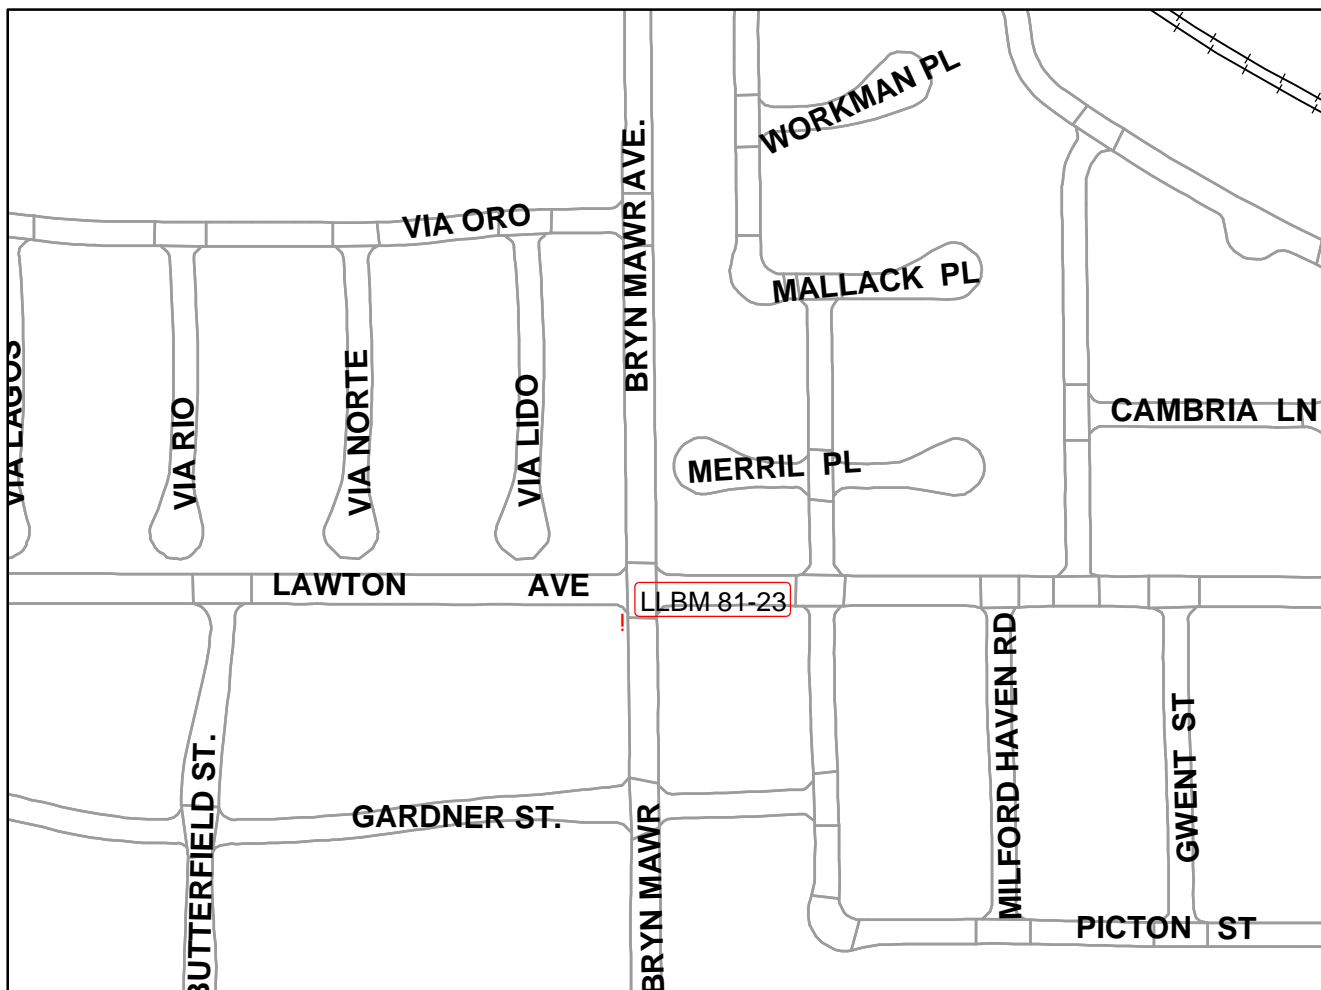
**LLBM 81-23**

BRASS CAP IN N.E. CORNER OF DROP INLET, 1'  
BEHIND CURB RET. AT S.W CORNER INT. OF  
LAWTON AVE. AND BRYN MAWR AVE.

1219.247

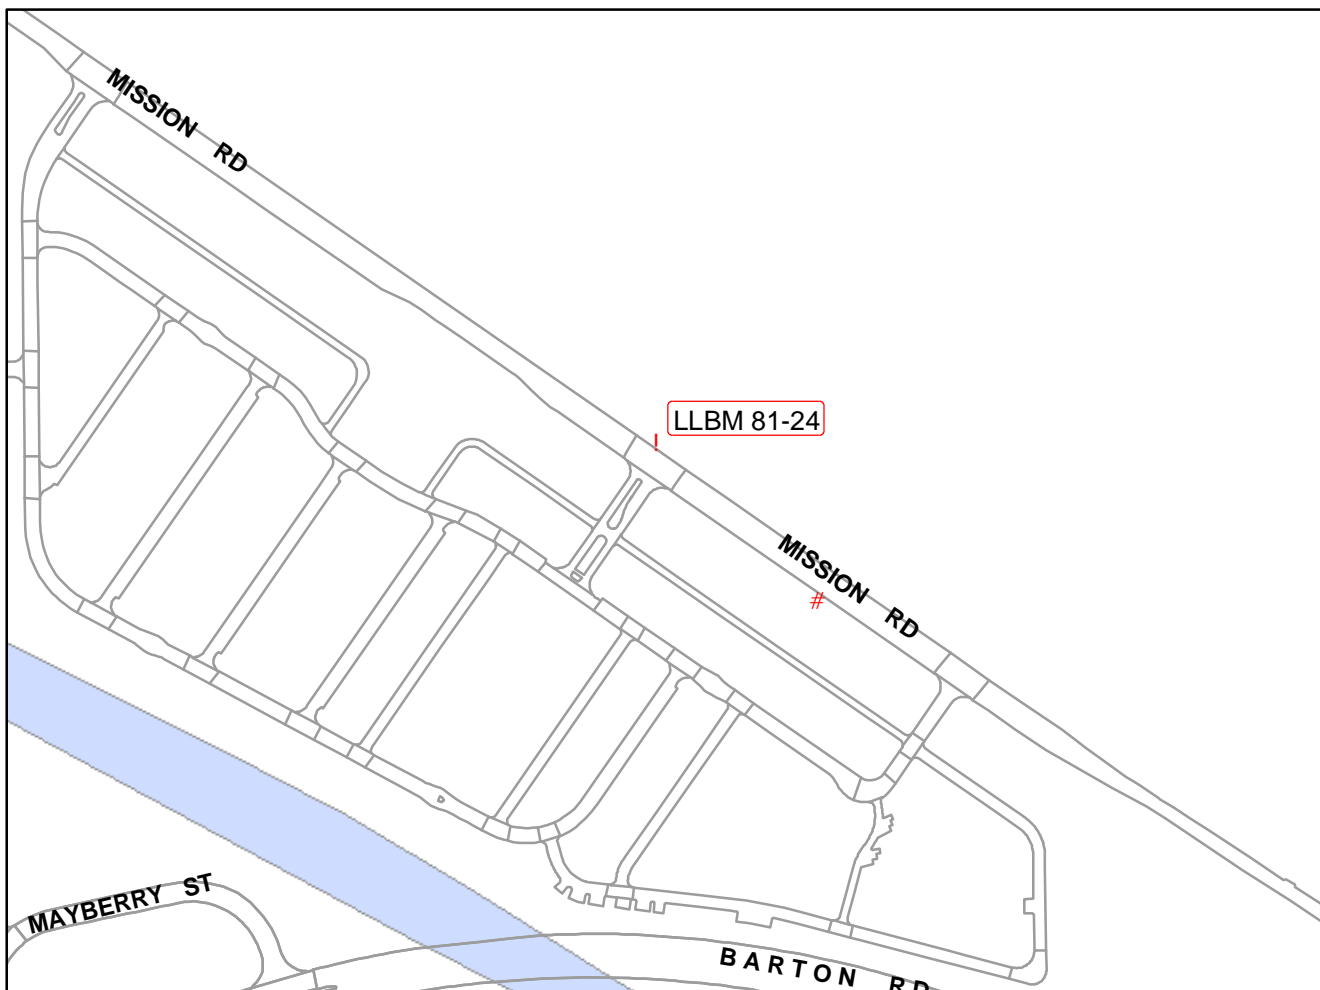
**LLBM 81-24**

BRASS CAP IN NORTH WEST CORNER OF CONC.  
BLOCK WEIR BOX, 40' NORTH OF CL OF MISSION  
RD. AND 40' EASTERLY OF TRANSFORMER POLE  
NO. OF 344481E, 0.30 MI. WESTERLY CALIFORNIA  
ST. ALONG MISSION RD.

1176.658

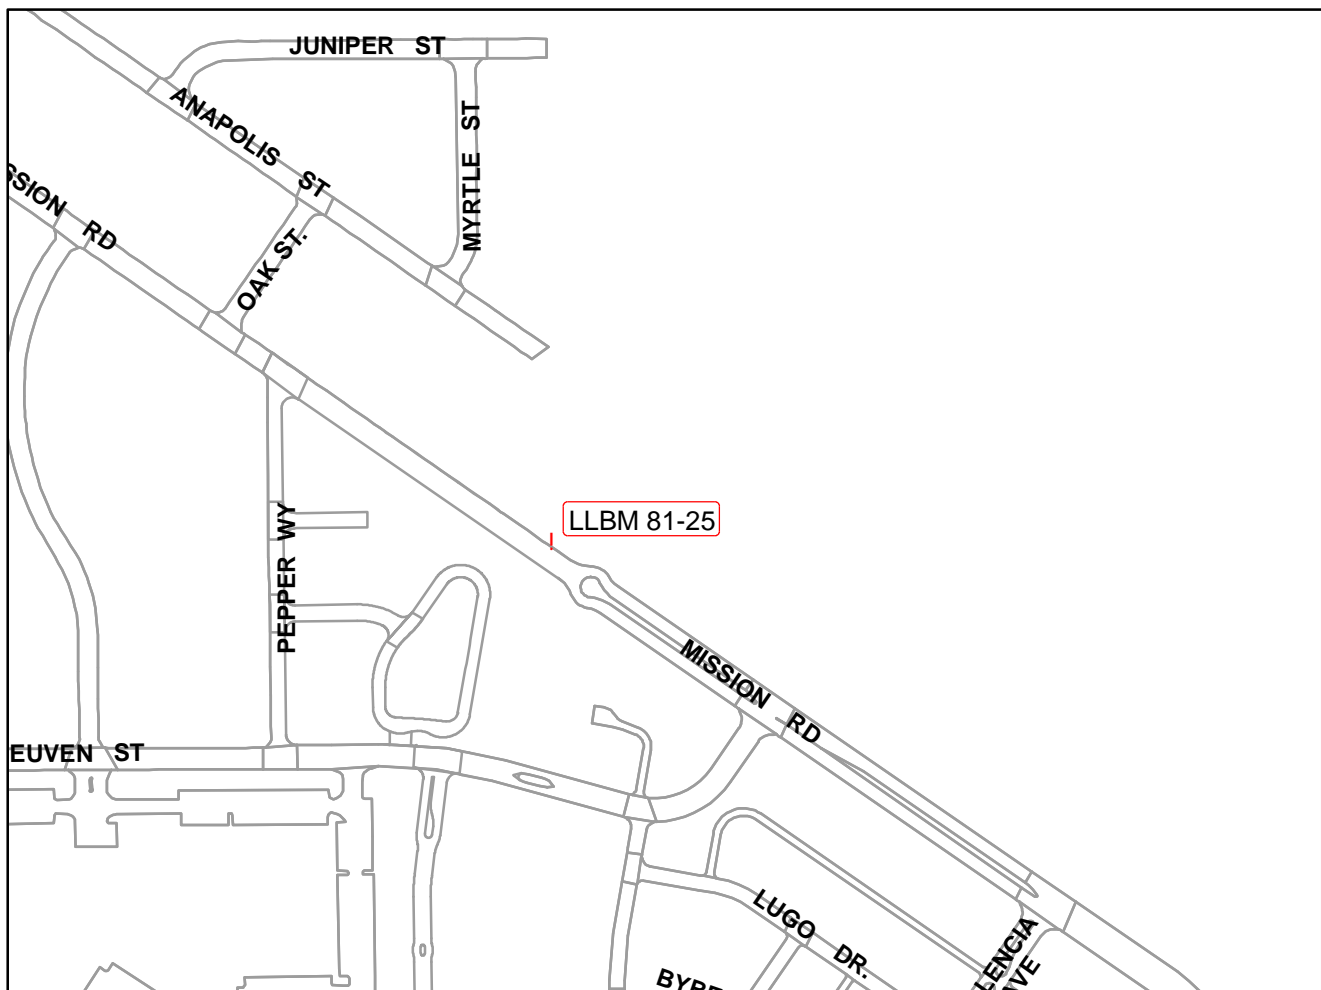
**LLBM 81-25**

BRASS CAP IN SIDEWALK 1' SOUTH OF S.W.  
CORNER OF 4' HIGH GUACHANA RANCHERRA  
MONUMENT (HISTORICAL LANDMARK NO. 35), 35'  
NORTH OF CL OF MISSION ROAD. APPROX. 60' +/-  
WEST FROM EDISON TRANSMISSION LINES 0.30 MI.  
EASTERLY OF MT. VIEW AVE. ALONG MISSION RD.

1136.566

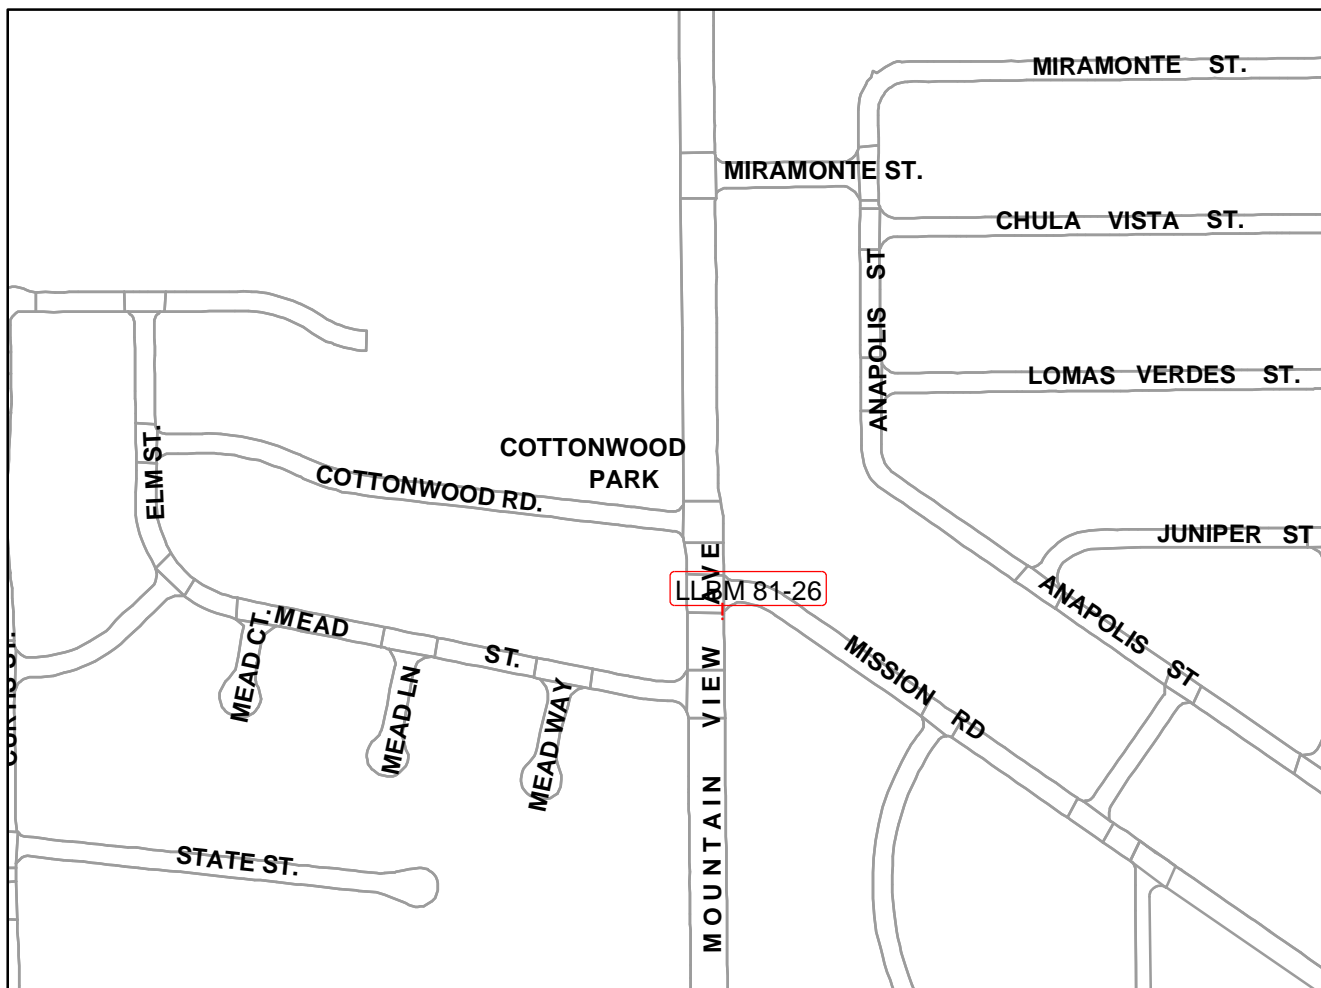
**LLBM 81-26**

BRASS CAP IN S.W. CORNER OF CONC. DROP  
INLET, 1' BEHIND CURB, 7' SOUTH OF SOUTH CURB  
RET. AT S.E. CORNER INT. OF MOUNTAIN VIEW  
AVE. AND MISSION RD.

1123.436

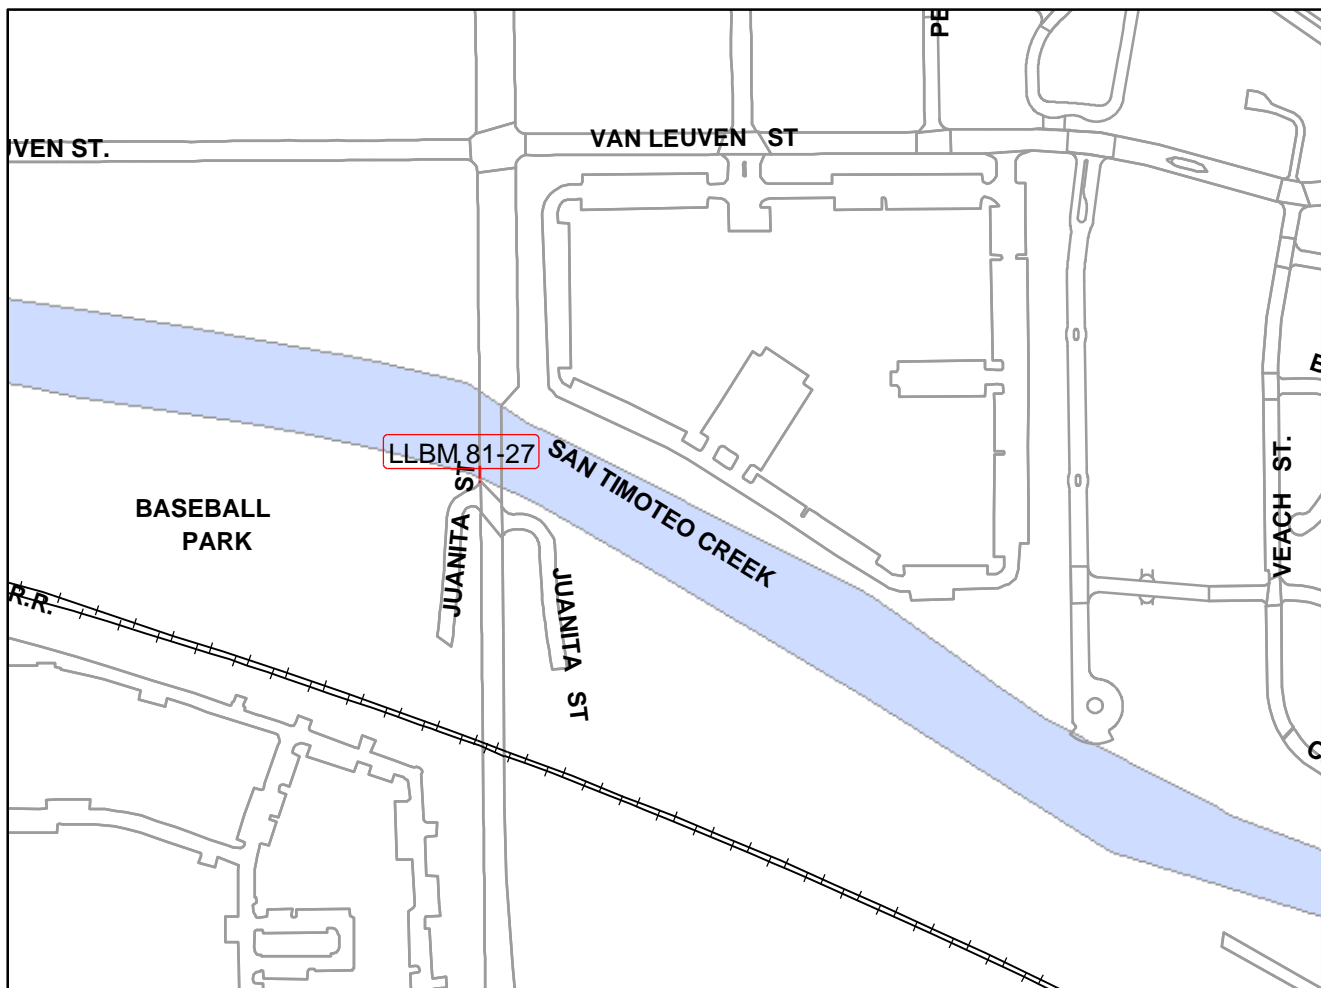
**LLBM 81-27**

BRASS CAP IN SIDEWALK 1' BEHIND WEST CURB AT SOUTH END OF ABUTMENT FOR MOUNTAIN VIEW AVE. BRIDGE OVER SAN TIMOTEO CREEK, 1' NORTH OF NORTH CURB RET., N.W. CORNER OF INT. OF MOUNTAIN VIEW AND JUANITA ST.

1148.750

February 7, 2006: Verified location.

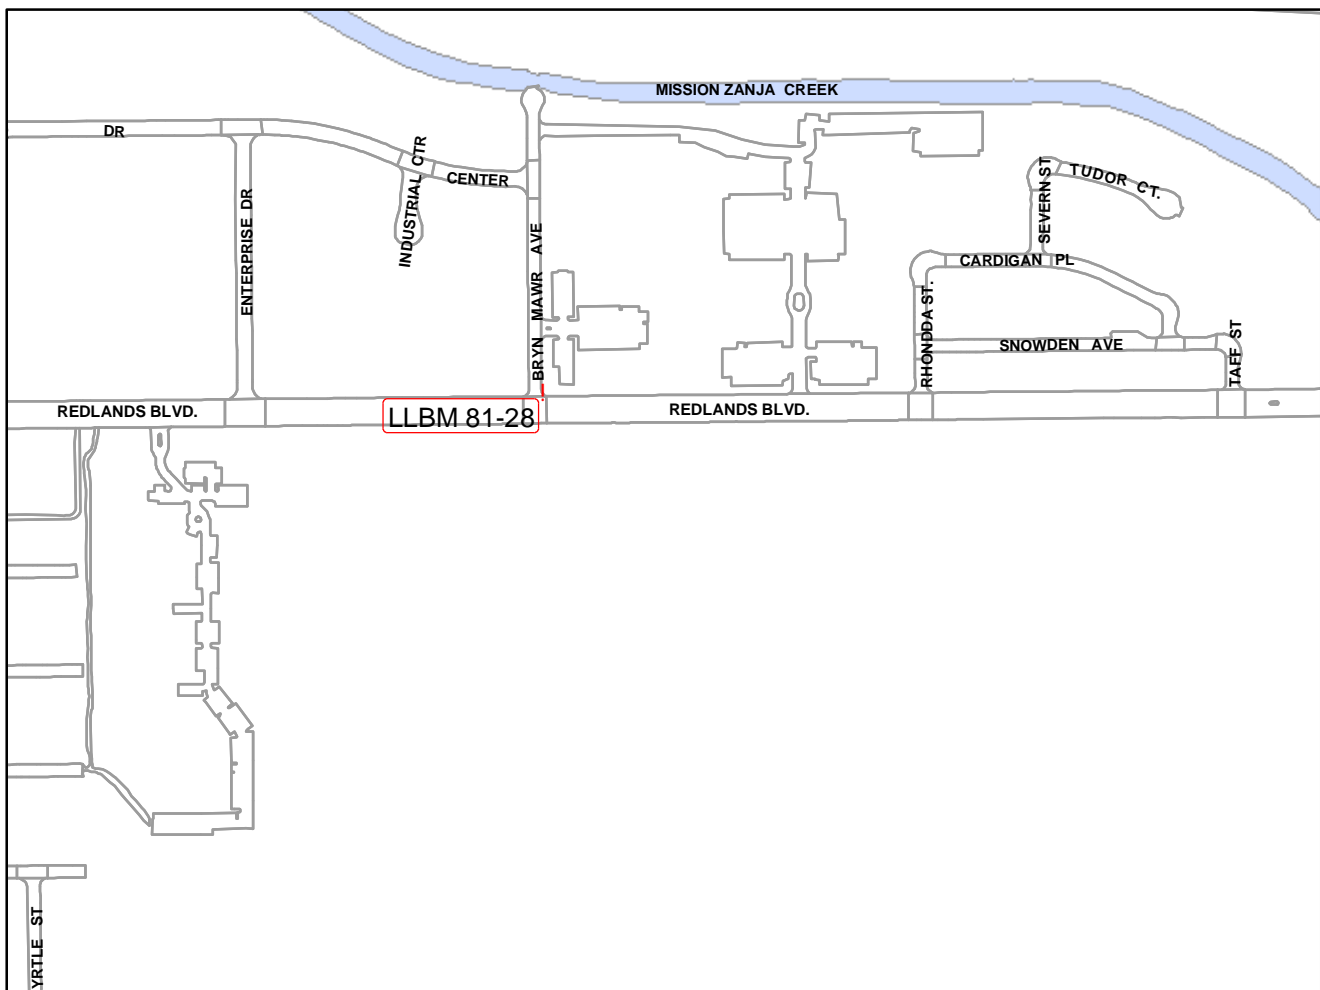
**LLBM 81-28**

BRASS CAP IN TOP OF CONC. CURB NEAR M.O.C.  
OF CURB RET., N.E. CORNER AT INT. OF REDLANDS  
BLVD. AND BRYN MAWR AVE., 0.54 MILES EAST OF  
MOUNTAIN VIEW AVE. ALONG REDLANDS BLVD.

1135.579

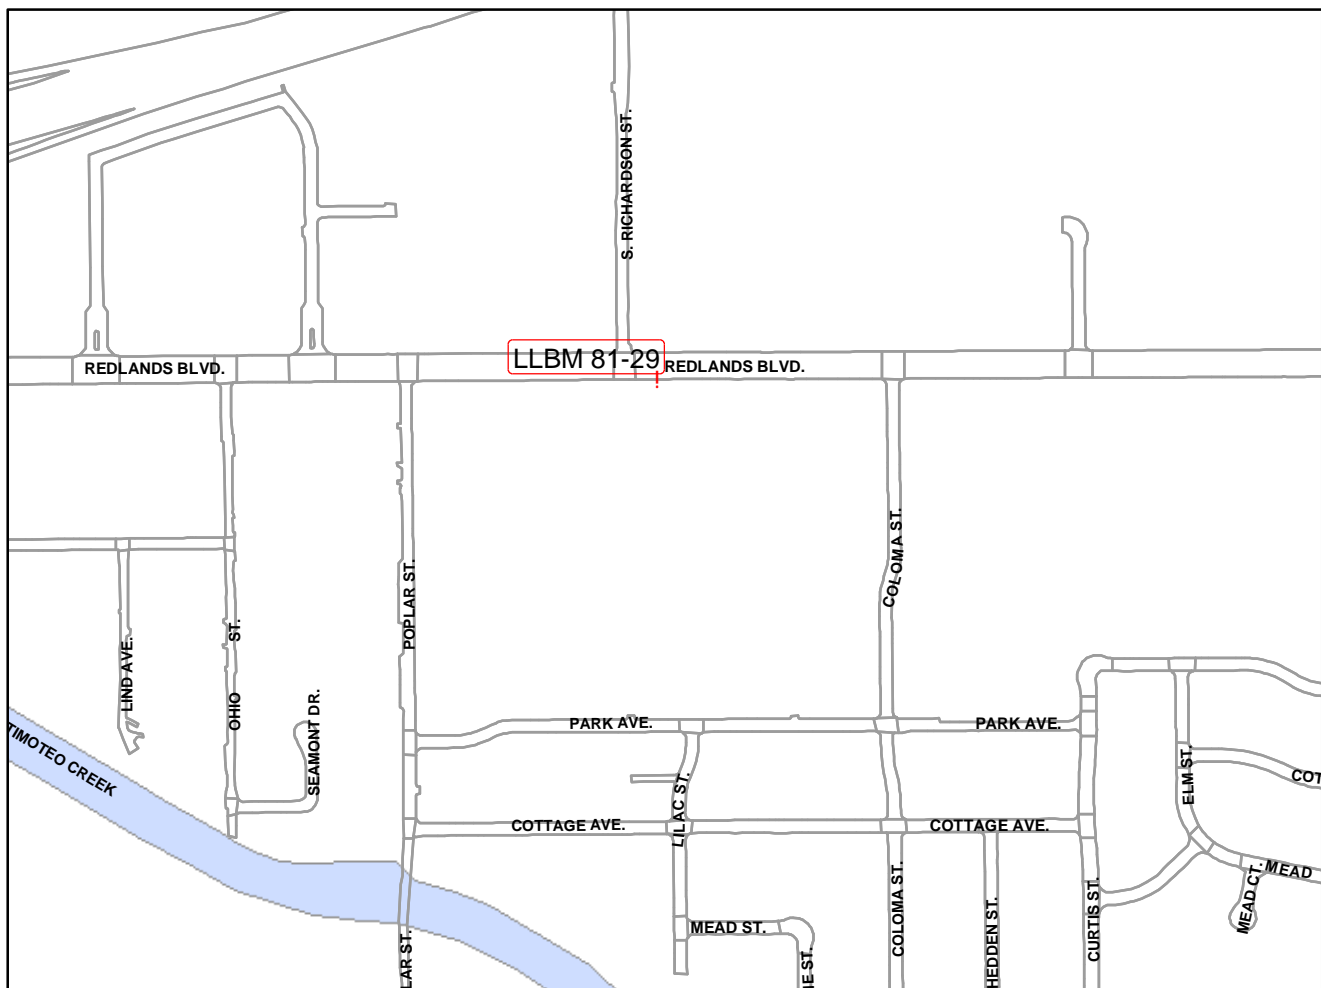
**LLBM 81-29**

BRASS CAP IN N.E. CORNER OF CONC. CATCH  
BASIN ON SOUTH SIDE OF REDLANDS BLVD., 112'  
EAST OF CL INT. REDLANDS BLVD. AND  
RICHARDSON ST.

1092.594

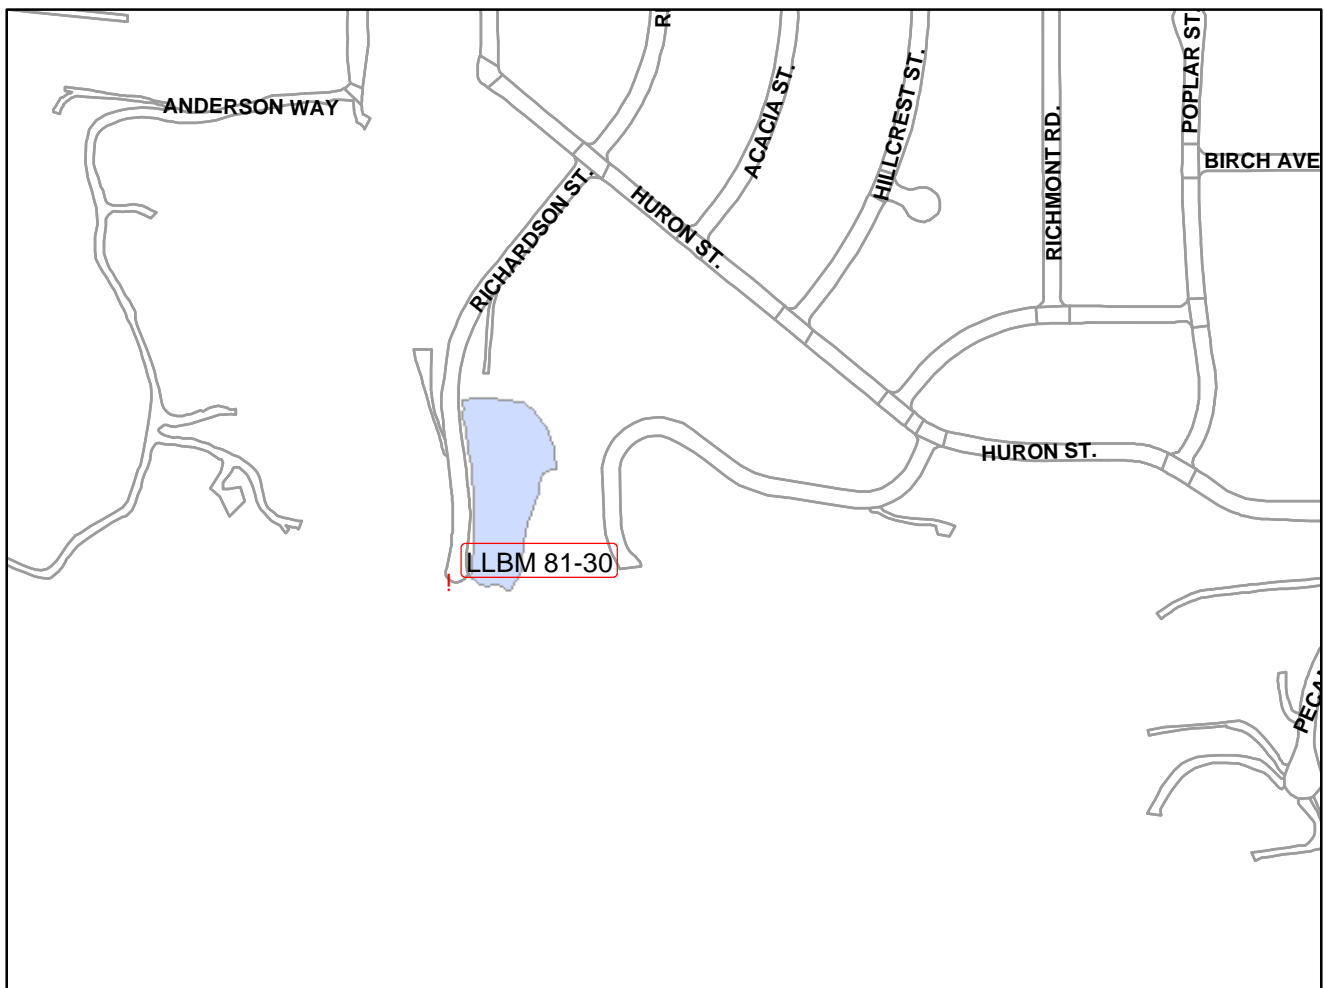
**LLBM 81-30**

BRASS CAP IN N.W. CORNER OF CONC. BASE FOR  
LIGHT STD. NO. 2114767E, 3' SOUTH OF A.C. BERM  
AT SOUTH END OF RICHARDSON ST.

1297.228

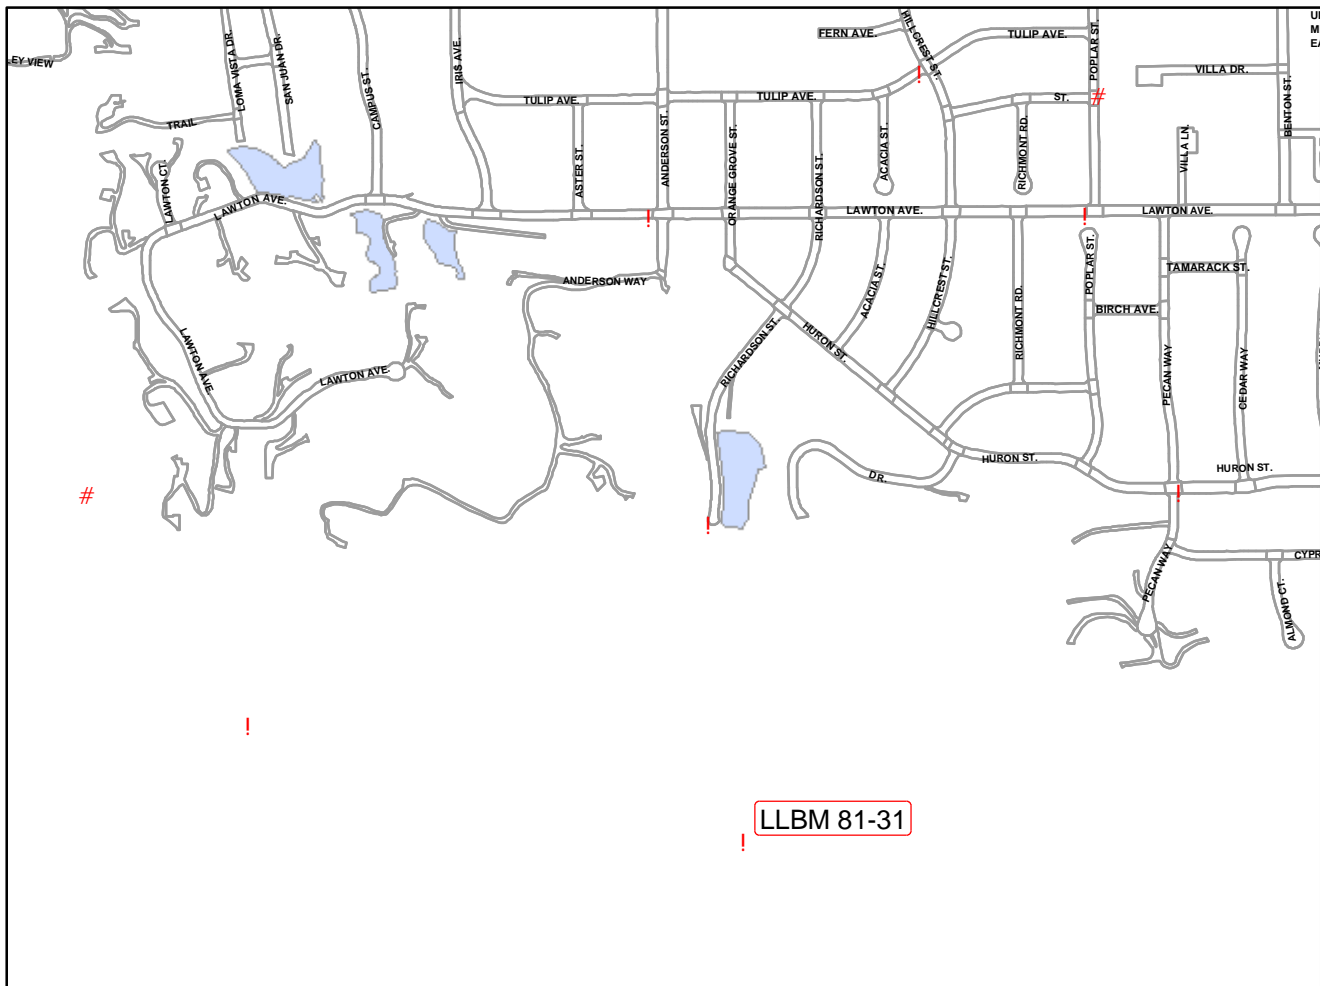
**LLBM 81-31**

BRASS CAP IN S.E. CONC. PIER OF SOUTHERN CALIFORNIA EDISON TOWER (DEVER - VISTA NO. 1 3/4), 1500' +/- SOUTH AND 300' +/- EAST OF SOUTH END OF RICHARDSON ST.

1479.274
