# **CITY OF LOMA LINDA**

**BENCH MARKS**

# City of Loma Linda Bench Mark Map

# Bench Marks

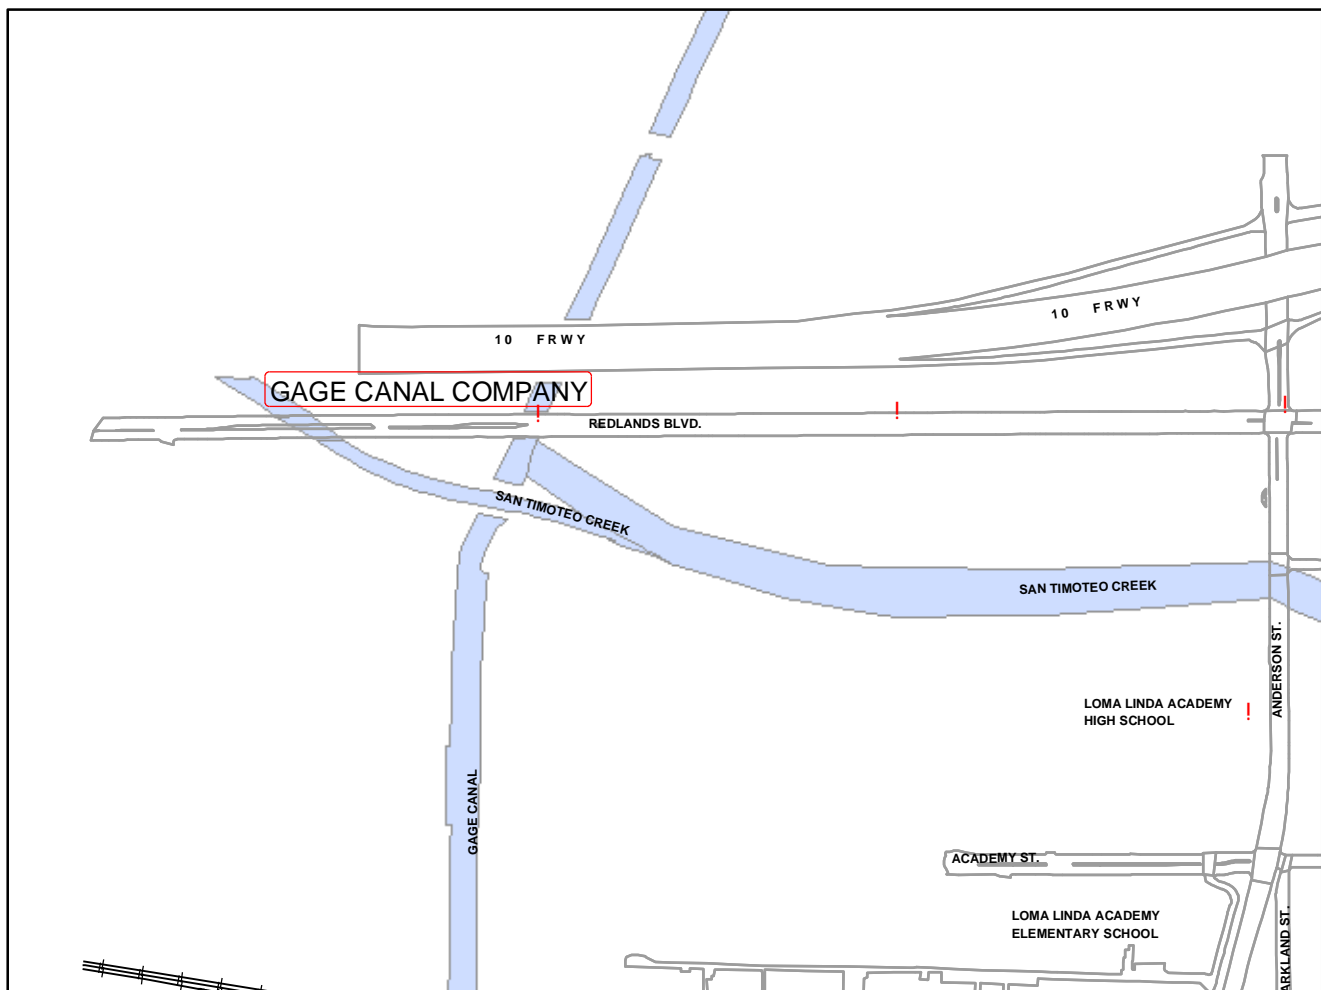
**GAGE CANAL COMPANY**

BRASS CAP IN TOP OF CURB NORTH SIDE OF  
REDLANDS BLVD., APPROX. AT CL OF GAGE CANAL  
0.5 MI. WEST OF INTERSECTION OF ANDERSON  
ST. AND REDLANDS BLVD.

1042.385

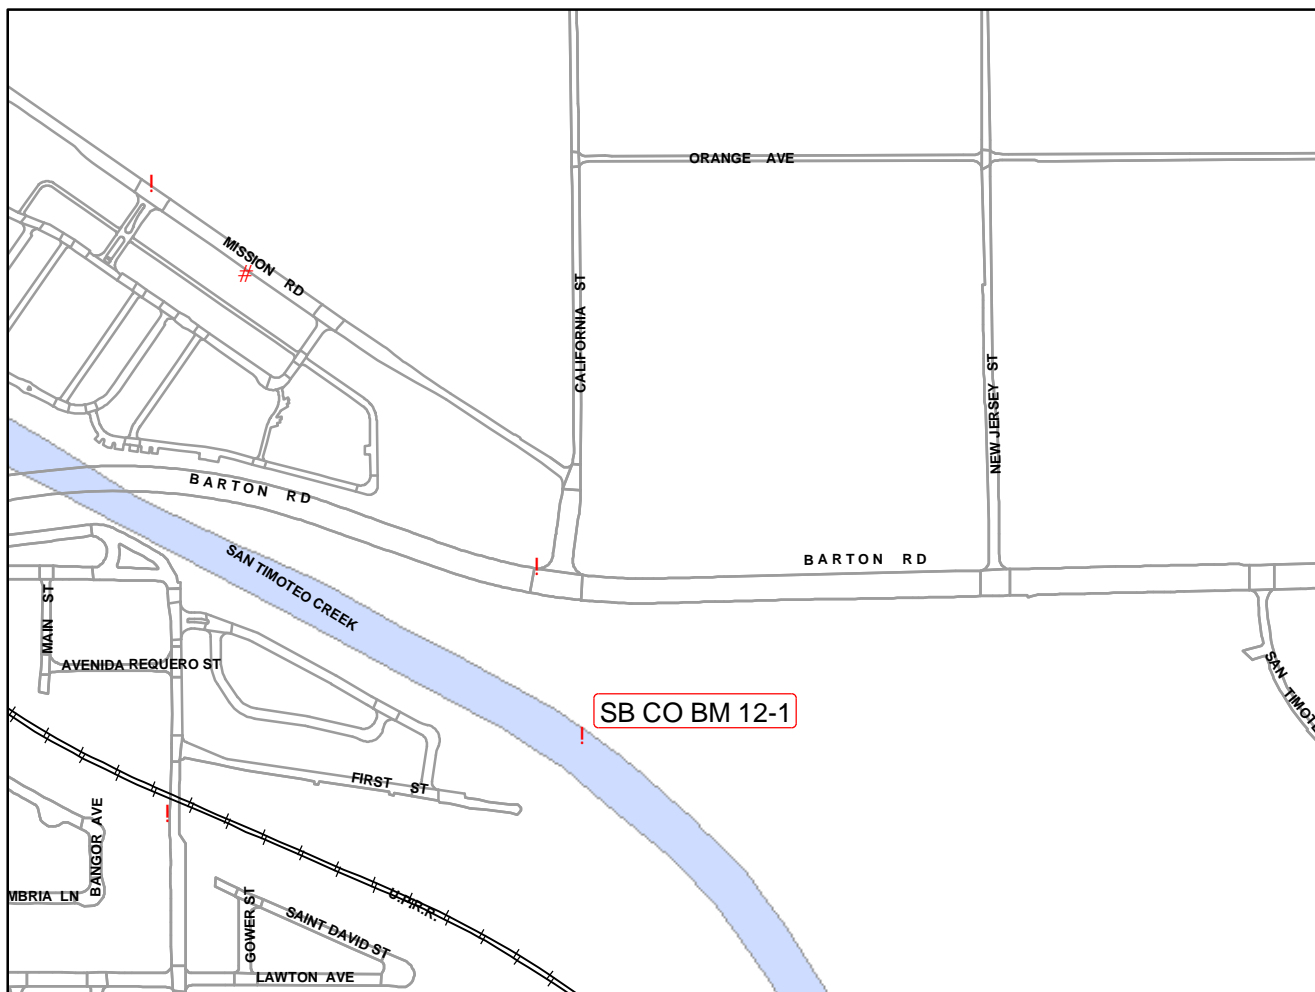
**SB CO BM 12-1**

0.1 MI. SO. OF BARTON RD. & CALIFORNIA ST. SET  
DRIVE PIN W/C.S. TAG, 1 FOOT NO. S.P.R.R.  
TRESSEL, 6 1/2' E. OF E. RAIL S.P. SPUR TRACKS  
NO. SIDE OF SAN TIMOTEO WASH.

1204.352

January 25, 2006: Went to verify location,  
unable to locate. Believed to be  
underground due to construction of San  
Timoteo Channel.

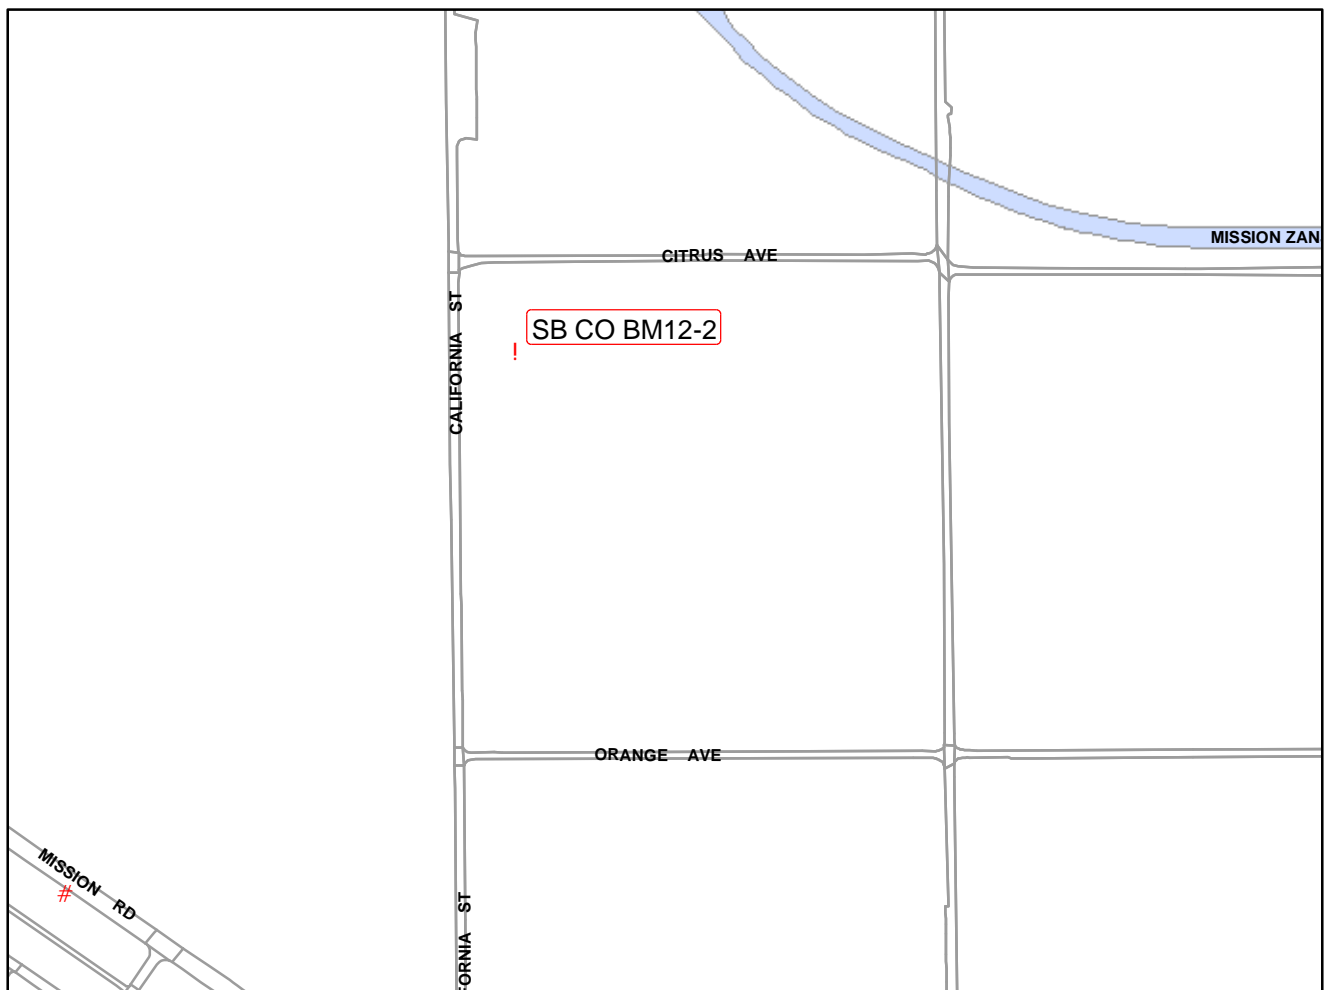
**SB CO BM12-2**

0.5 MI. NORTH ALONG CALIFORNIA ST. FROM  
INTERSECTION OF BARTON RD. & CALIFORNIA ST.,  
SET BRASS DISK IN S.W. CORNER W. HEAD WALL  
FOR S.P. SPUR TRACKS, 96' E. OF CALIFORNIA ST.  
0.1 MI. SOUTH OF CENTERLINE CITRUS AVE. LEVEL  
WITH TRACKS, 125' N.E. OF PP #239

1177.833

January 17, 2006: Went to verify location,  
unable to locate.

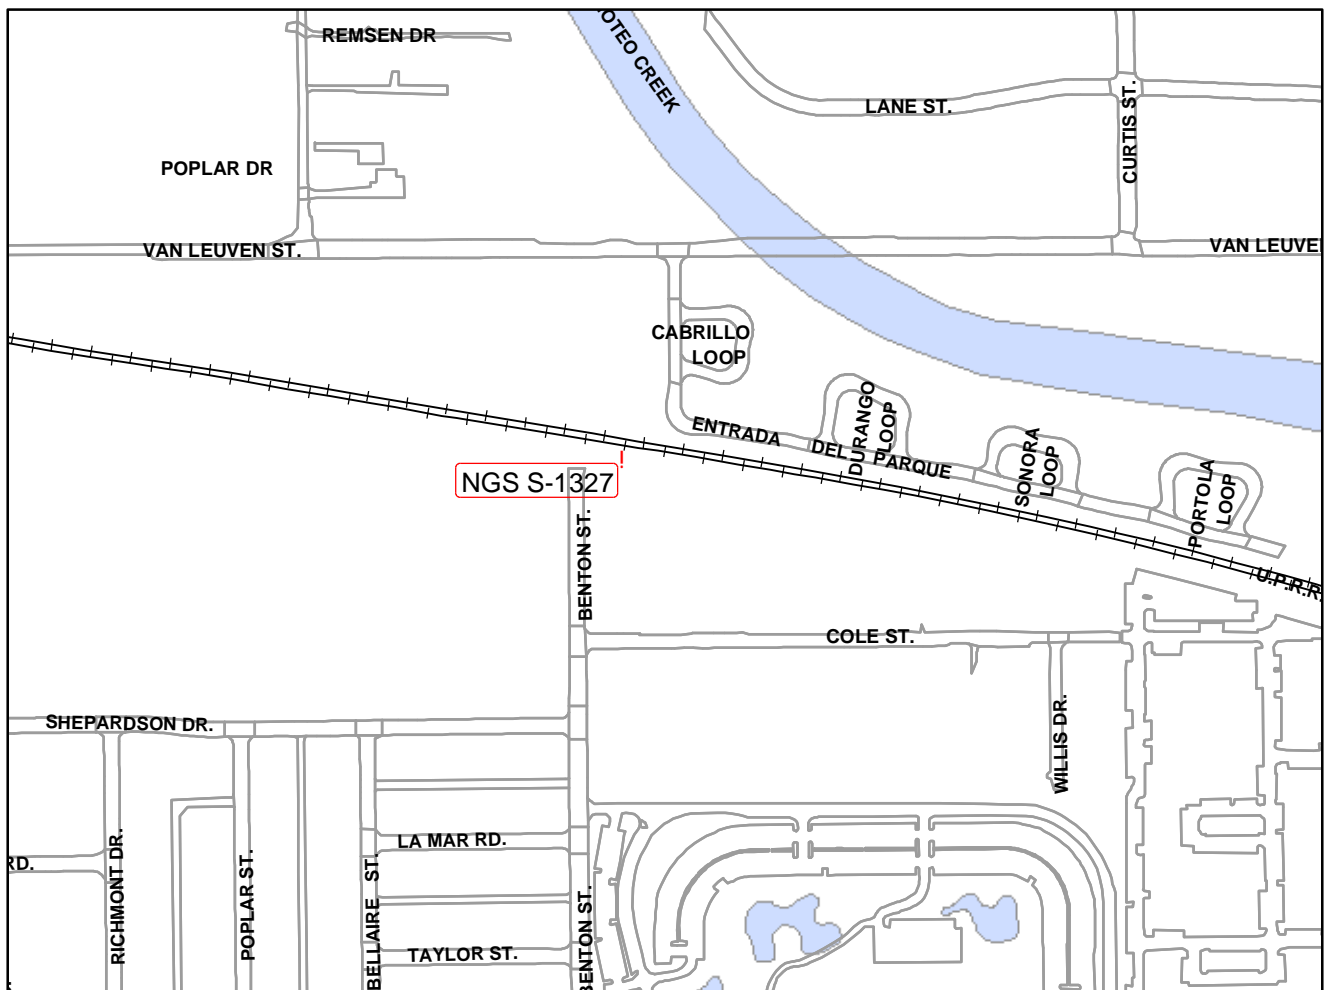
**NGS S-1327**

BRASS CAP IN WEST FOOTING OF RAILROAD  
SIGNAL SUPPORT, SOUTH SIDE OF RAILROAD  
TRACKS, 120' EAST OF CL AT DEAD END OF  
BENTON ST.

1113.245

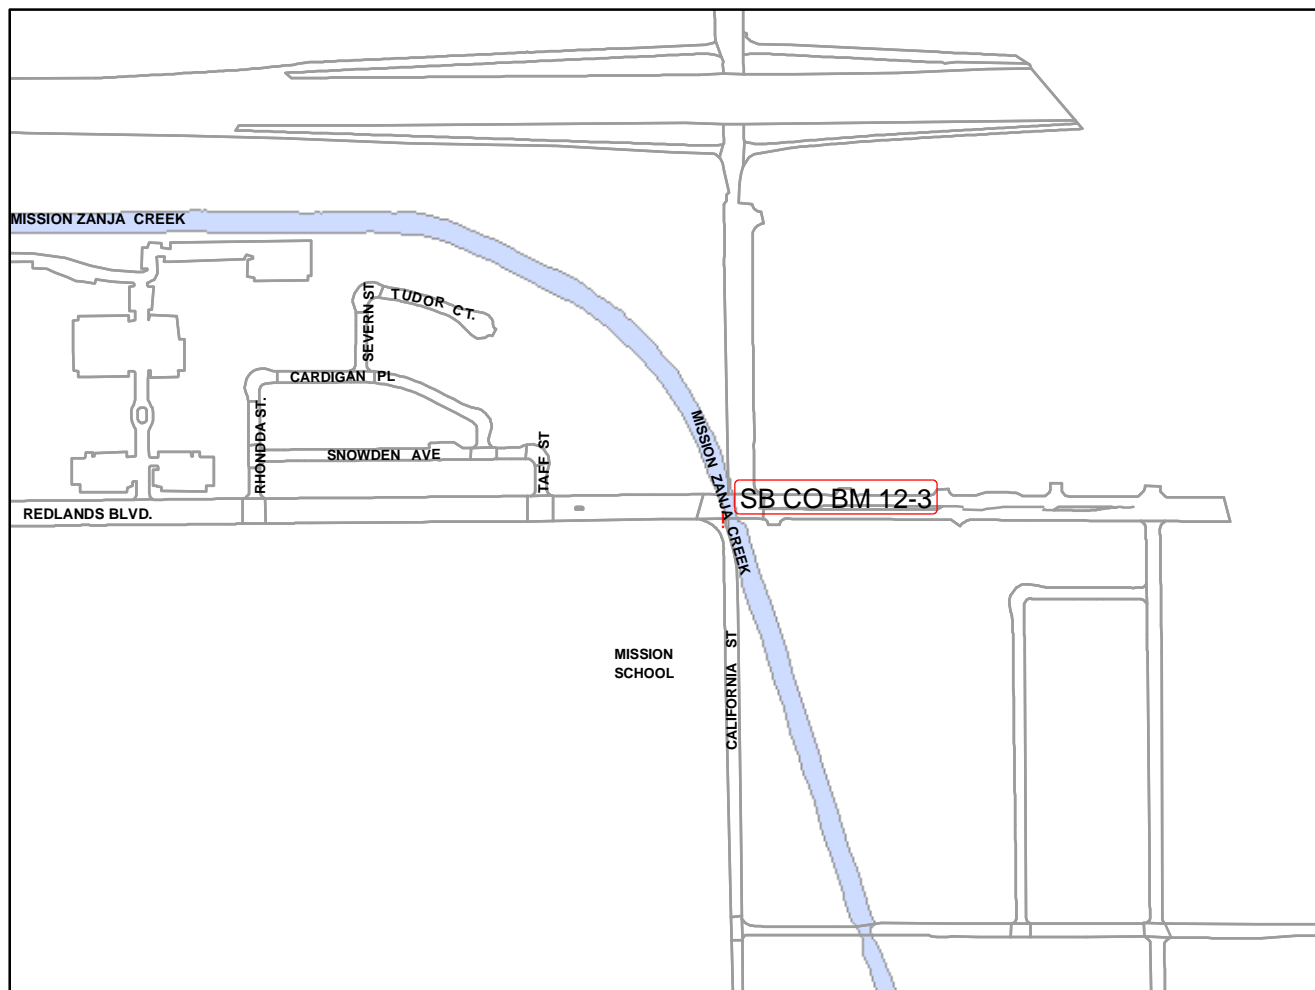
**SB CO BM 12-3**

1.0 MI. NO. ALONG CALIFORNIA ST. FROM  
INTERSECTION OF BARTON RD. & CALIFORNIA ST.  
AT THE INTERSECTION OF CALIFORNIA ST. &  
REDLANDS BLVD., SET BRASS DISK IN MIDDLE OF  
S.W. WING WALL OF BRIDGE #54-08, 48' SO. OF CL  
REDLANDS BLVD., 22' E. OF CL CALIFORNIA ST., 1'  
LOWER THAN REDLANDS BLVD., ACROSS THE  
STREET FROM MISSION SCHOOL GROUNDS

1160.408

January 25, 2006: Verified location. At  
intersection of Redlands Blvd. and  
California St.

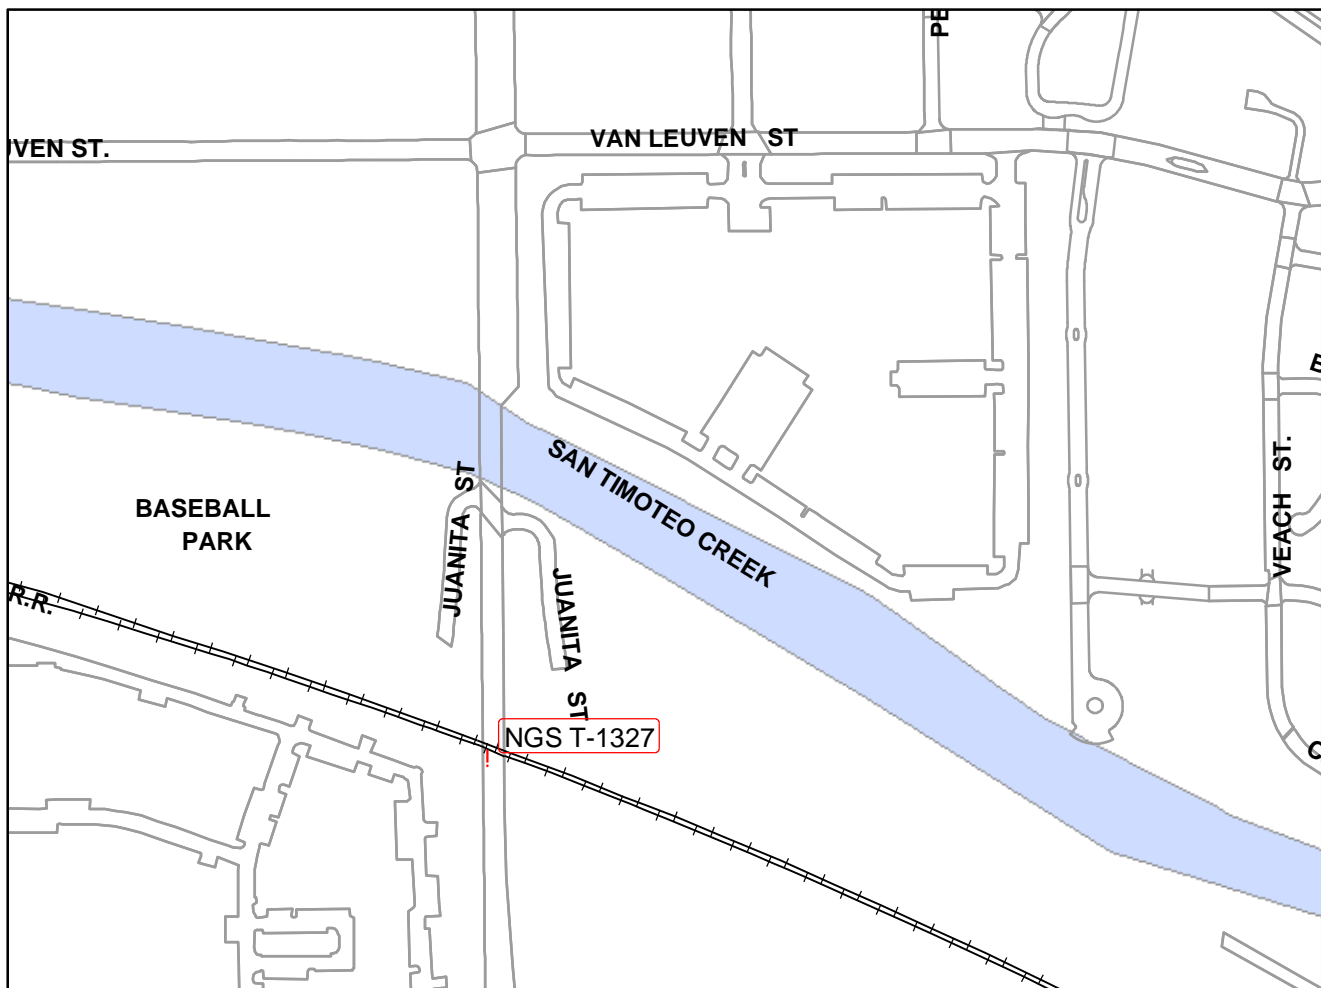
**NGS T-1327**

BRASS CAP SET IN CONC. 0.5 MI. NORTH OF INT.  
MOUNTAIN VIEW AVE. AND BARTON RD. BENEATH  
MOUNTAIN VIEW AVE. R.R. BRIDGE, 15' EAST OF  
WEST EDGE OF BRIDGE, 12' SOUTH OF SOUTH  
RAIL, 0.7' BELOW TOP OF RAIL

1149.168

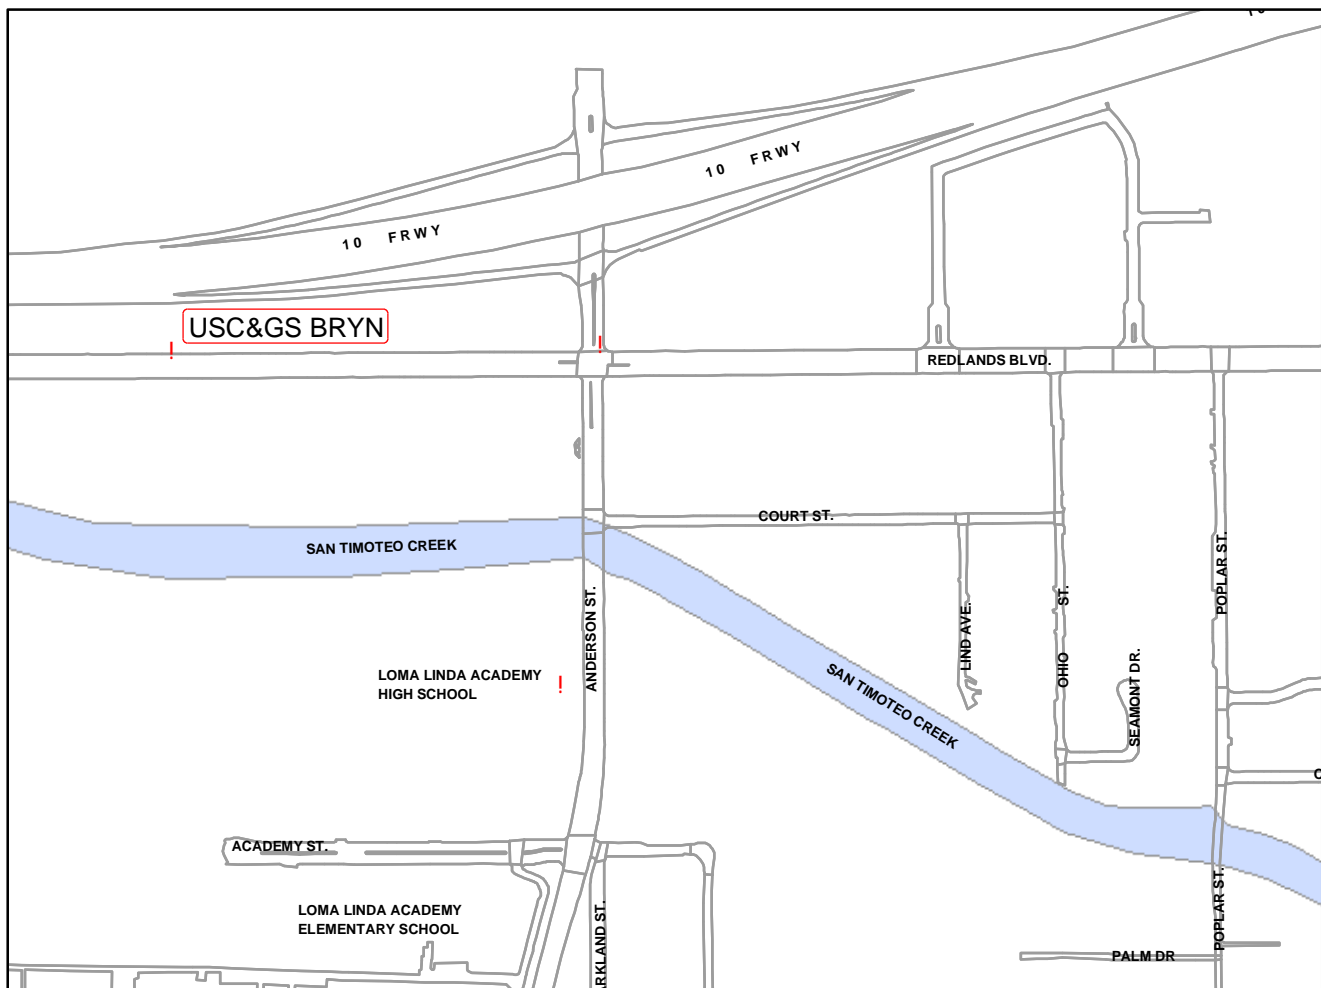
**USC&GS BRYN**

BRONZE TRIANGULATION STA. DISK 0.2 MI. WEST REDLANDS BLVD. AND ANDERSON ST., 26.2' NORTH OF THE CL OF THE NORTH TRAFFIC LANES OF THE BLVD., 4' NORTH OF P.P. NO. 18720 C.W.T., 4 1/2' BEHIND CURB, ABOUT 1' HIGHER THAN THE HIGHWAY, AND SET IN THE TOP OF A CONC. POST PROJECTING 0.2' ABOVE THE GROUND

1052.765

February 7, 2006: Verified location.

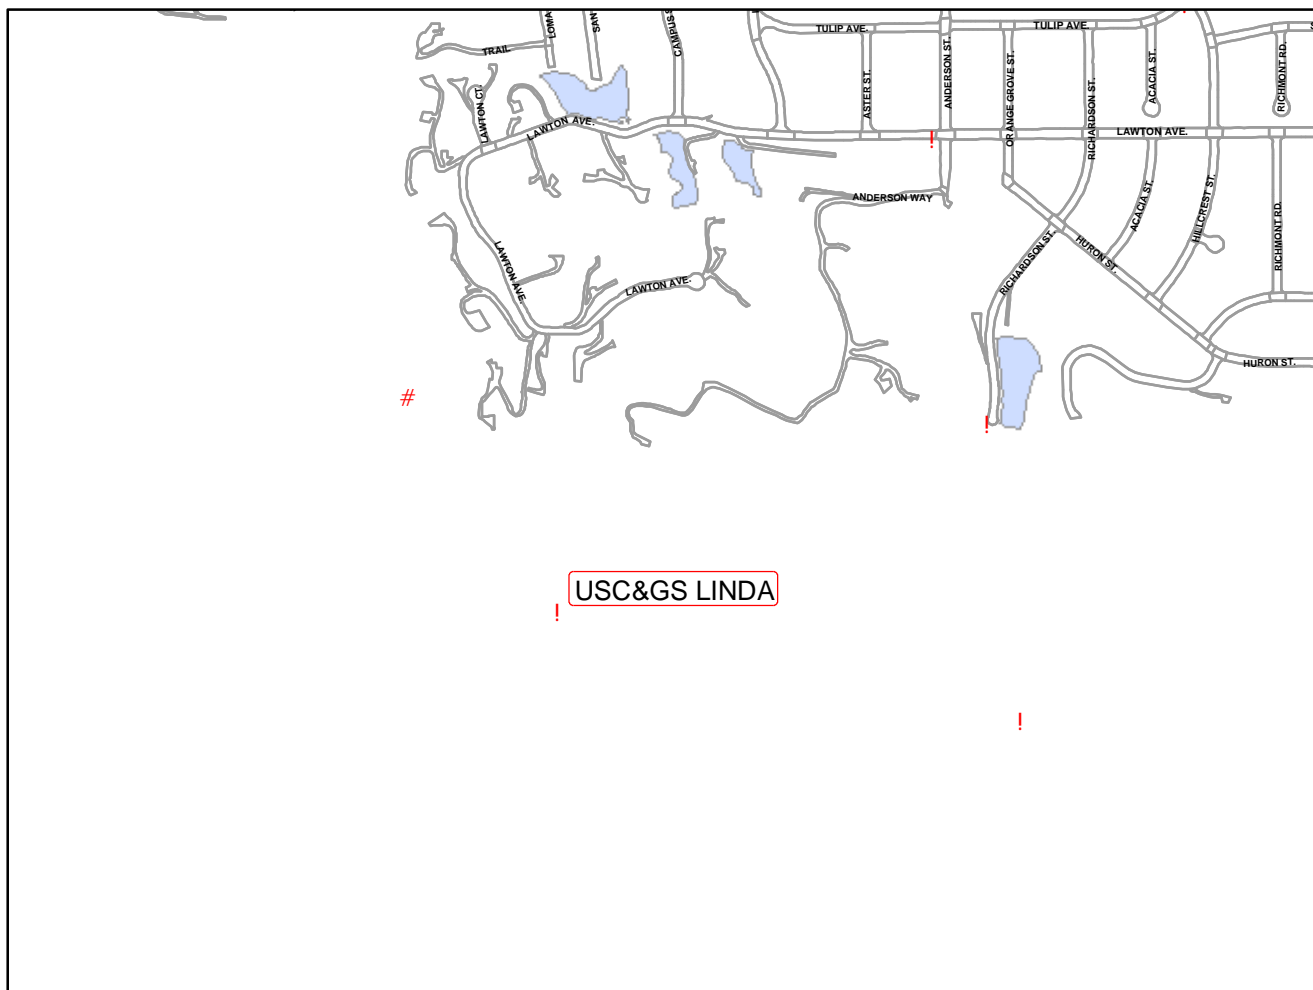
**USC&GS LINDA**

BRONZE TRIANGULATION STA. DISK 0.65 MI.  
SOUTH ALONG TRAIL FROM END OF SIERRA VISTA  
DR., ON SOUTHEASTERN END OF LONG RIDGE,  
AND ABOUT 300' NORTH OF BARREN SPOT  
MARKING HIGHEST PORTION OF RIDGE, JUST IN  
FRONT OF STEEP DECLINE, SET IN 10 IN. SQUARE  
CONC. POST, 2' EAST OF 3' HIGH FENCE POST

1586.074

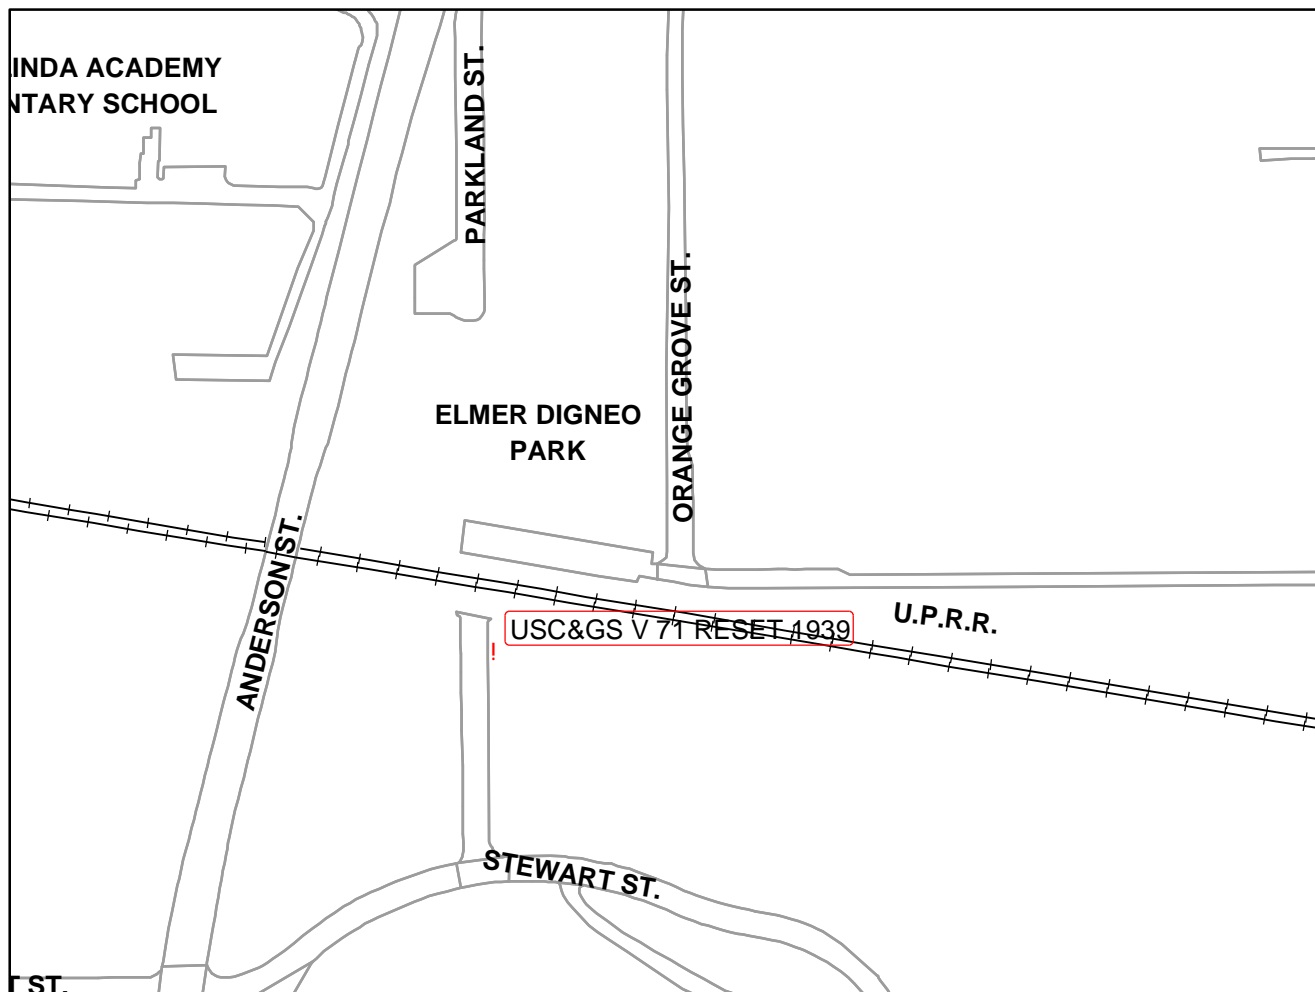
**USC&GS V 71 RESET 1939**

BRONZE DISK ABOUT 105' SOUTH OF THE SOUTH RAIL OF THE MAIN LINE TRACK, 41' EAST OF THE CL OF PARKLAND ST., 18' EAST OF EAST CURB, 1' NORTH OF A WITNESS POST, SET IN THE TOP OF A CONC. POST PROJECTING 0.6' ABOVE THE GROUND

1079.680

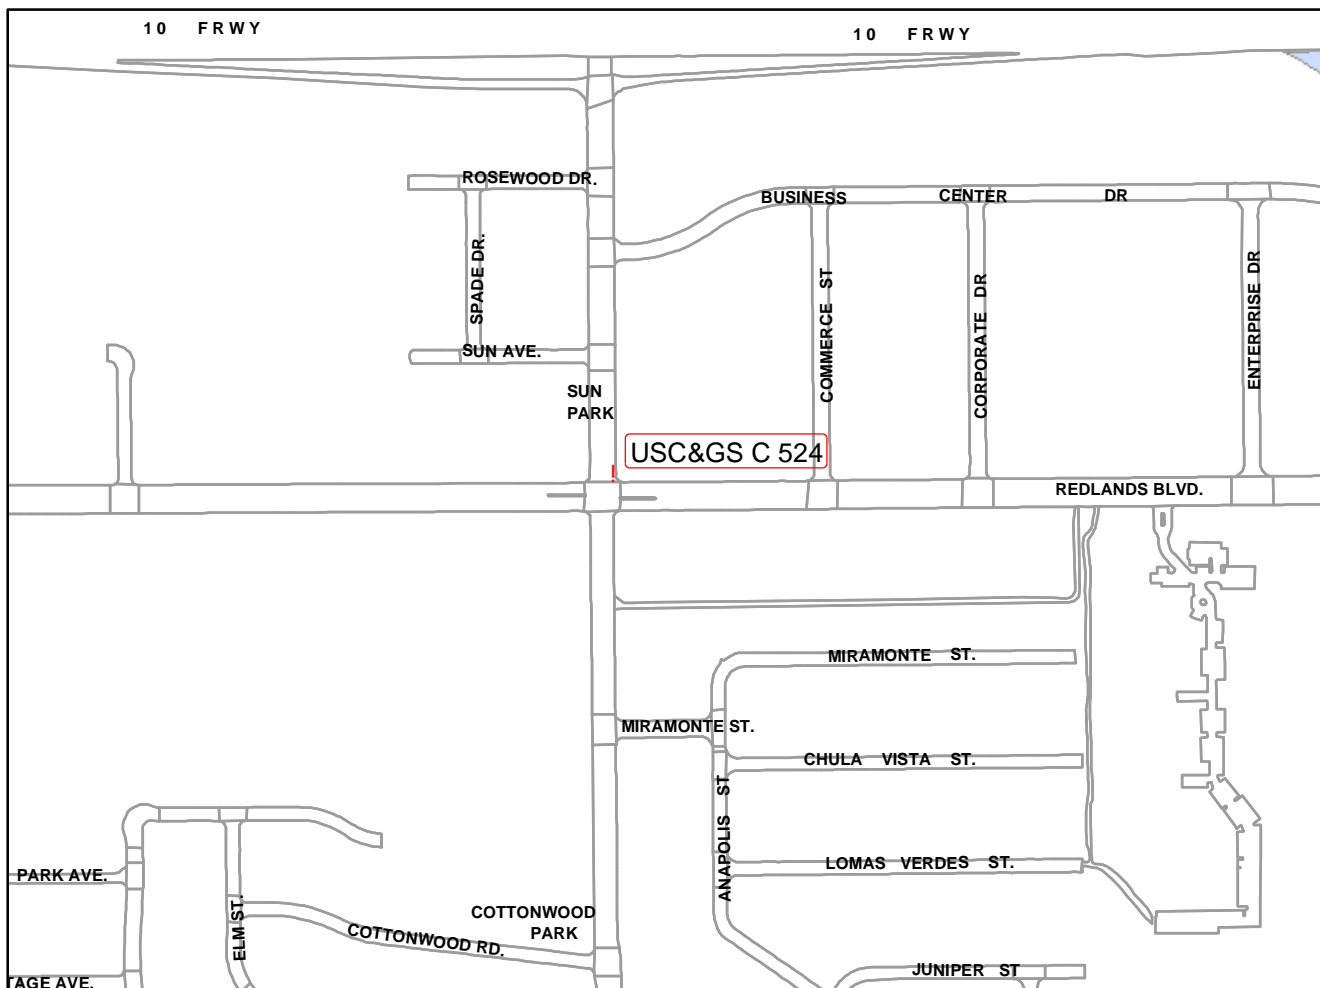
**USC&GS C 524**

BRASS DISK AT THE INT. OF REDLANDS BLVD. AND MT. VIEW AVE. 23.0' NORTH OF THE NORTH CURB OF REDLANDS BLVD., 2.1' EAST OF THE EAST CURB OF MT. VIEW AVE., 11' SOUTH OF P.P. 1789141E, ABOUT 1/2' HIGHER THAN THE AVE., AND SET IN TOP OF A CONC. POST PROJECTING 0.4' ABOVE GROUND

1113.360

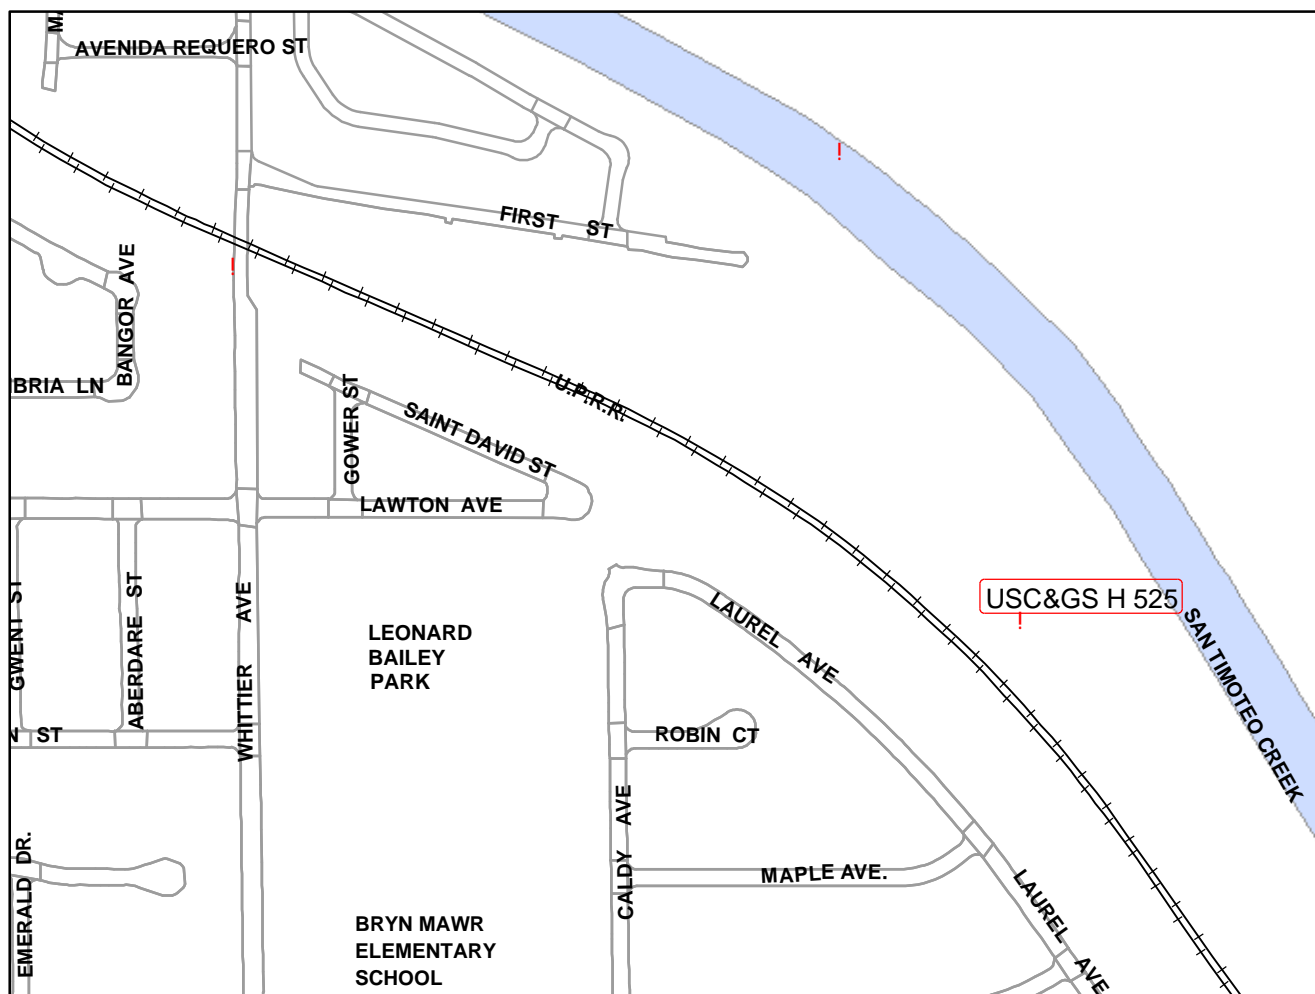
**USC&GS H 525**

BRASS DISK 0.4 MI. S.E. ALONG THE SOUTHERN PACIFIC RAILROAD CO. R.R. FROM THE STATION AT BRYN MAWR, 39.7' EAST OF THE EAST RAIL, 11' EAST OF THE CL OF A TRACK ROAD, 2.6' EAST OF THE 1ST POLE WEST OF MILEPOST 545, 1.7' WEST OF A WITNESS POST, ABOUT 1' HIGHER THAN THE TRACK, AND SET IN A CONC. POST PROJECTING 0.5' ABOVE GROUND

1231.057

February 7, 2006: Went to verify location, unable to locate.

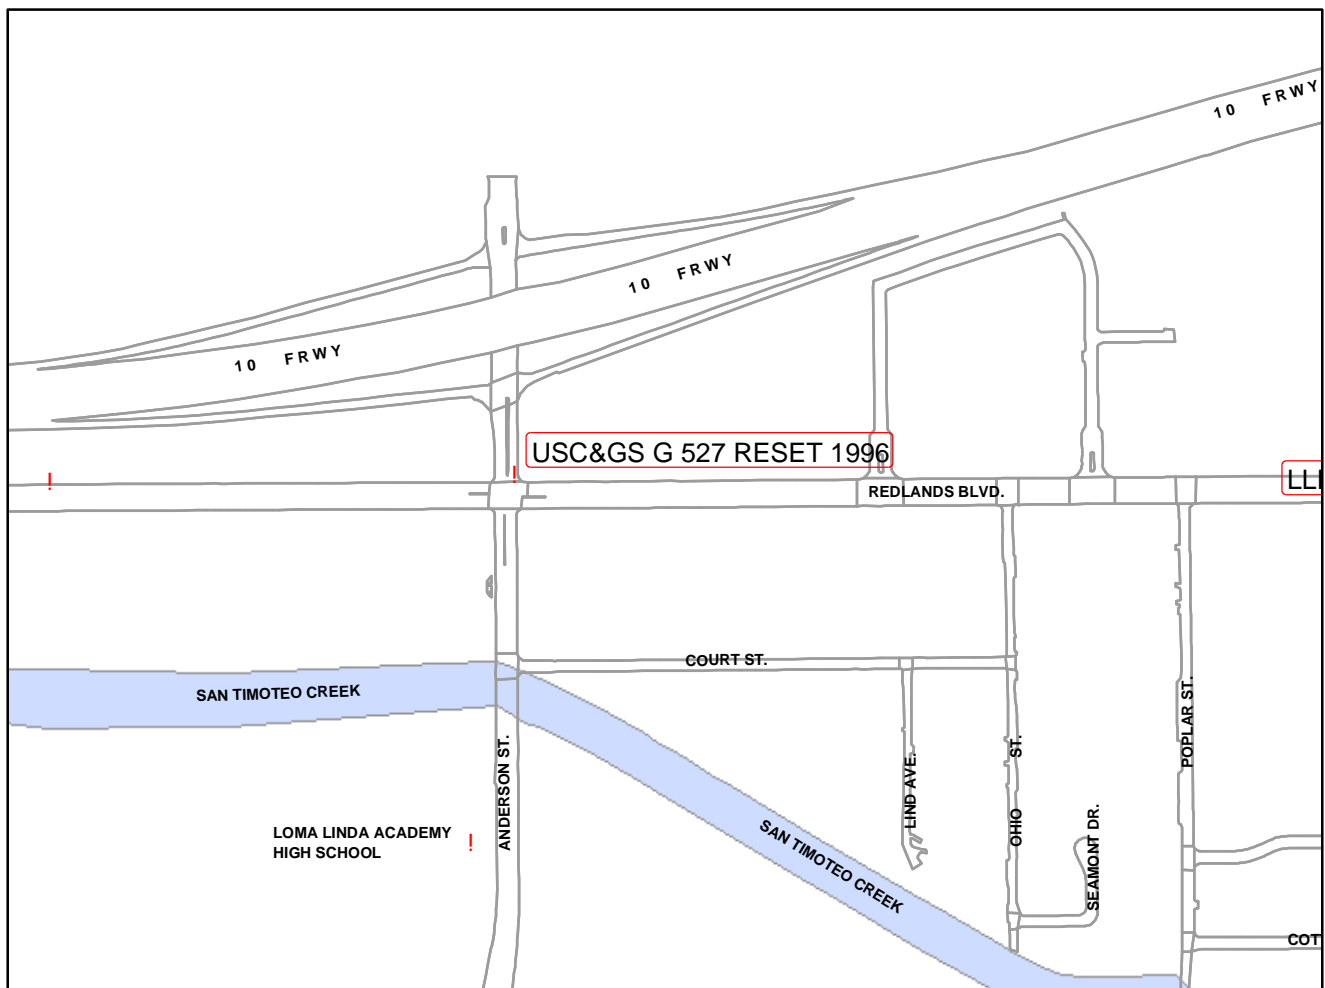
**USC&GS G 527 RESET 1996** USC&GS

STANDARD DISK LOCATED 0.5 MI. NORTH ALONG ANDERSON ST. FROM THE CROSSING OF THE SOUTHERN PACIFIC CO. R.R. AT LOMA LINDA, AT THE INTERSECTION OF REDLANDS BLVD., IN THE TOP OF THE NORTH END OF THE N.E. CURB RET.

1064.854

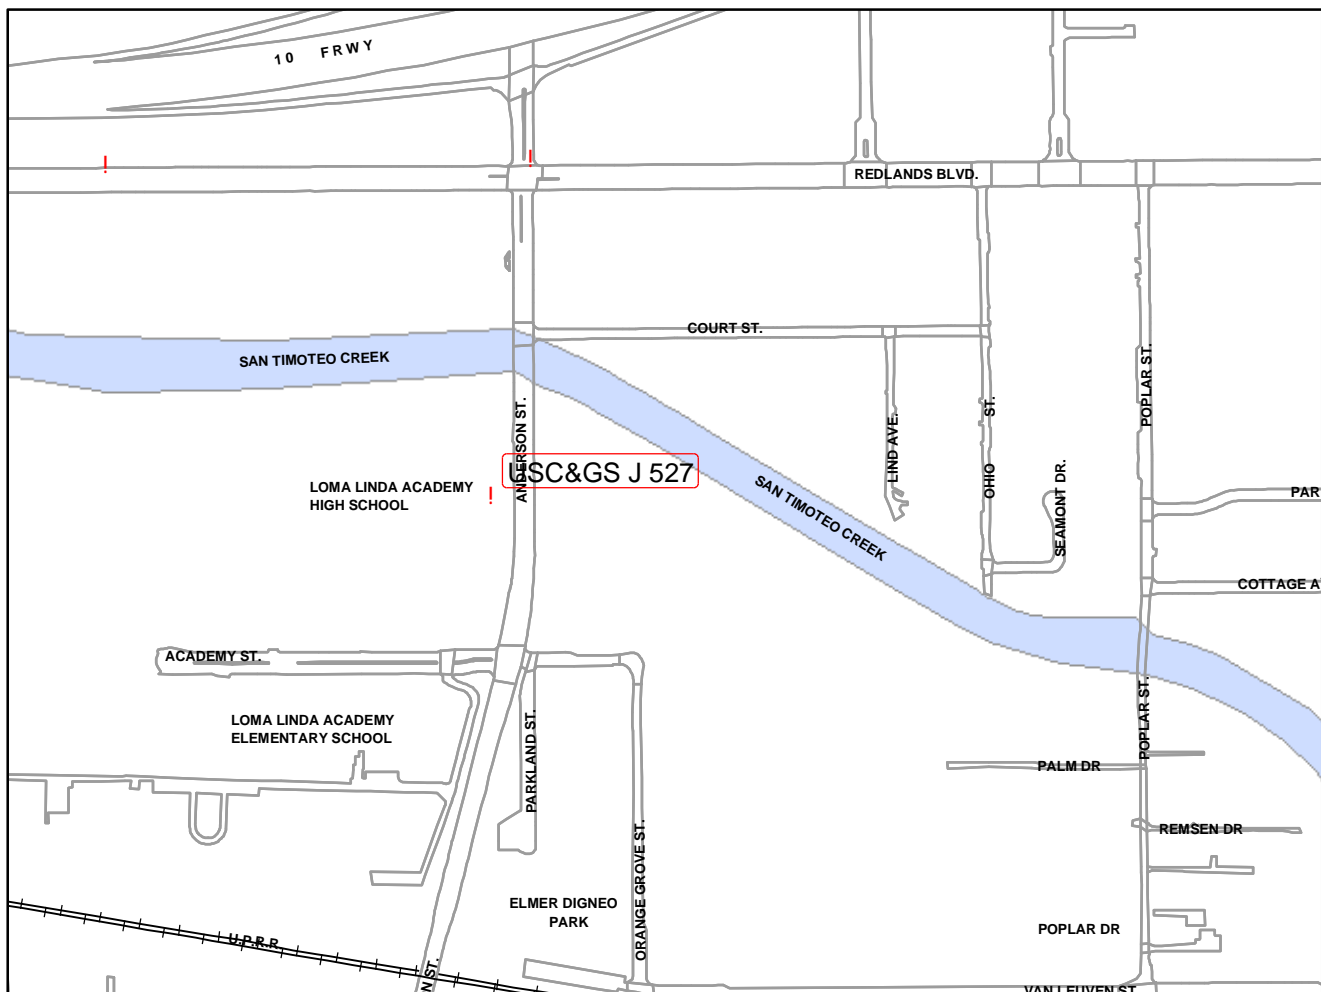
**USC&GS J 527**

BRASS DISK 0.30 MI. NORTH ALONG ANDERSON ST.  
FROM THE CROSSING OF THE SOUTHERN PACIFIC  
CO. R.R., AT THE LOMA LINDA ACADEMY, SET  
VERTICALLY IN THE EAST FACE OF THE SOUTH  
CONCRETE COLUMN AT THE MAIN ENTRANCE, 96.4'  
WEST OF THE CL OF THE STREET 1.2' SOUTH OF  
THE SOUTH EDGE OF THE ENTRANCE AND 0.7'  
ABOVE THE ENTRANCE FLOOR

1073.730

January 25, 2006: Verified location.

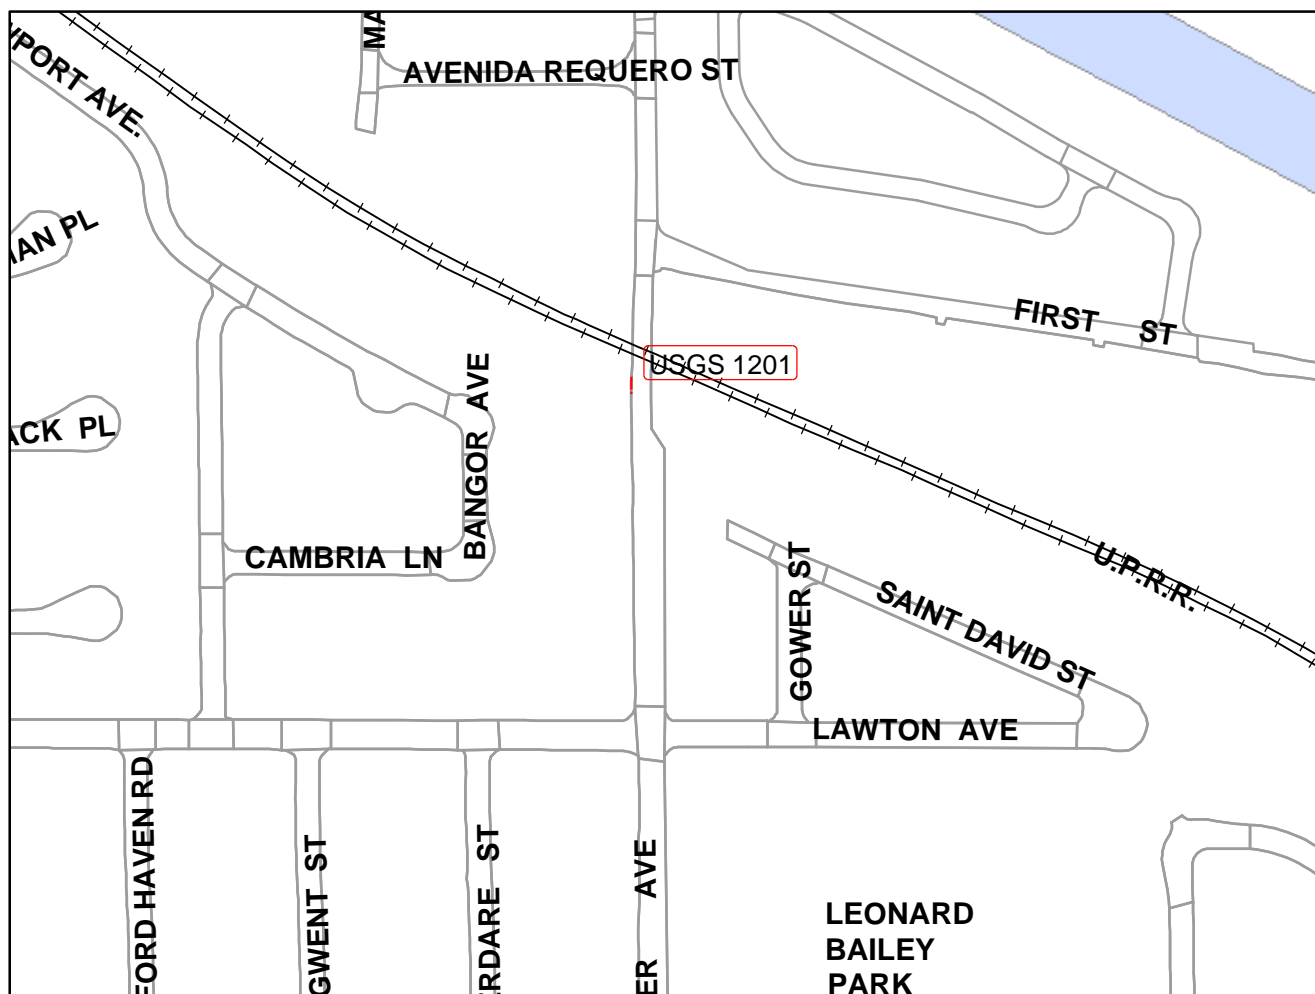
**USGS 1201**

BRONZE CAP AT RAILROAD CROSSING B544.5  
(WHITTIER AVE.), 11 1/2' EAST OF P.P. NO.  
1407053E, 17' WEST OF THE CL OF WHITTIER AVE.,  
13' SOUTH OF THE CENTER OF CULVERT 544.47  
AND RIVETED ON TOP OF A 3 1/2 INCH IRON PIPE  
PROJECTING 0.6' ABOVE GROUND, 51' SOUTH OF  
THE SOUTH TRACK OF THE MAINLINE, AND IN LINE  
WITH THE SOUTH RIGHT OF WAY FENCE

1201.445

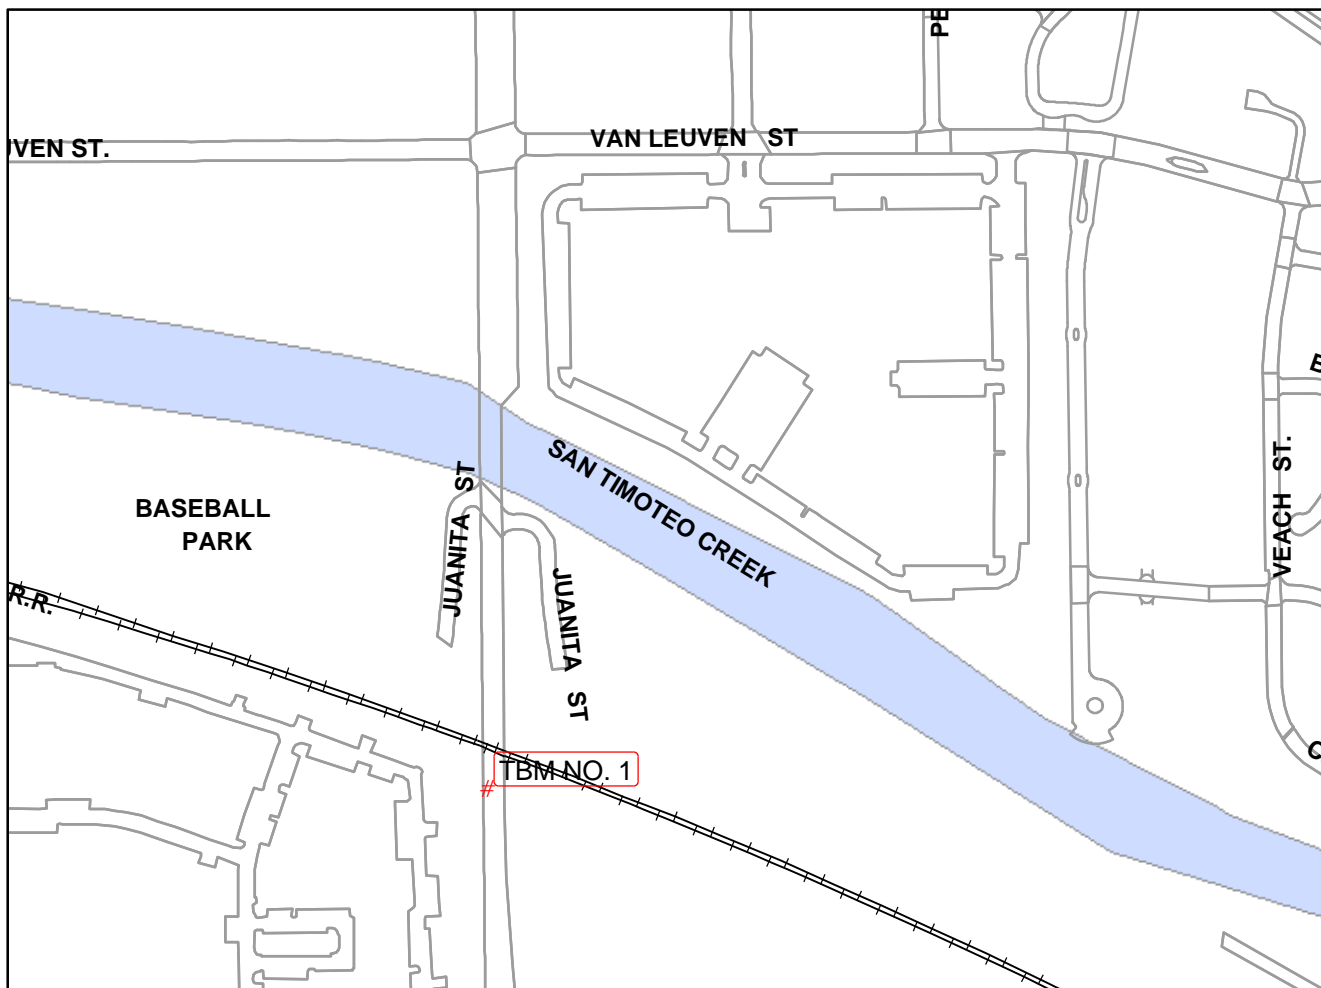
**TBM NO. 1**

SPIKE IN SIDEWALK 1' BEHIND CURB ON WEST  
SIDE OF MOUNTAIN VIEW AVE. AT THE SOUTH END  
OF ABUTEMENT FOR BRIDGE OVER RAILROAD  
TRACKS

1182.089

February 7, 2006: Verified location, no ID.

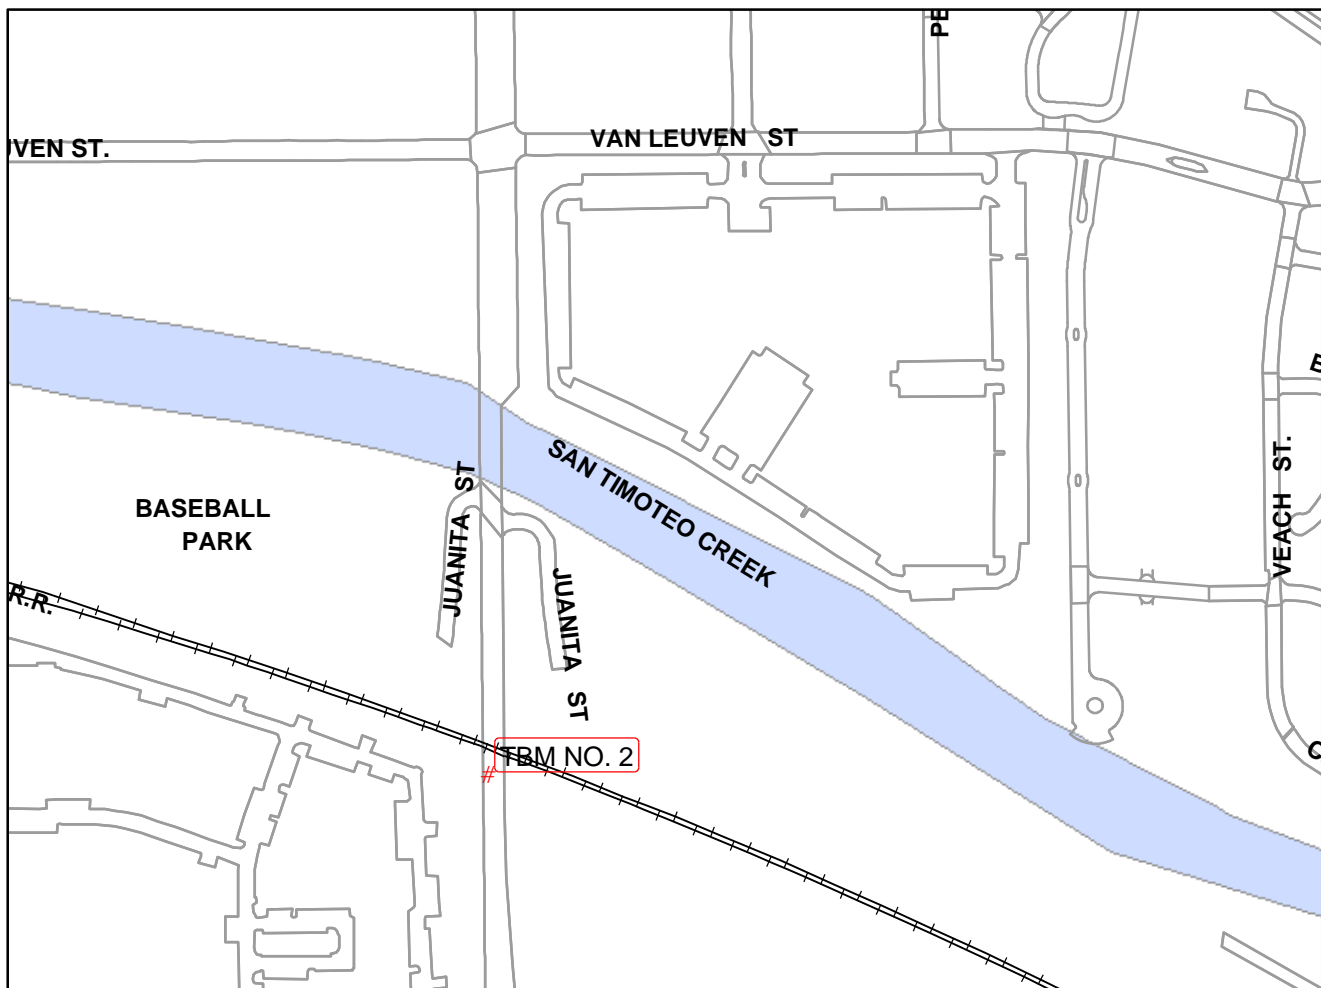
**TBM NO. 2**

SPIKE IN SIDEWALK 1' BEHIND CURB ON WEST  
SIDE OF MOUNTAIN VIEW AVE. AT SOUTH END OF  
BRIDGE OVER RAILROAD TRACKS

1181.533

February 7, 2006: Verified location, no ID.
