# **CITY OF LOMA LINDA**

**BENCH MARKS**

# City of Loma Linda Bench Mark Map

# Bench Marks

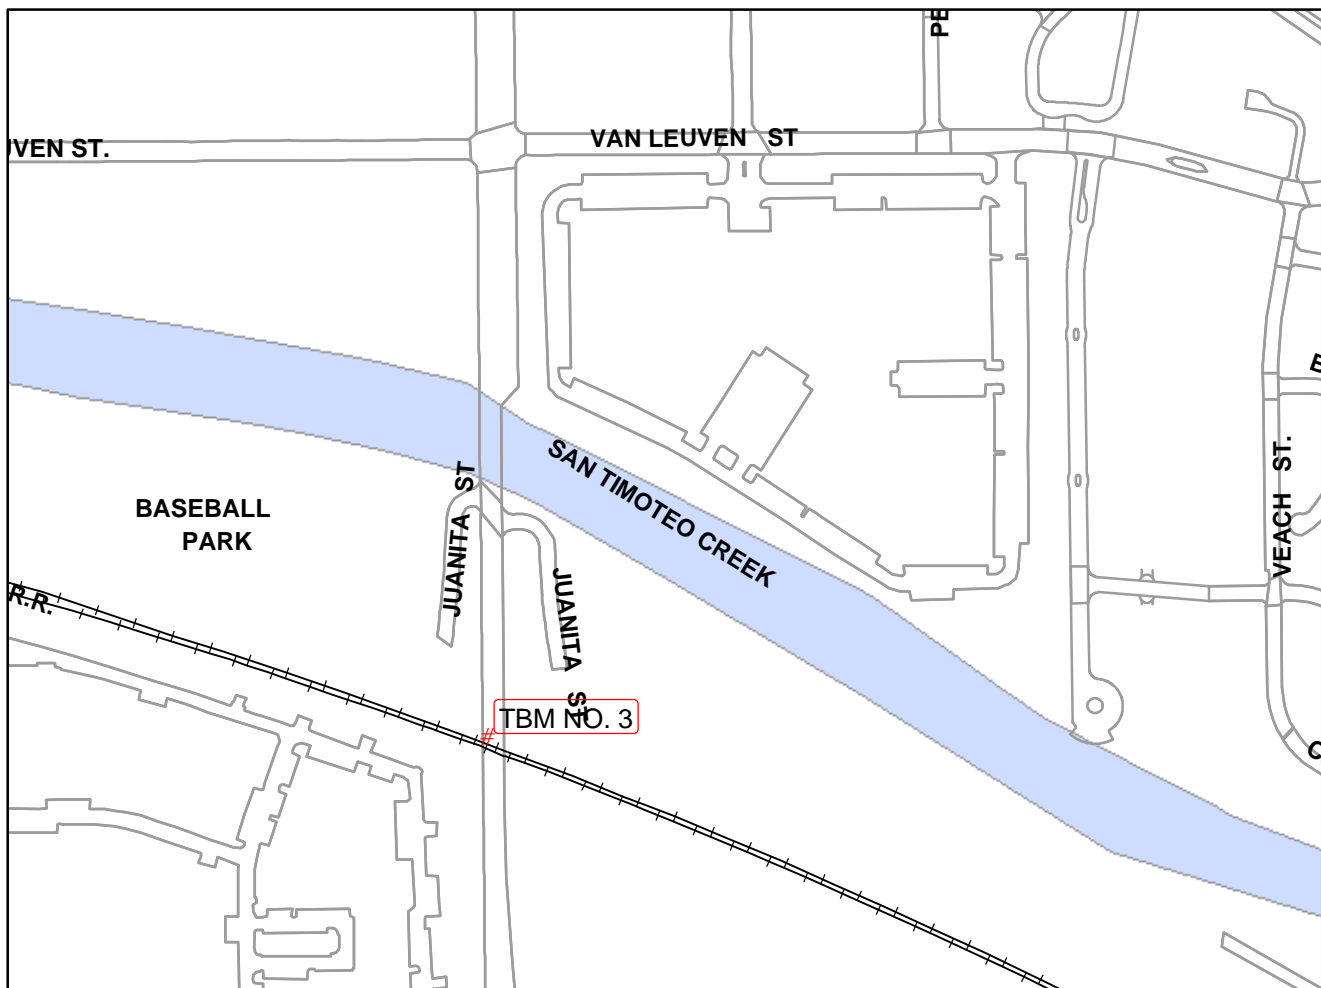
**TBM NO. 3**

SPIKE IN SIDEWALK 1' BEHIND CURB ON WEST  
SIDE OF MOUNTAIN VIEW AVE. APPROXIMATELY IN  
MIDDLE OF BRIDGE OVER RAILROAD TRACKS

11/19/6855 1179.460

February 7, 2006: Verified location, no ID.

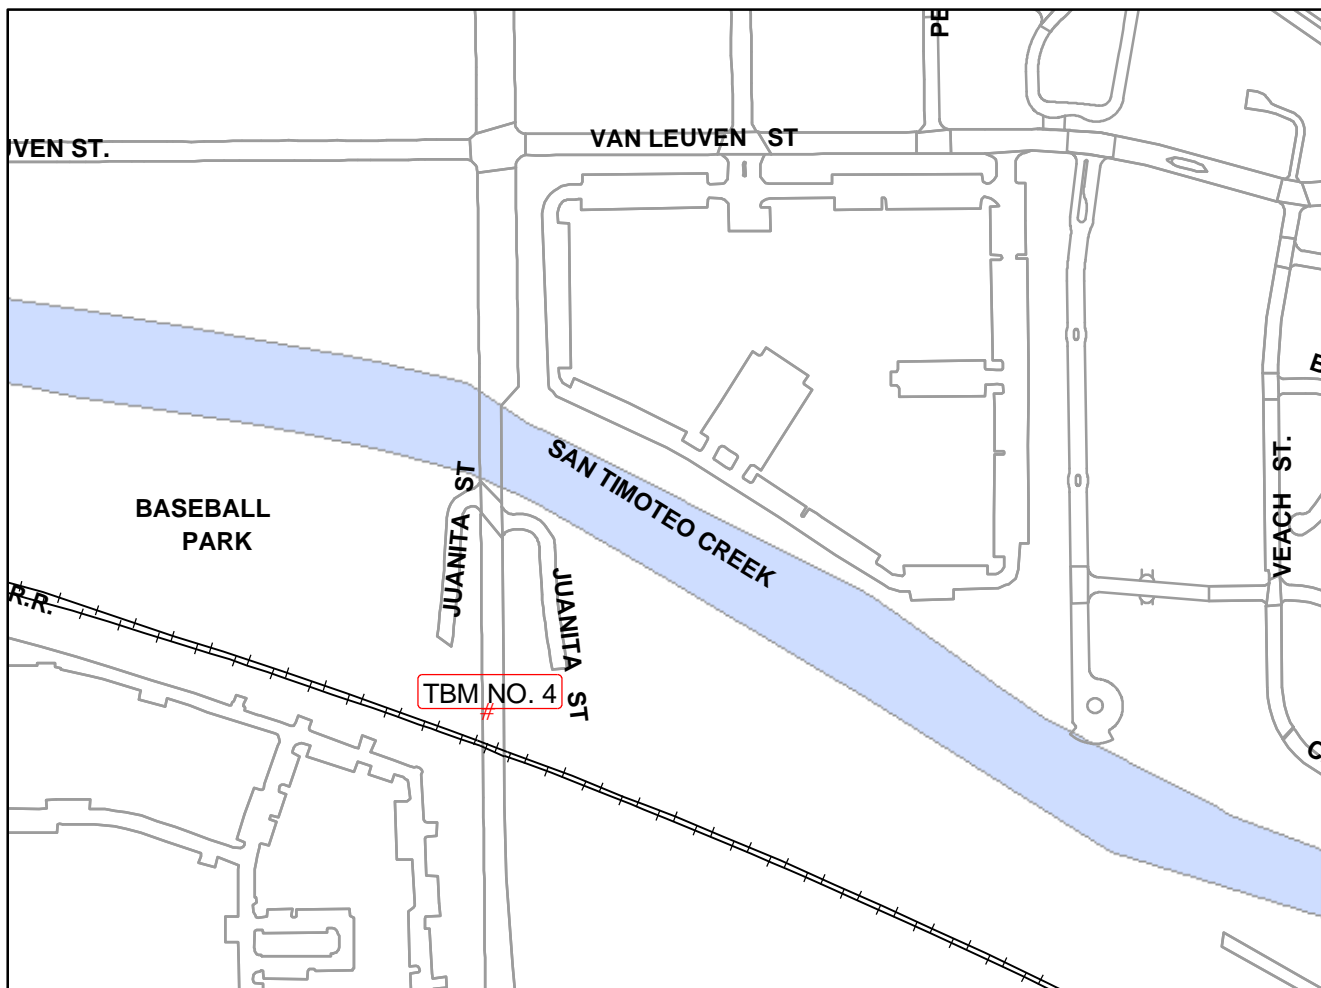
**TBM NO. 4**

SPIKE IN SIDEWALK 1' BEHIND CURB ON WEST  
SIDE OF MOUNTAIN VIEW AVE. AT NORTH END OF  
BRIDGE OVER RAILROAD TRACKS

1177.524

February 7, 2006: Verified location, no ID.

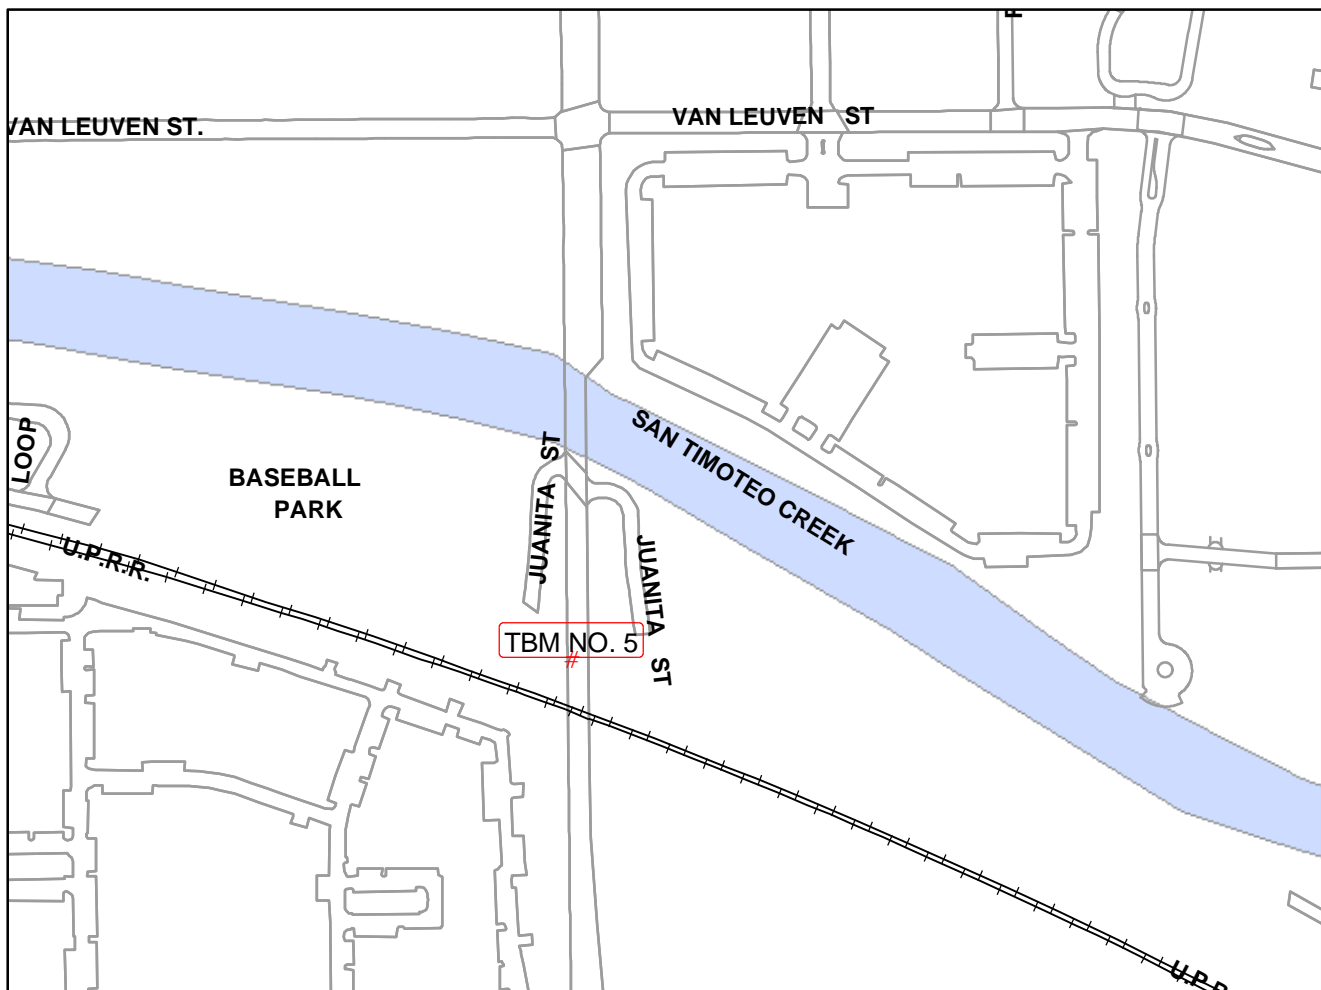
**TBM NO. 5**

SPIKE IN SIDEWALK 1' BEHIND CURB ON WEST  
SIDE OF MOUNTAIN VIEW AVE. AT NORTH END OF  
NORTH ABUTEMENT FOR BRIDGE OVER RAILROAD  
TRACKS

1176.036

February 7, 2006: Verified location, no ID.
